## MARINE INVESTIGATION REPORT

M09W0064

COLLISION

UNITED STATES FISHING RESEARCH VESSEL *VELERO IV*

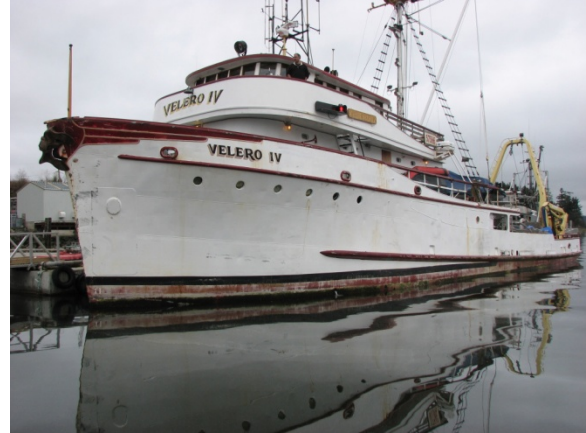
**Photo 1.** *Velero IV*

The *Velero IV* is a U.S.-registered fishing research vessel (see Photo 1) of welded steel construction with accommodation for 12 persons. The vessel is powered by a direct-drive diesel engine. The wheelhouse is equipped with navigation and communications equipment including radar, depth sounder, very high frequency (VHF) radiotelephones, two autopilots, an automatic identification system (AIS), a chart plotter, and a global positioning system (GPS). Fitted atop the vessel's deckhouse are three 1000-watt quartz floodlights and a spotlight. From the seated conning position on the bridge, visibility is obstructed in some areas to the stern and on the port bow directly below the line of sight of the vessel's superstructure. The vessel also packs salmon and herring during the fishing season.

The *Velero IV* sustained damage to the port side shell plating amidships in the area above and below the waterline, as well as damage to the steel cap/wood trim of the bulwarks near the port bow.

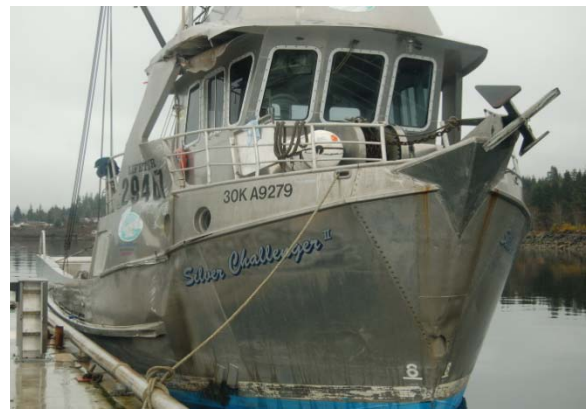
**Photo 2.** *Silver Challenger II*

The *Silver Challenger II* is a small fishing vessel (see Photo 2) of closed construction with a welded aluminum hull and deckhouse. The deckhouse is located forward of amidships and contains the wheelhouse, the galley, accommodation, the engine room entrance, and stairs to the wheelhouse. The wheelhouse is equipped with a centreline steering station and navigation and communications equipment including radar, depth sounder, VHF radios, an autopilot, a chart plotter, and a GPS. The steering station offers an all-round view. It is not equipped with an AIS, nor is this required.

The *Silver Challenger II* sustained damage to the starboard portion of the deckhouse and starboard upper deck, causing it to lose watertight integrity in that area. The master made repairs in Port Hardy to the satisfaction of Transport Canada before being allowed to continue the voyage.
