# MARINE INVESTIGATION REPORT

## M16C0137

### Collision

Passenger vessel C03097QC  
Les Bergeronnes, Quebec  
29 August 2016

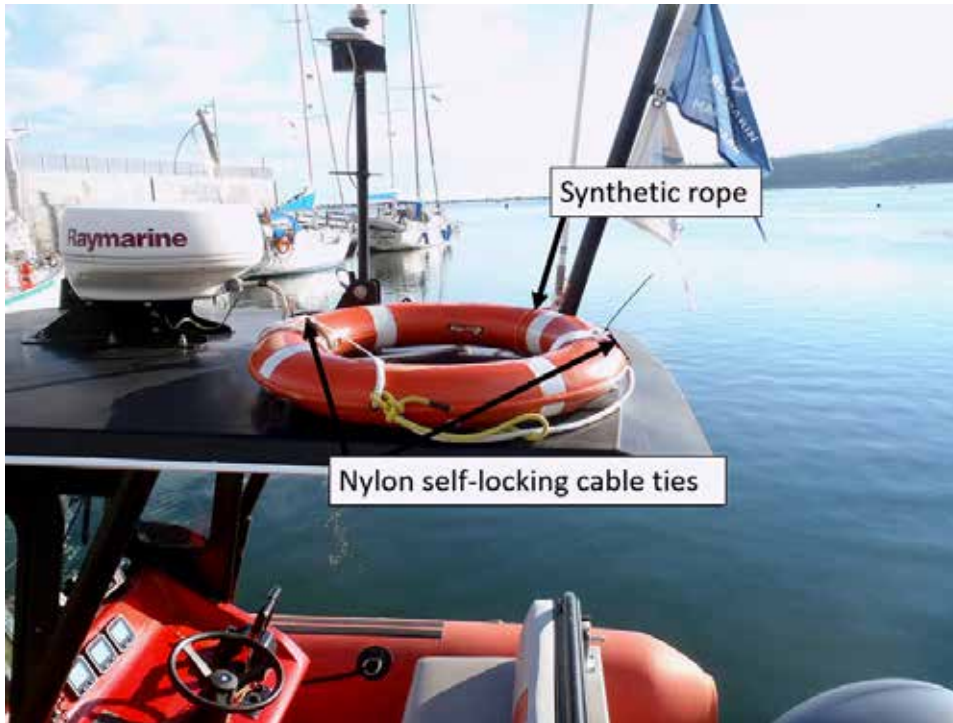
Figure 3. Lifebuoy stowage arrangement

have identified the missing re-boarding device, the improperly stowed lifebuoy, the inadequacy of a single dual-watch VHF radio to monitor 5 different frequencies, the non-configured DSC function, the incomplete passenger pre-departure briefing, and the vessel modifications done by the AR.

Specifically, the issues identified were the improper stowage of lifebuoys, the incomplete digital selective calling configuration of the very high frequency radiotelephones, the absence of a re-boarding device on board vessels that require one, the lack of use of the propulsion shutdown safety lanyard by operators, and incomplete pre-departure briefings to passengers.

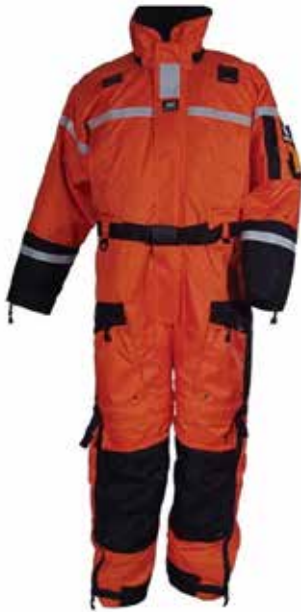
The vessel operator and the passengers of the *Aventure 6* wore flotation clothing to protect themselves in adverse environmental conditions and in the event of an emergency. The vessel operator wore a Helly Hansen 1-piece flotation suit (Figure 5) and every passenger wore a Mustang flotation jacket, which is classified as marine anti-exposure apparel, and regular (non-buoyant, uninsulated) water-resistant pants (Figure 6).

Figure 5. Helly Hansen 1-piece flotation suit worn by vessel operator

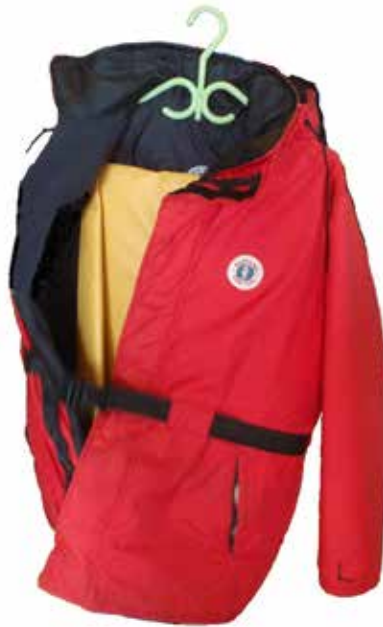
Figure 6. Mustang flotation jacket and yellow water-resistant pants worn by passengers

2. The *Aventure 6* did not comply with the confirmation letter, which required that the passengers wear lifejackets and that a copy of the vessel's stability document be kept on board at all times. The passengers and the operator were instead wearing Transport Canada-approved personal flotation devices.
