# MARINE INVESTIGATION REPORT

## M17P0400

### Striking of No. 2 berth

Roll-on/roll-off ferry *Seaspan Swift*  
Tilbury Island, Delta, British Columbia  
15 November 2017

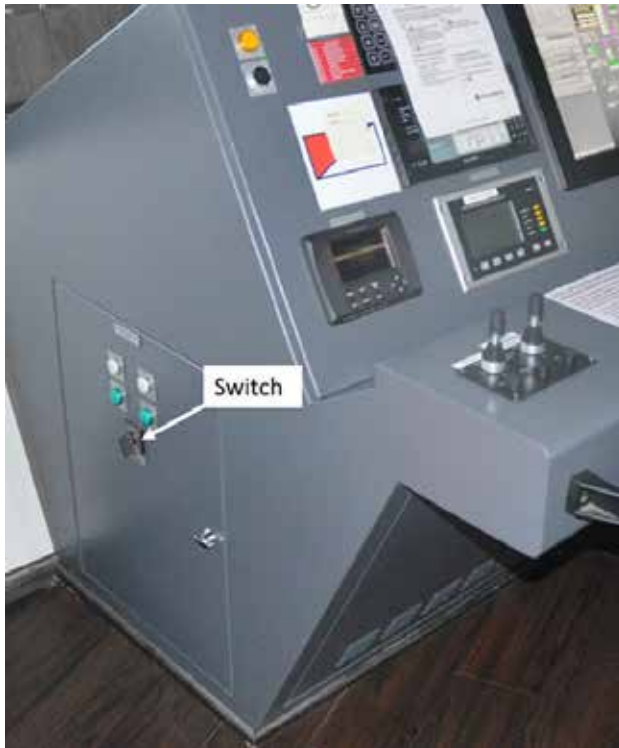
Figure 2. Location of switch

At approximately 1518, the regular master came up to the bridge in preparation to take over command from the relief master once the vessel was berthed. The regular master stood by on the port side of the bridge control console near a protruding electrical switch<sup>8</sup> (Figure 2).

At 1519, the regular master's knee made contact with the switch.<sup>9</sup> This momentarily turned off both radar displays and activated the bridge windshield washer, which sprayed water onto the bridge windows.

<sup>9</sup> After the occurrence, the company electrician checked the switch and determined that it had a loose connection.

In this occurrence, the accidental power outage caused by a crew member's knee contacting an uncovered switch on the side panel resulted in a confusing and distracting situation on the bridge.

- The loose connection in the 120V switch that triggered the momentary power interruption to the radar displays was repaired, and a protective arrangement was installed over the switch. The company also posted a list of equipment connected to this switch.

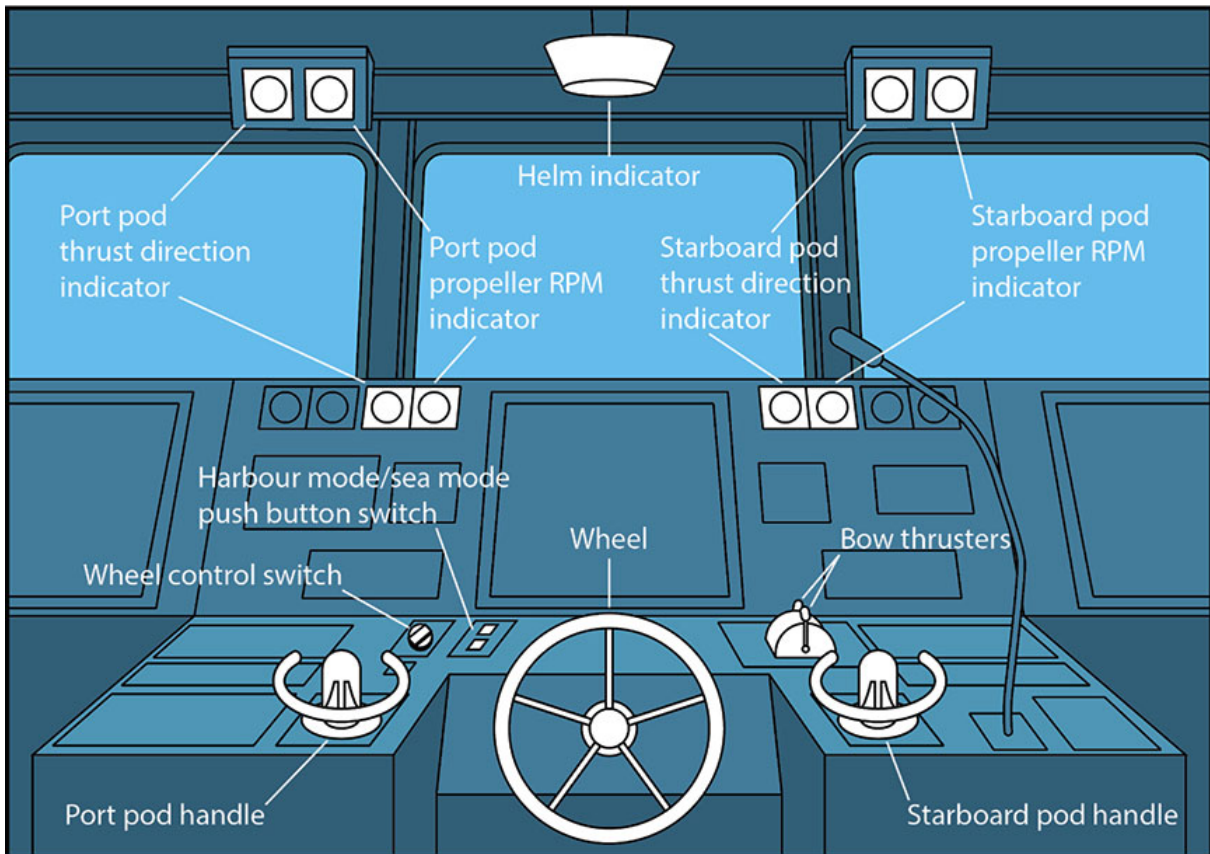
Figure 3. Layout of steering controls and indicators on the 2 vessels

The *Seaspan Swift* and its sister vessel, the *Seaspan Reliant*, were originally designed with 2 types of manual steering controls: a wheel and pod handles. The pod handles, located on either side of the bridge centre console (Figure 3), can turn the pods independently or in synchro mode.<sup>15</sup> The pods are capable of rotating horizontally 360° in either direction. When the steering control is set to the pod handles, an indicator on the propulsion control panel, labelled “AZIMUTH,” lights up (Figure 4).

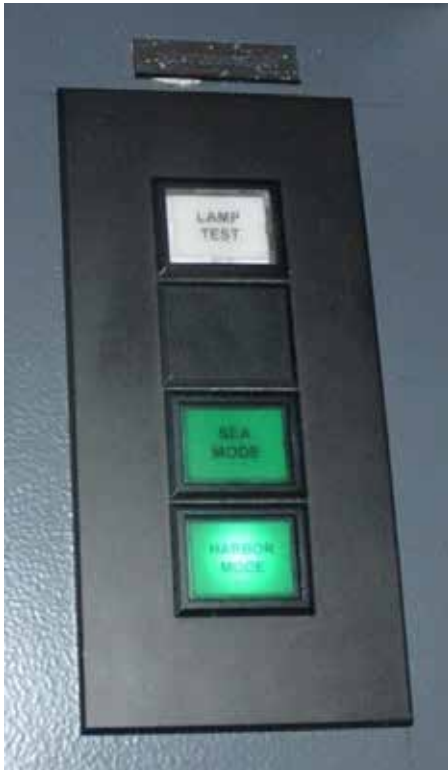
Figure 5. Harbour/sea mode changeover function

The vessel has autopilot and 2 manual steering controls (wheel and pod). Both autopilot and the 2 manual steering controls have 2 modes: harbour and sea (Figure 5). Sea mode is usually used for transiting in open waters; harbour mode is used for manoeuvring in restricted waters and berthing. When the vessel's speed exceeds 8 knots, the harbour/sea mode alarm sounds to alert the master that he or she has the option to put the vessel in sea mode. When autopilot or pod steering control is used in sea mode, the pods are restricted to moving  $\pm 30^\circ$  from the centreline.<sup>16</sup>

On the *Seaspan Reliant*, which was always operated in harbour mode, the harbour/sea mode changeover function was not connected. This meant that there was no audible alarm when the vessel's speed dropped below 8 knots or increased to more than 8 knots.

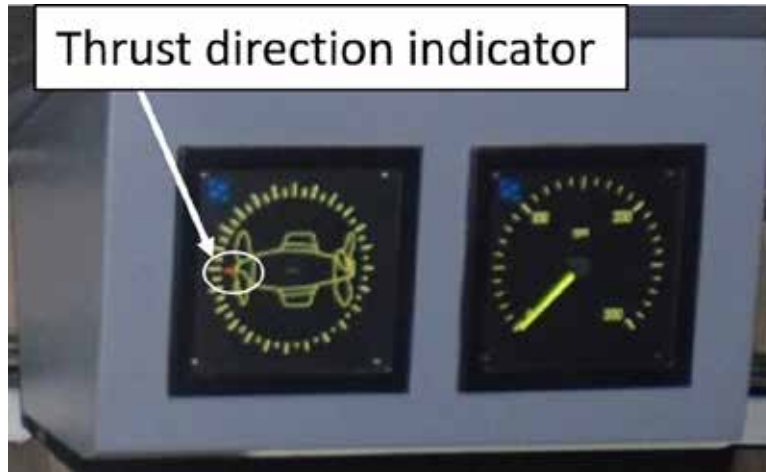
Figure 9. Thrust direction indicator (left) and rpm indicator (right). The red triangle-shaped pointer is circled.

The red triangle-shaped pointer is 6 mm high, and the typical distance between where the operator stands and the displays on the bridge front windows is approximately 210 cm.

The VA of the red pointer from the longest anticipated viewing distance is 9.8 minutes of arc. ASTM International, an organization that develops technical standards, recommends a standard of 16 minutes of arc.<sup>17</sup> This standard is important for legibility. An insufficient VA that depends on font size and distance makes the red pointer difficult to read, as well as makes it appear similar at 0° and 180° from the operator's vantage point.

The port thrust direction indicator on the *Seaspan Swift* bridge window is approximately 210 cm from the operator, and the height of the red triangle-shaped pointer is 6 mm. The resulting visual angle of the red pointer from the longest anticipated viewing distance is 9.8 minutes of arc, which is significantly less than the recommended standard of 16 minutes. An insufficient visual angle that depends on font size and distance makes the red pointer
