## **MARINE TRANSPORTATION SAFETY INVESTIGATION REPORT M18P0230**

### **GIRDING AND CAPSIZING**

Tug *George H Ledcor*

13 August 2018

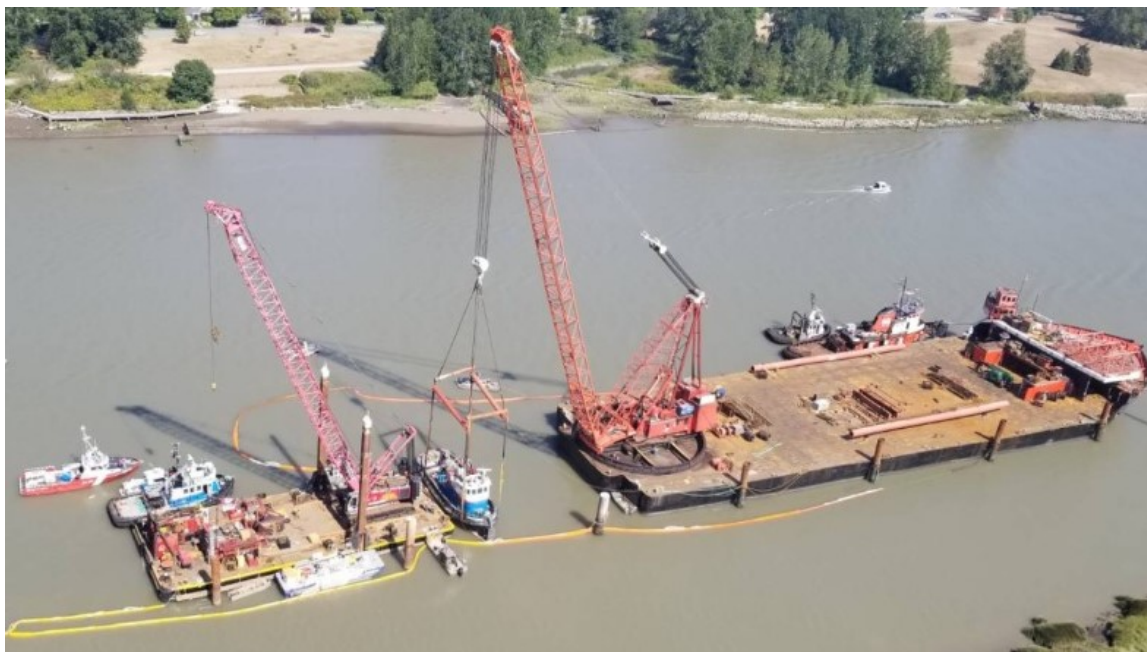
Figure 5. Crane barges lifting the George H Ledcor (Source: Canadian Coast Guard Environmental Response)

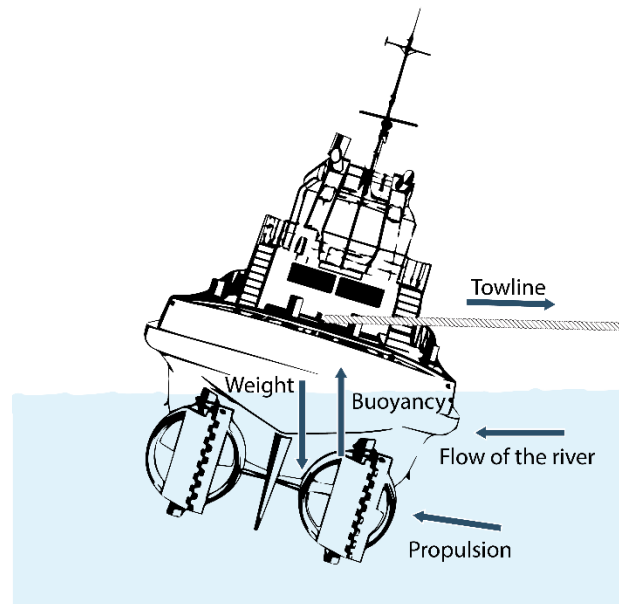
In this occurrence, the assist tug was used to push the barge up the river. The assist tug was positioned on the centre of the barge's stern and was being used to push only; it was not helping guide the barge. The assist tug applied a longer turning lever and had more influence on the direction and momentum of the barge (in a straight line) than the lead tug with the shorter turning lever (Figure 7). As a result, the lead tug, with its shorter turning lever, was unable to turn the barge.

Figure 6. Forces that can contribute to a girding situation (Source: TSB)

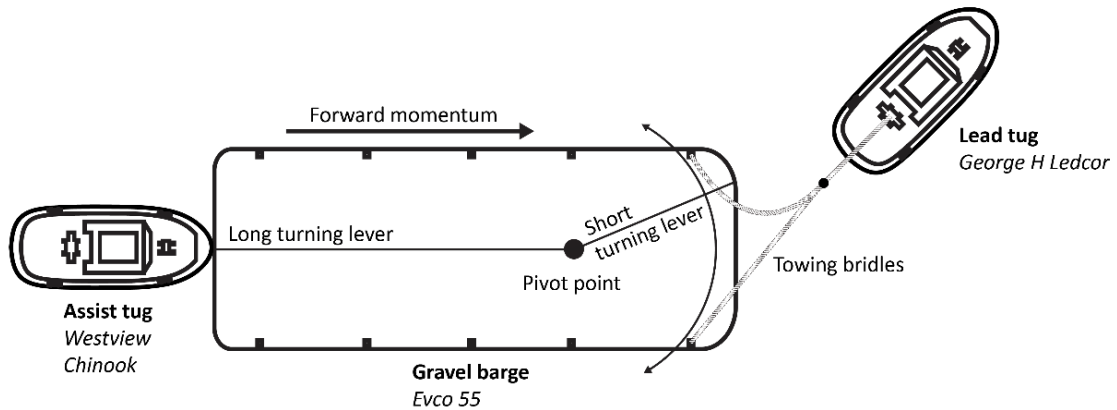
Figure 7. Comparison of turning levers for the George H Leducor and the Westview Chinook (Source: TSB)

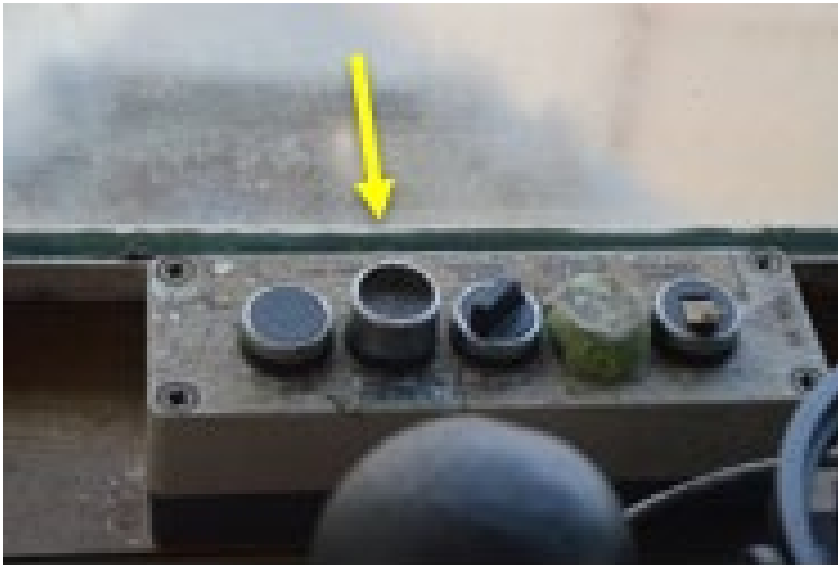
The *George H Leducor* had abort mechanisms located at each of the 3 conning stations. The TSB examined the abort mechanisms on the *George H Leducor* and observed that the location, orientation, and colour of the buttons for the abort mechanisms on the 3 control panels were different. The 3 buttons were labelled, but the labels were obscured by the position of other controls and switches. The 3 mechanisms had guards to prevent inadvertent activation, but each of the guards was of a different design. Table 2 summarizes the observations made about each of the mechanisms.

Figure 8. Abort mechanism at the wheelhouse conning station, with the abort button indicated by a yellow arrow (Source: TSB)

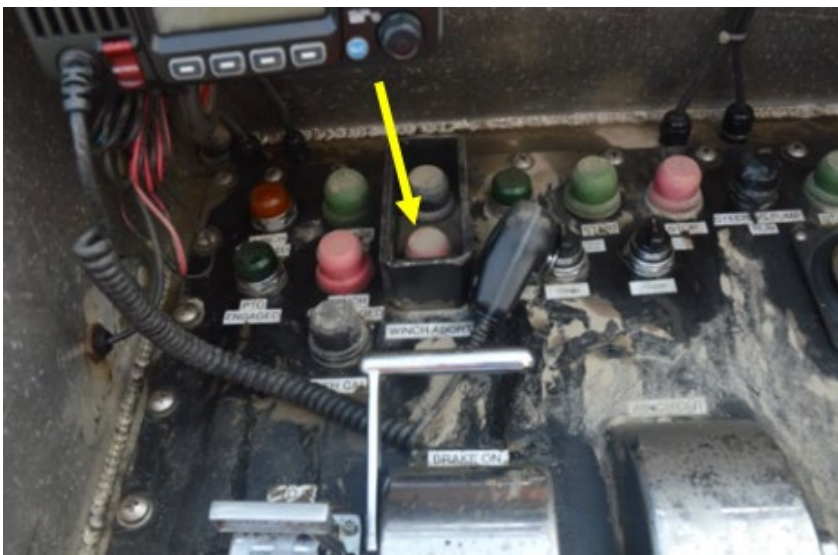
Figure 9. Abort mechanism at the conning station on the upper aft deck, with the abort button indicated by a yellow arrow (Source: TSB)

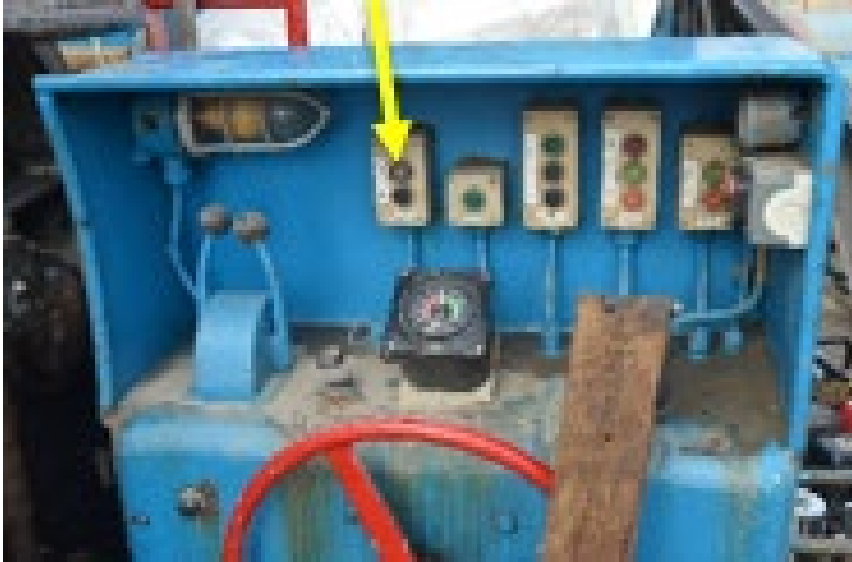
Figure 10. Abort mechanism at the conning station on the main deck, with the abort button indicated by a yellow arrow (Source: TSB)

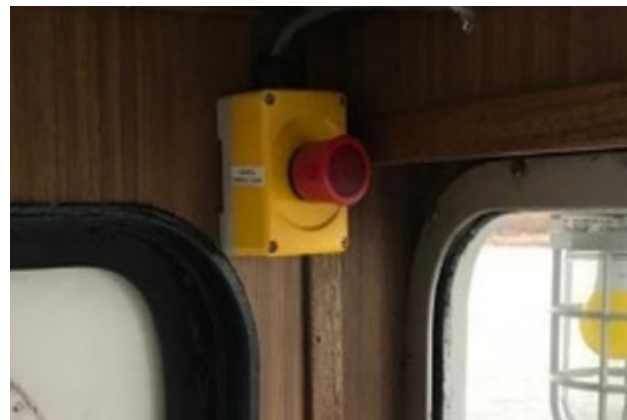
Figure 11. Newly added standardized button for abort mechanism (Source: Ledcor Resources and Transportation Inc.)

Following the occurrence, the company installed additional abort mechanisms of a standard design in a common location on all of its tugs (Figure 11).

Ledcor also installed additional abort mechanisms of a standard design in common locations throughout its fleet of tugs. The abort mechanisms are more visible, are illuminated, and have an audible alarm when activated. Ledcor is also in the process of ensuring that liferaft painter lines are of the recommended length for its vessels and operations.

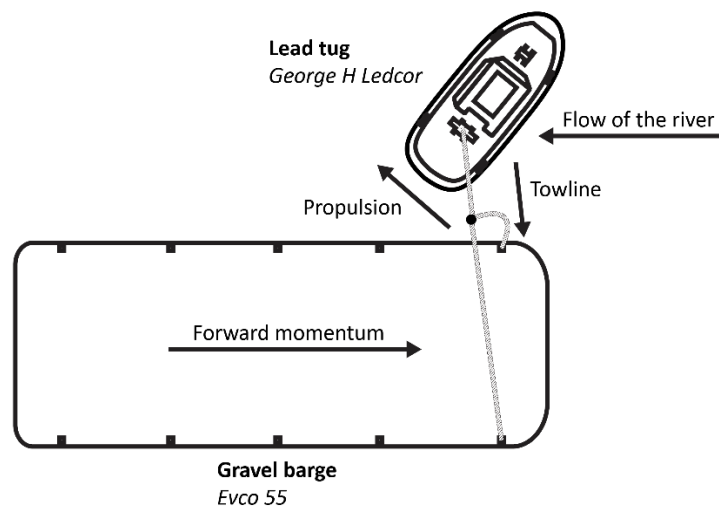
Once the master recognized that the barge had not responded to the course alteration, he called off the assist tug and applied more port rudder. However, the barge continued on a straight course and began to overtake the tug, at which point the short towline, which was not secured by hold-down gear, began to exert a broadside force on the tug, placing it in a girded position. When the barge began to pass off the stern of the tug's starboard side, the master applied full starboard rudder and full throttle. However, given the forces acting on the vessel's stability, such as thrust from the propellers, flow of river against the hull, and increasing force from the towline, this action increased the tug's heel (Figure 12). As this progressed, the master did not have sufficient time to initiate corrective action.

Figure 12. Forces acting on the stability of the *George H Ledcor* as it is overtaken by the barge *Evco 55* (Source: TSB)

Within seconds, the tug's deck edge and bulwarks were submerged, creating a dragging force that heeled the tug further to starboard. At this point, the crew attempted to abort the tow, but they were unsuccessful and the tug rapidly capsized. Neither the master nor the deckhand was able to alert the mate and second deckhand in the accommodation space, communicate with the *Westview Chinook*, transmit a distress call, or don life jackets. The
