# Marine Transportation Safety Investigation Report M20P0320

## GROUNDING

Barge *Lafarge Eagle*, towed by tug *Mauna Loa* with tug *Sea Imp XI* assisting  
Fraser River, British Columbia  
01 November 2020

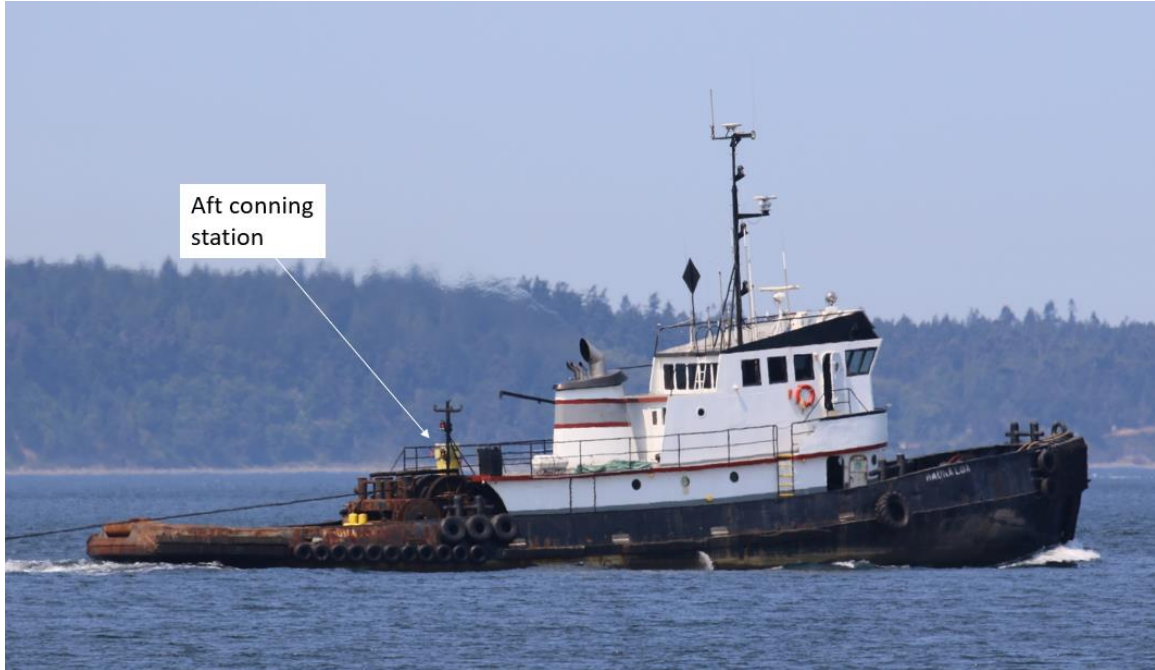
The wheelhouse contains a conning station with navigation equipment and machinery controls. A second conning station is located on the aft starboard side of the deck (Figure 1). This conning station faces aft and contains controls for the engine, bow thruster, steering, and towing pins. The tug is registered in the United States (U.S.) and is owned and operated by Salmon Bay Barge Line, Inc.

Figure 1. The *Mauna Loa*, with aft conning station labelled (Source: Jackie Pritchard, with TSB annotations)

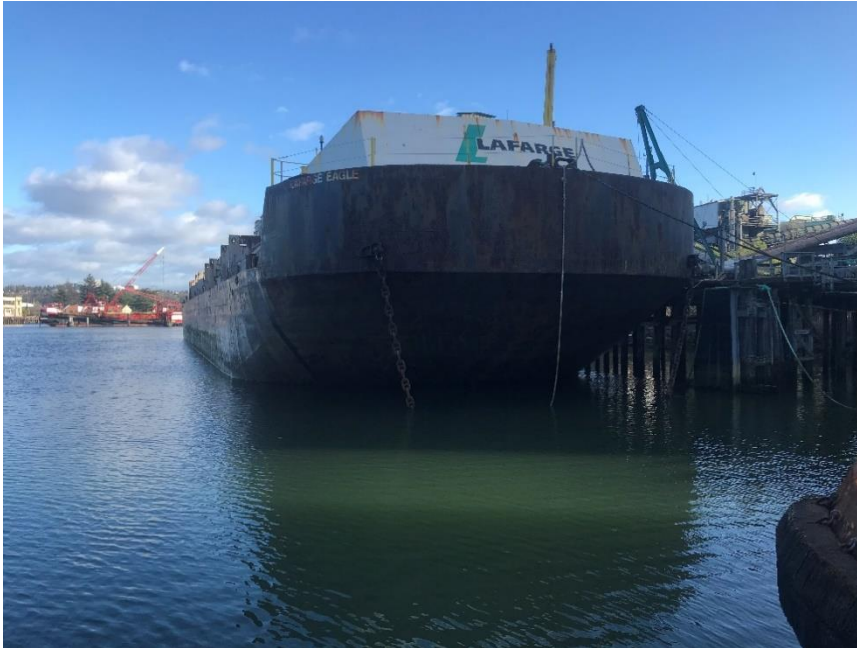
The *Lafarge Eagle* (Figure 2) is a non-propelled steel barge that is 98.57 m in length and used for transporting bulk cement. The hull is divided by 5 transverse watertight bulkheads into fore and aft peak compartments and 4 cargo holds. The cargo holds are capable of carrying approximately 7700 t of bulk cement. The barge has a raked bow and stern. The stern has a deep, rounded pushing notch and port and starboard towing skeys. A towing bridle is attached to eye bolts on the port and starboard sides of the bow. The barge is owned and operated by the same company as the *Mauna Loa* and is also registered in the U.S.

At the time of the occurrence, the barge was loaded with approximately 7051 t of bulk cement. The maximum draft was 5.64 m, and the vessel was trimmed 0.24 m by the stern.

Figure 2. The *Lafarge Eagle* (Source: Salmon Bay Barge Line, Inc.)

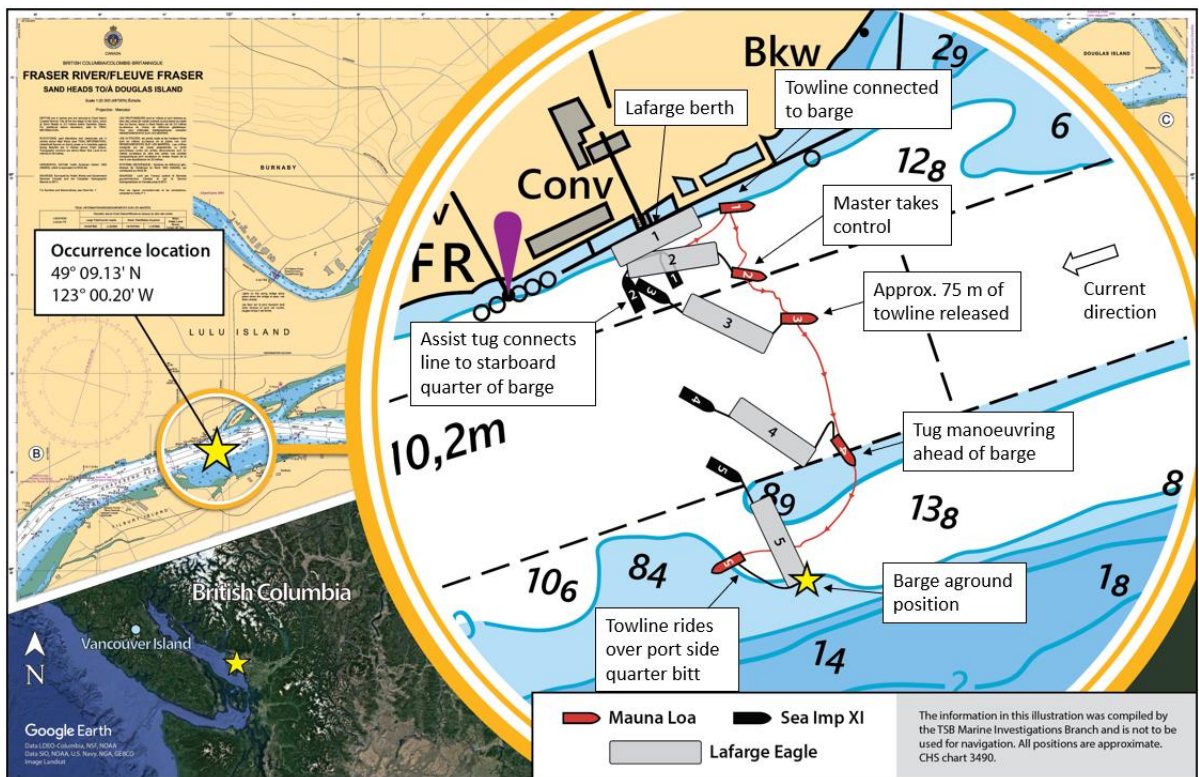
At 2120, the *Mauna Loa* made fast the tow while the *Sea Imp XI* held the barge alongside to prevent it from moving down river under the influence of the current (Figure 3). The length of the towline was approximately 20 to 30 m from the stern of the *Mauna Loa* to the barge. A training master was on board the *Mauna Loa*, and he was assigned to the controls at the aft conning station with the master monitoring beside him. At 2145, the crew commenced unmooring, and the barge was underway at 2157.

Figure 3. Map and chart showing the location of the occurrence, with inset image showing the track of the *Mauna Loa*, and the estimated positions of the *Lafarge Eagle* (Source of map: Google Earth, with TSB annotations. Source of chart and inset image: Canadian Hydrographic Service, with TSB annotations)

At approximately 2201, the *Mauna Loa* positioned upriver and in front of the barge, but the tug and barge were now on courses that diverged by almost 90°. The tug was making good a course of 142° at 1.7 knots, while the barge was making good a course of 226° at approximately 1.5 to 2 knots. The relative motion of the 2 vessels resulted in the towline becoming taut and heeling the *Mauna Loa* approximately 20° to starboard. To avoid a risk of girding,<sup>2</sup> the master released approximately 75 m of towline.

With the towline slack, the barge continued making good a course across the river toward the shallows on the other side. The master attempted to manoeuvre the *Mauna Loa* ahead of the barge, turn to starboard, and begin towing the barge downriver. However, by approximately 2204, the barge ran aground approximately 100 m outside the channel in position 49°09.12' N, 123°00.31' W, just as the *Mauna Loa* had completed rounding off ahead of the barge and had altered its own course downriver.
