# MARINE TRANSPORTATION SAFETY INVESTIGATION REPORT M21C0214

## **PERSON OVERBOARD AND SUBSEQUENT LOSS OF LIFE**

Fishing vessel *Suvak*

26 August 2021

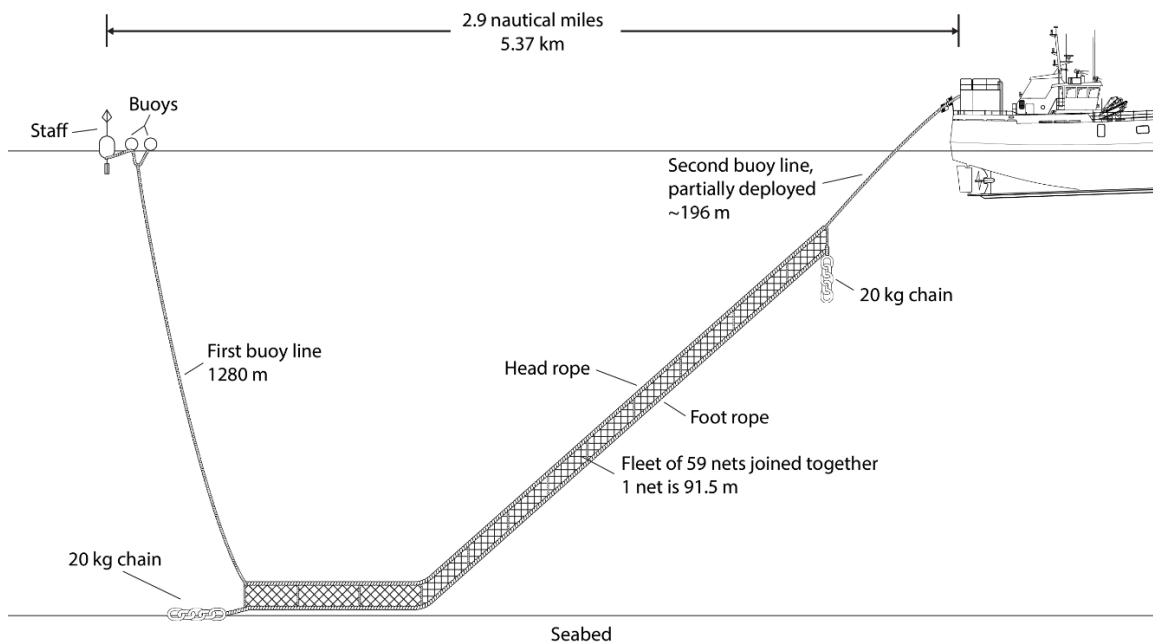
The *Suvak* operates with up to 10 fleets of nets. One fleet of nets consists of between 50 and 80 connected nets. A head rope runs along the top edge of the nets, and a foot rope runs along the bottom edge of the nets (Figure 3). On either end of the foot rope, there are detachable chains weighing 20 kg each. These anchor the bottom edge of the nets to the seabed. On both ends of the head rope, there is a buoy line of between 1000 m to 1500 m in length. The buoy line is connected to a set of buoys that provides an upward force on the head rope and keeps the net from collapsing in on itself. Depending on ice conditions, a staff may also be attached to the buoy line. A staff is a pole with a radar reflector that marks the ends of the nets.

Figure 3. Illustration of a fleet of nets being set (not to scale) (Source: TSB)

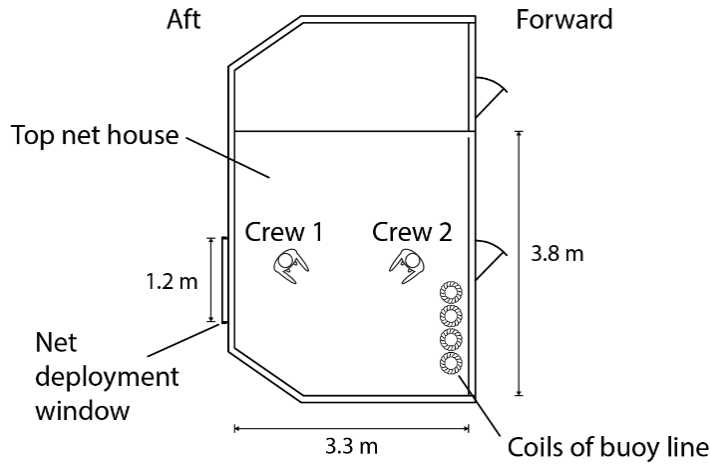
Figure 4. Diagram showing the layout and dimensions of the top net house (Source: TSB)

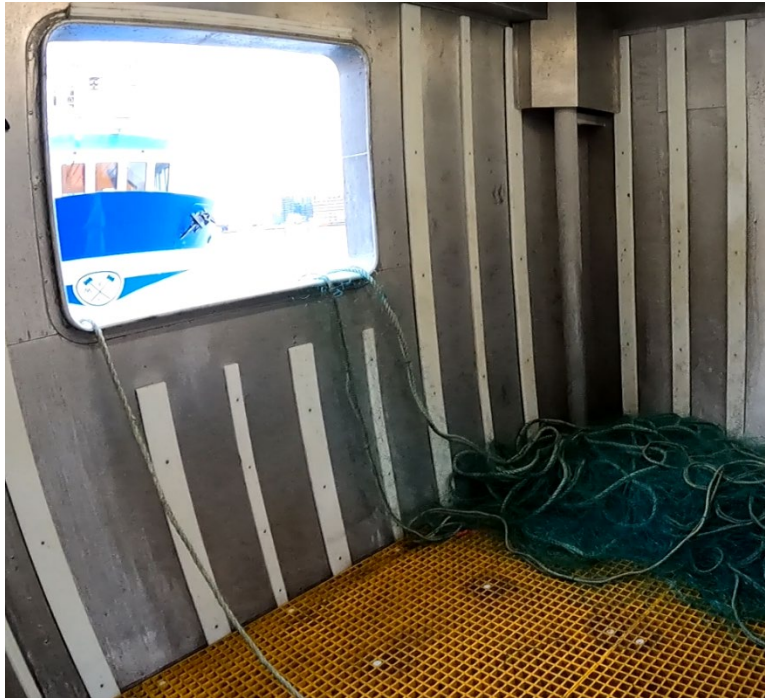
stands near the coils and passes sections of them to the other crew member, who stands near a window in the aft bulkhead of the top net house and throws the sections of coil through the window into the water (Figure 4). The window is approximately 0.9 m high by 1.2 m wide (Figure 5).

Figure 5. Window in aft bulkhead of the top net house (Source: TSB)

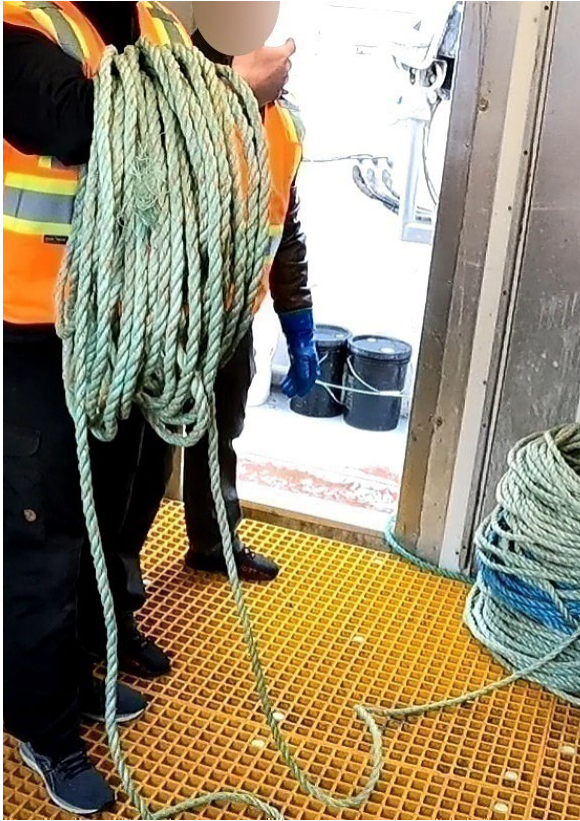
In the past, the crew members working in the top net house had sometimes adapted the procedure by inserting their arm into the coil in order to pick up enough buoy line to maintain the required pace. Whenever supervising crew members noticed this adaptation being used, they would verbally warn the crew members.

Figure 7. Demonstration of adaptation where right arm is inserted into the coil of buoy line (Source: TSB)

Crew 2, who had a smaller physical stature, adapted the procedure for picking up the coils of buoy line to keep up the pace. In combination with mental and physical fatigue, this adaptation led to his arm becoming entangled in the buoy line and caused him to go overboard, resulting in his death.
