Transportation
Safety Board
of Canada

MARINE TRANSPORTATION SAFETY INVESTIGATION REPORT M22A0332

PERSON OVERBOARD

Pilot boat *A.P.A. No. 18*

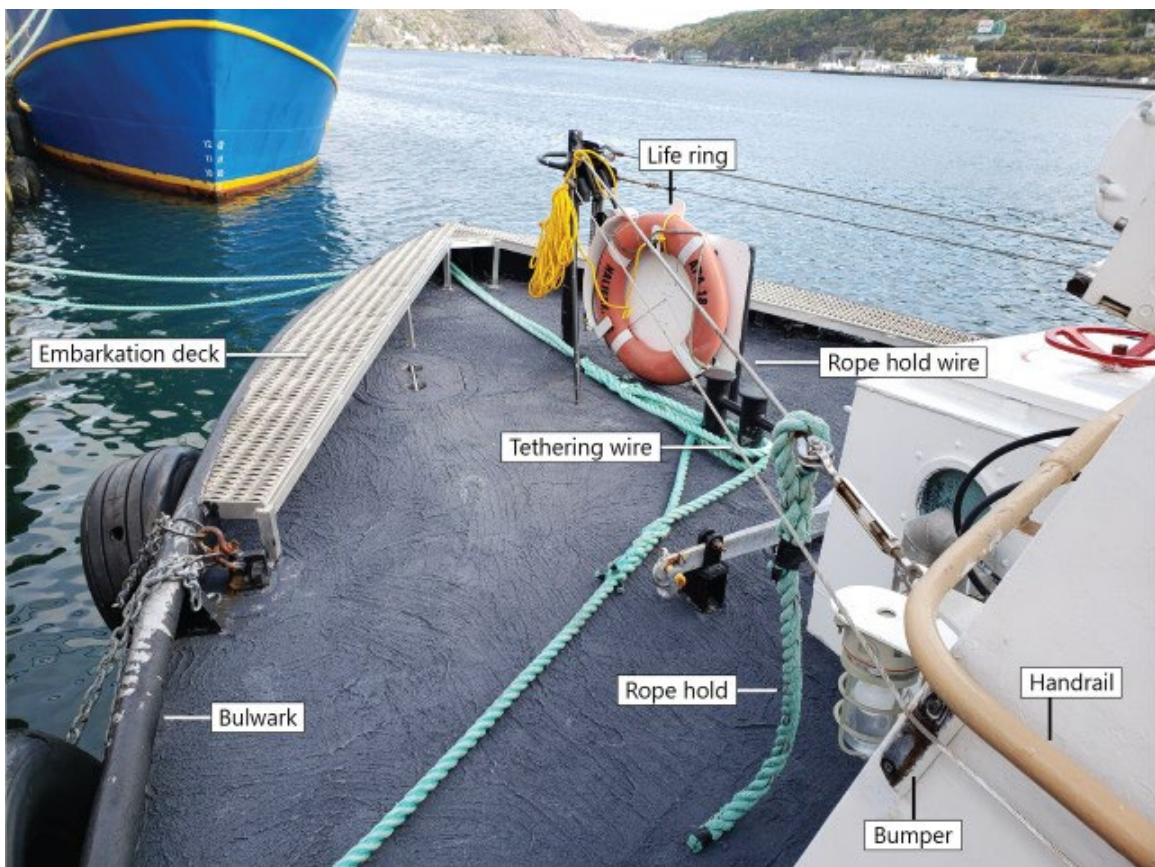
Figure 2. View of the *A.P.A. No. 18*'s bow, including the vessel's embarkation deck, wire attached to the bow stanchion, rope hold, and rubber bumper fixed to the corner of the wheelhouse (Source: TSB)

The wires were made of stainless steel, approximately 0.5 inches in diameter. One end of each wire was attached to the bow stanchion with a turnbuckle; the other end was attached with a hard eye connector just forward of the fixed steps.

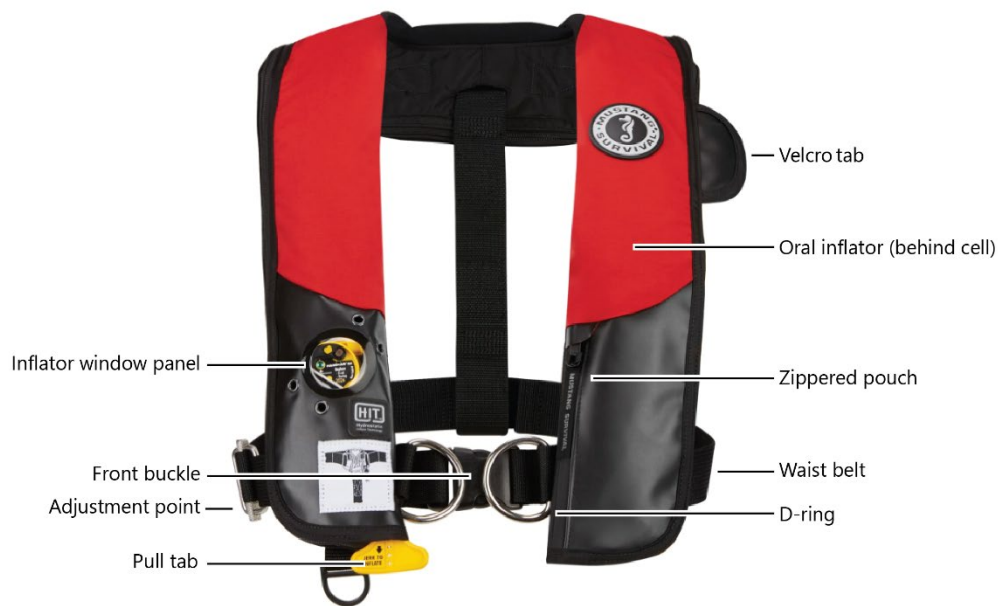
The PFD worn by the deckhand involved in this occurrence was manufactured by Mustang Survival Corp. (Mustang) in May 2017 (model number MD 3154). It was approved in compliance with UL1180 standards, with Canadian modifications; these standards are equivalent to CAN/CGSB-65.7-2007.⁵¹

Figure 4. Model of personal flotation device worn in the occurrence (Source: Mustang Survival Corp.)

The occurrence PFD (Figure 4) was an inflatable collar type, red on the outside and yellow when inflated, had 2 heavy-duty D-rings for tethers, and had a person-overboard locating device attached.⁵² The PFD was designed to be used in an offshore environment and had 38 pounds of buoyancy when inflated. It was designed to inflate using a 2-part inflator cap and inflator body system; when the complete assembly was installed, the inflator body with

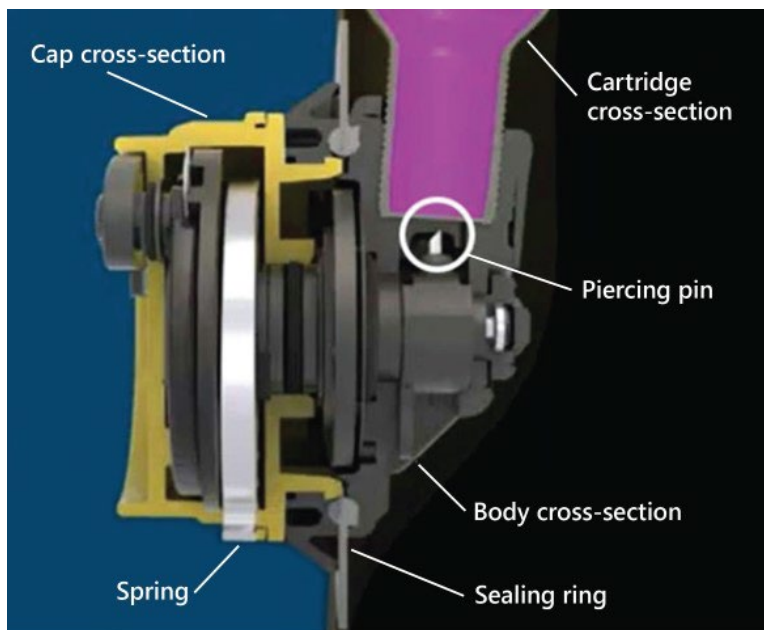
In order for the occurrence inflatable PFD to function, and for the bladder to remain inflated once filled, the cap and body must be securely mated, sandwiching a soft silicone ring in the bladder wall which serves as a gasket. This mating provides the bladder with a gas-tight seal. If this is not done correctly, the bladder will not retain CO₂ or air, and the PFD will not inflate.

Figure 5. Cross-section of inflator cap and body assembly, with CO₂ cartridge attached to inflator body (Source: TSB)

During the examination of the occurrence PFD, the expiry date noted on the cap was 2027, and there had been an initial activation of the inflator cap when the water met the water-sensitive element, but the inflator body did not activate. This allowed the inflation activation mechanism inside the inflator cap to rotate. However, the mating gear on the inflator body did not engage and the piercing pin did not move or puncture the CO₂ cartridge. The examination and testing determined that the cap and body were unmated. The cap activated and the body did not, indicating that the cap and body were separated at some point prior to the occurrence and not as a result of recovery efforts. Because the inflator cap and inflator body were not mated, the PFD bladder was not sealed, which

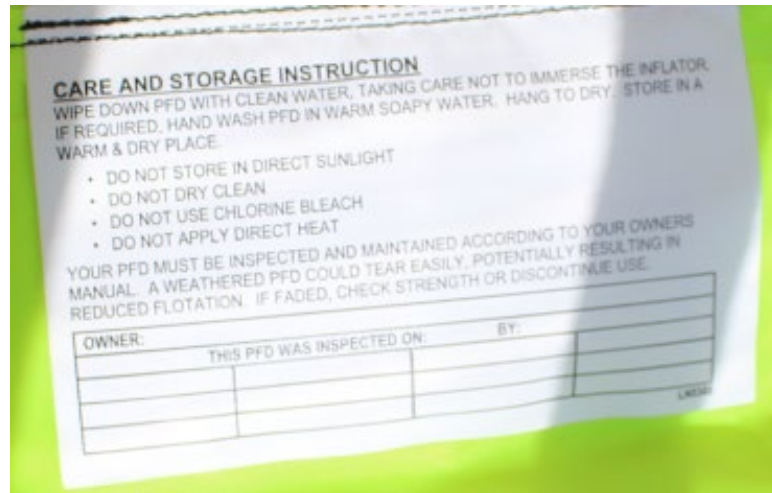
PFD. The shared PFDs on board the *A.P.A. No. 18* were inspected on 16 September 2022 and 25 September 2022 and the inspections were recorded in the vessel safety checklist. The record of inspection on the care and storage label (Figure 6) inside the occurrence PFD was blank.⁵⁵

Figure 6. Care and storage instruction label from the occurrence PFD showing the blank inspection record (Source: TSB)
