RAILWAY INVESTIGATION REPORT R16H0024

Collision between train and track unit

Canadian Pacific Railway

Mile 118.36, Nemegos Subdivision

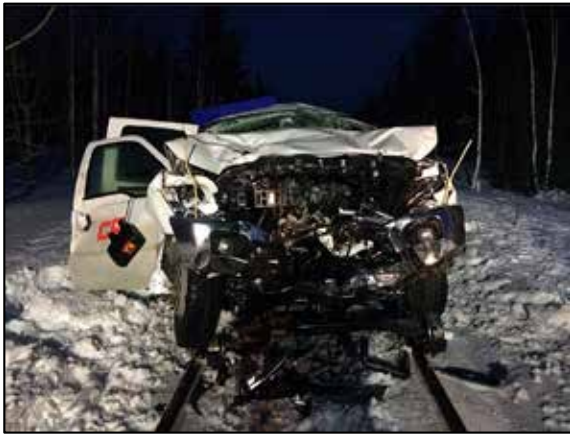
Figure 2. Front view of hi-rail vehicle after collision

About 5 minutes after the last radio broadcast, as the train entered the left-hand curve at Mile 118.50 at a speed of about 42 mph, the train crew observed an approaching vehicle on the main track about 750 feet away. The train crew initiated an emergency brake application. At about the same time, the MOW employees observed the approaching train. The machine operator stopped the vehicle (Mile 118.36) and placed it in Park. Both MOW employees then rapidly exited the vehicle. About 6 seconds later, the train, travelling at about 35 mph, struck the stationary vehicle. There were no injuries and the train did not derail. The locomotive sustained minor damage. The vehicle was destroyed (figures 2 and 3).
