RAILWAY INVESTIGATION REPORT

R16C0065

Non-main-track train collision and derailment

Canadian Pacific Railway

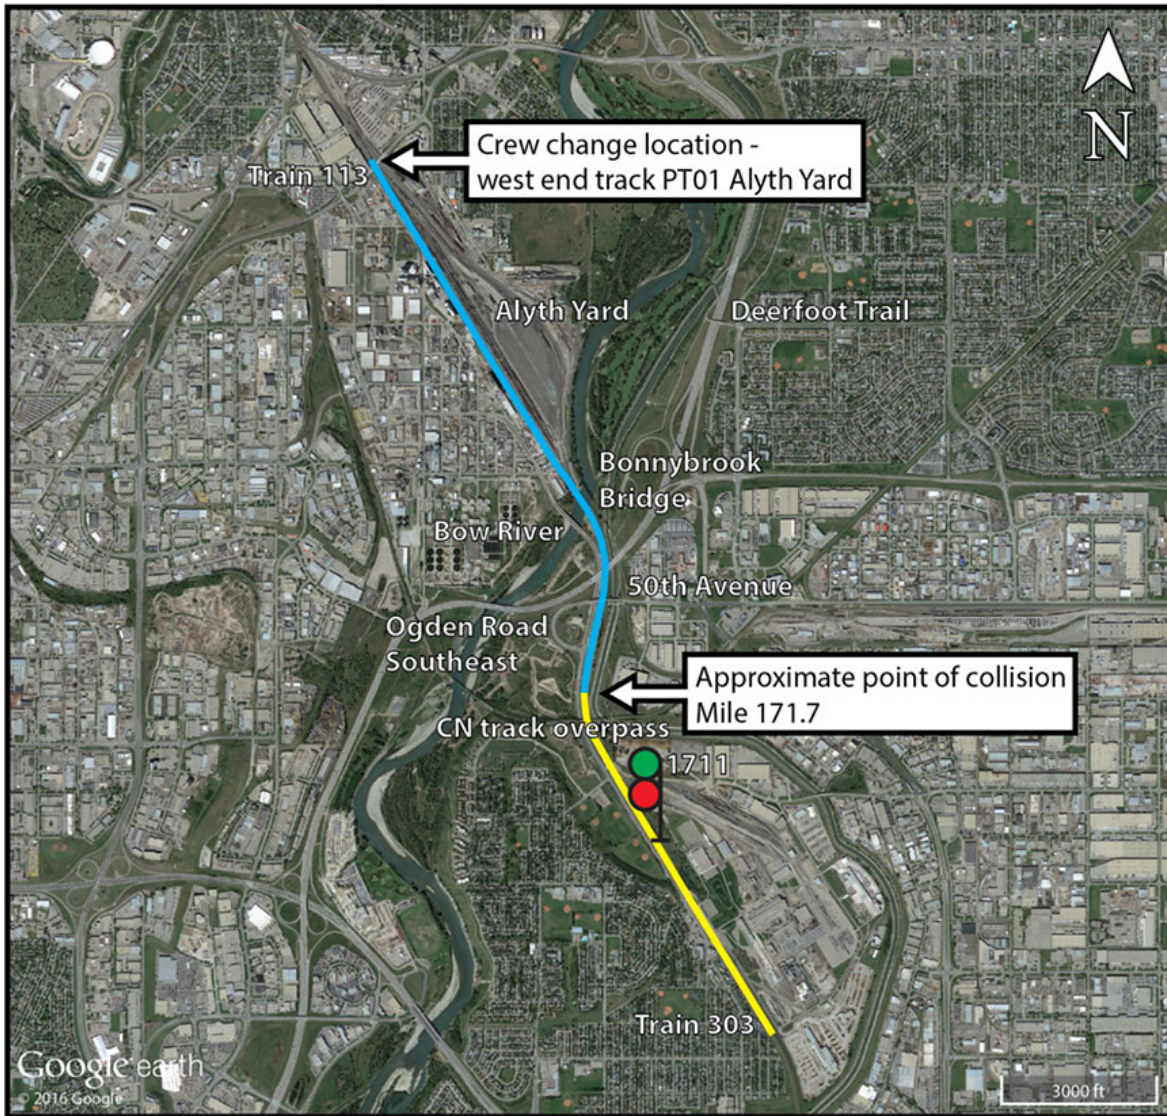
Figure 2. Location of collision (Source: Google Earth, with TSB annotations)

At 0918:25, while travelling at about 22 mph, the lead locomotive of train 303 collided with the tail end car of train 113 at Mile 171.7 (Figure 2).

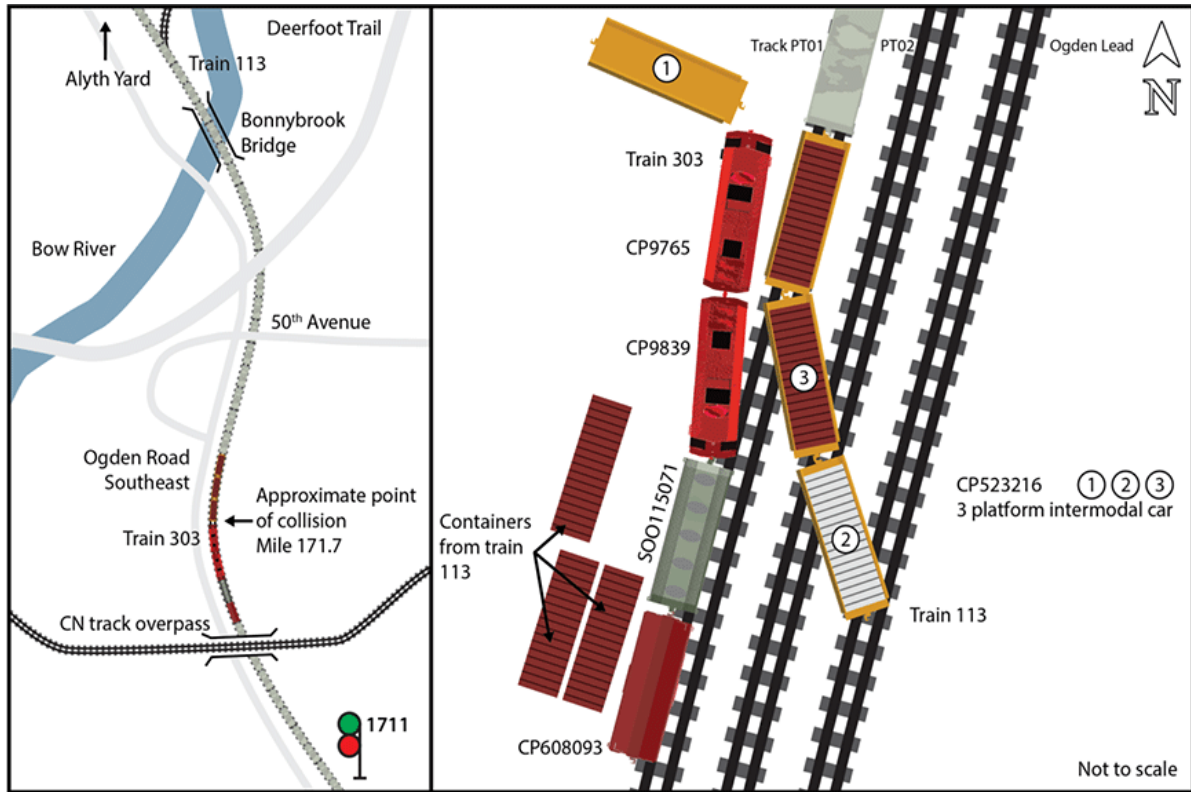
Figure 3. Position of locomotives and equipment after the collision

The 2 head-end locomotives on train 303 (CP 9765 and CP 9839) had derailed to the south⁵ of track PT01 (Figure 3). All wheels on both locomotives had derailed with the locomotives remaining in an upright position. The first 2 covered hopper cars behind the locomotives (SOO 115071 and CP 608093, which were both loaded with food products) derailed upright. Covered hopper car SOO 115071 sustained damage to its air brake control valve and reservoirs as well as damage to its coupler, draft gear, safety appliances, and hopper doors. Covered hopper car CP 608093 sustained roller-bearing damage.

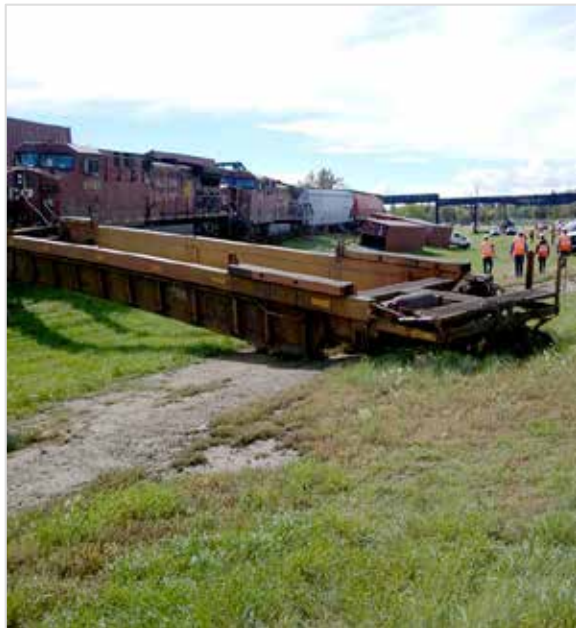
Figure 4. Derailment site (looking east)

The tail-end car of train 113 (CP 523216, a loaded 3-platform intermodal car) derailed all wheels. Two derailed platforms from CP 523216 were to the north and one derailed platform was to the south (Figure 4 and Figure 5). The centre sill on this car was damaged.
