# RAILWAY INVESTIGATION REPORT

## R16W0242

### **Uncontrolled movement, collision and derailment**

Mile 138.70, Weyburn Subdivision

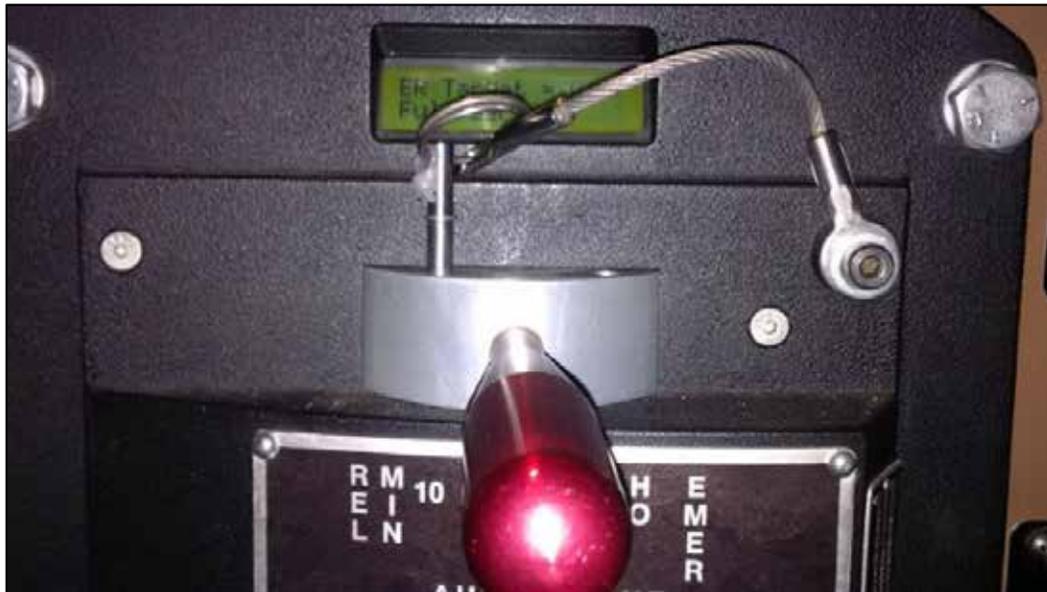
This feature is intended to be used for locomotives in a trailing position. In these situations, when the automatic brakes are cut out, the pin would be inserted to lock the automatic brake handle in the handle off position to ensure that the emergency brakes are not inadvertently applied. For the head-end locomotive, the pin is not necessarily intended to be used to prevent inadvertent movement of the automatic brake handle. However, if the pin is inserted when the automatic brake handle is in the full set position, the pin would prevent an inadvertent release of the brakes.

Figure 4. Automatic brake handle with locking pin inserted into the hole on the left side of the base of the handle, preventing the brake from being released.
