# RAIL TRANSPORTATION SAFETY INVESTIGATION REPORT R20H0130

## **COLLISION BETWEEN TRAIN AND TRACK UNIT**

Canadian National Railway Company  
Freight train G87441-25 and  
Track unit  
Mile 3.2, Caramat Subdivision  
Jackfish, Ontario  
28 November 2020

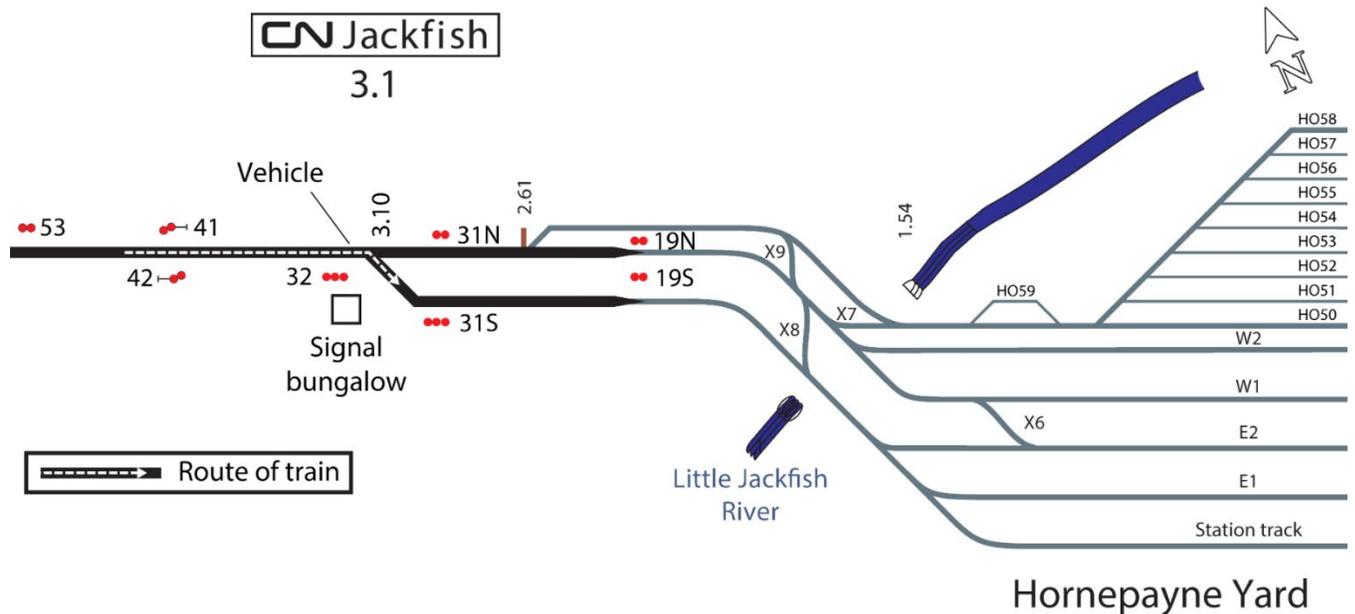
Figure 2. Track schematic diagram of the Caramat Subdivision between Jackfish and Hornepayne (Source: Canadian National Railway Company, with TSB annotations)

Shortly thereafter, the RTC was contacted by a CN signal maintainer (SM1), who was requesting a track occupancy permit (TOP)<sup>4</sup> to perform testing at the turnout switch at Jackfish. SM1 requested a TOP for track between Signal 19N (Mile 1.9) and Signal 32 (Mile 3.2). The RTC did not clearly hear the limits that were requested and asked if SM1 wanted to work on the north track, to which SM1 replied that he did. These limits would have permitted SM1 to operate the company hi-rail vehicle, otherwise known as a track unit,<sup>5</sup> on the north track and the main track up to Signal 32 in order to perform the required testing (Figure 2).

Since the RTC had just lined the route of the train through the turnout switch at Jackfish and onto the south track, the RTC provided SM1 with the limits that were available on the north track, from Signal 19N to Signal 31N (Mile 3.1). SM1 wrote down the limits of Signal 19N to

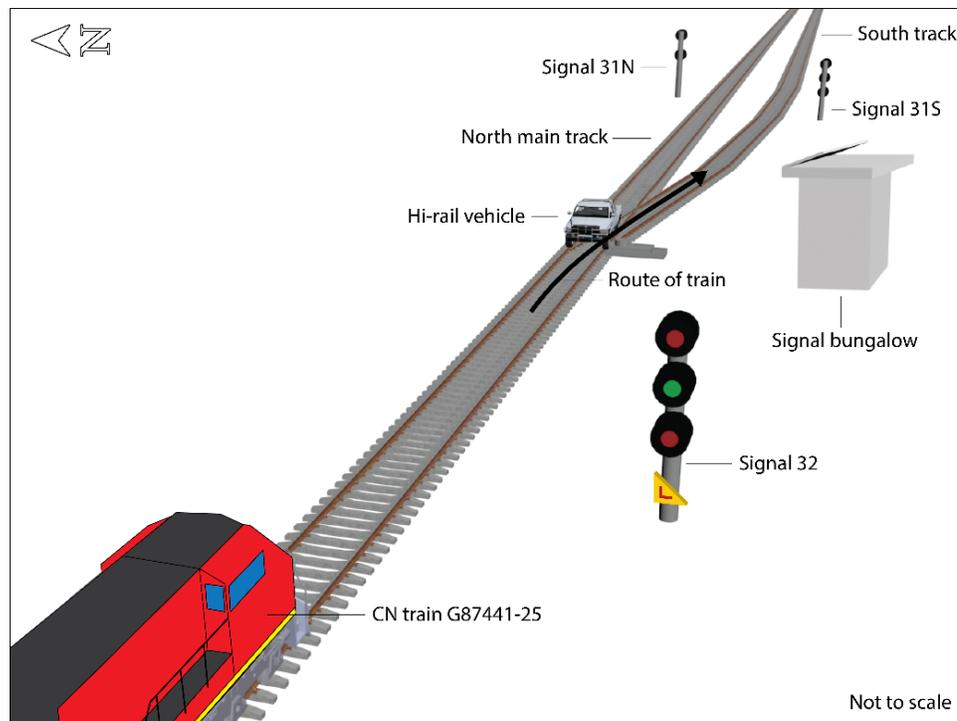
Figure 3. Site diagram (Source: TSB)

At about 1125, the train approached Hornepayne at 32 mph on a Limited to Clear signal,<sup>7</sup> which indicated that it could proceed through the No. 20 turnout<sup>8</sup> (switch) at Jackfish onto the south main track en route to the station. The train crew noticed a hi-rail vehicle on the track near the switch, but did not realize it was foul of their route. The locomotive engineer sounded the horn and continued.

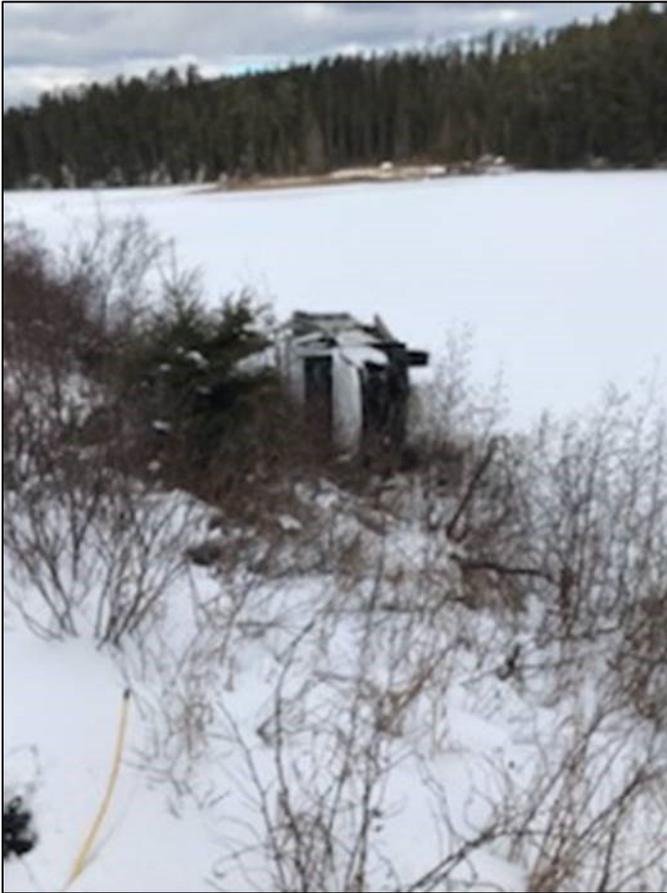
Figure 4. Hi-rail vehicle destroyed in the accident  
(Source: Canadian National Railway Company)

The hi-rail vehicle was destroyed and came to rest at the base of the north embankment (Figure 4). The locomotive sustained minor damage but the train did not derail. There were no injuries.
