# RAIL TRANSPORTATION SAFETY INVESTIGATION REPORT R21H0114

## **NON-MAIN-TRACK TRAIN COLLISION AND DERAILMENT**

Canadian National Railway Company  
Intermodal train Z14921-02 and industrial switching  
assignment L53231-02  
Mile 113.44, Kingston Subdivision  
Prescott, Ontario  
02 September 2021

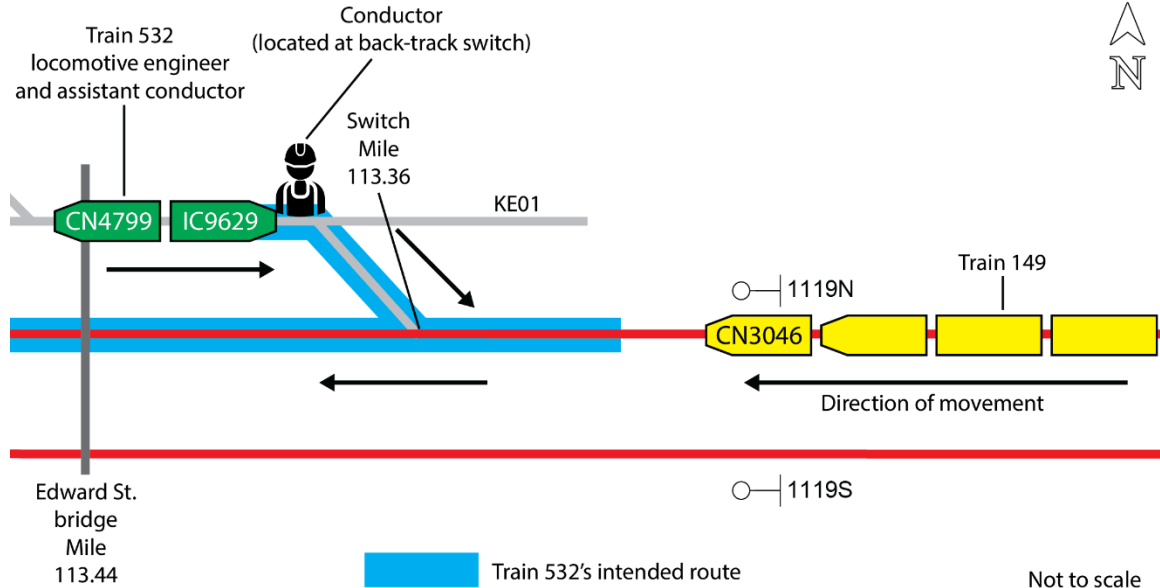
Figure 1. Schematic showing the location of the crew members of train 532 (Source: TSB)

After the switch was reversed, the assistant conductor on train 532 observed a train approaching on the main track from the east. At about the same time, the crew of train 149, after passing Signal 1119N on a Clear indication, made a radio call to train 532 to ascertain train 532's location. During the call, it was established that train 532 was in the spur track and train 149 was approaching on the north main track.

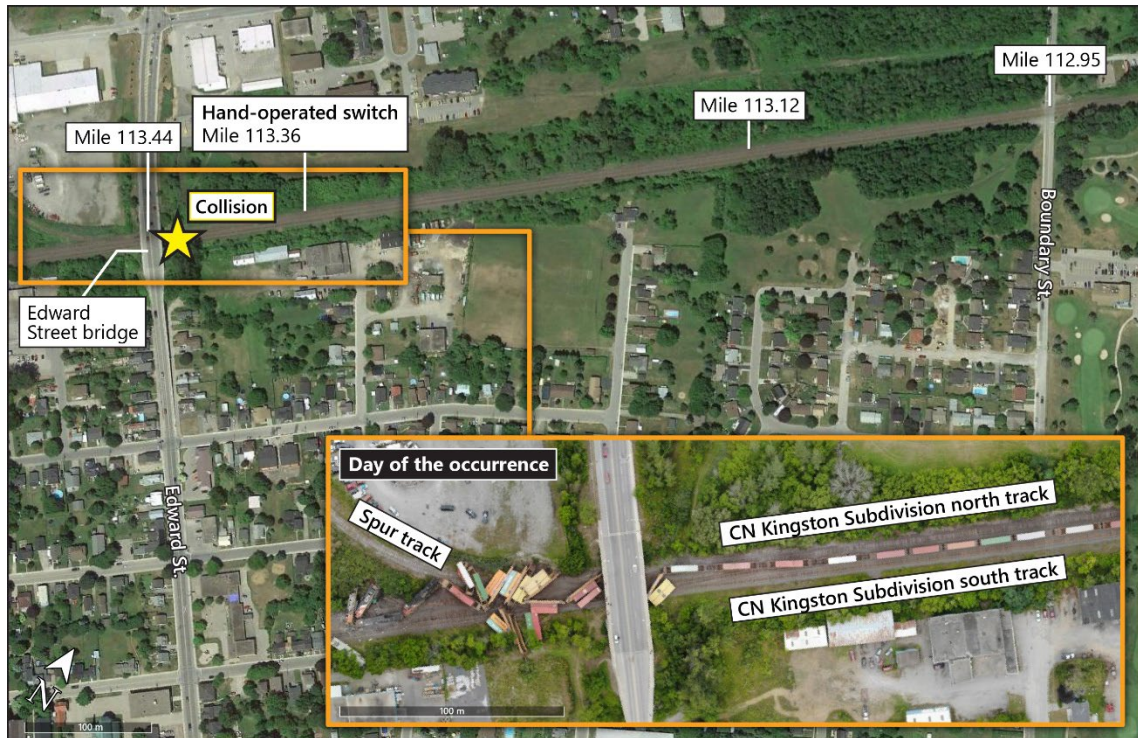
The crew members on train 149, which was travelling westward on the north main track at about 42 mph, observed a red reflectorized switch target indicating that the main-track hand-operated switch at Mile 113.36 was in the reverse position, i.e., lined for their train to diverge into the spur track. They applied the train's brakes in emergency approximately 970 feet east of the spur track switch, but the train was unable to stop. At 1028, the train diverged from the north main track onto the spur track and collided head-on with train 532 at a speed of 37 mph.

Figure 3. Map showing the collision point in the town of Prescott (Source: Google Earth, with TSB annotations), with inset map showing the location of the derailed rolling stock after the collision (Source: Ontario Provincial Police, with TSB annotations)

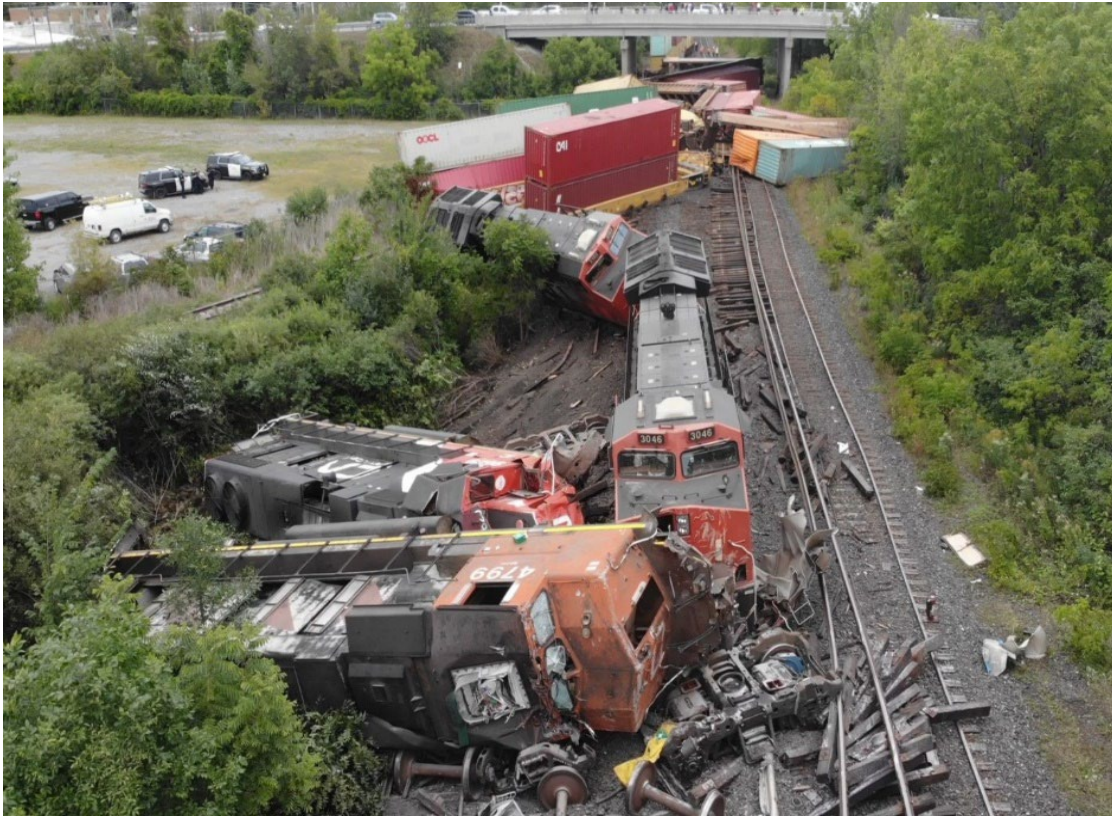
As a result of the collision, the 4 locomotives (2 on each train) derailed and sustained significant impact damage. Fourteen intermodal car bodies loaded with double-stack containers also derailed. There was significant damage to the north main track, the south main track, and the KE01 and KE07 spur tracks between Mile 113.36 and Mile 113.55; in total, approximately 1000 feet of track was destroyed (Figure 4).

Figure 4. Derailed rolling stock and damaged track after the collision (Source: Ontario Provincial Police)

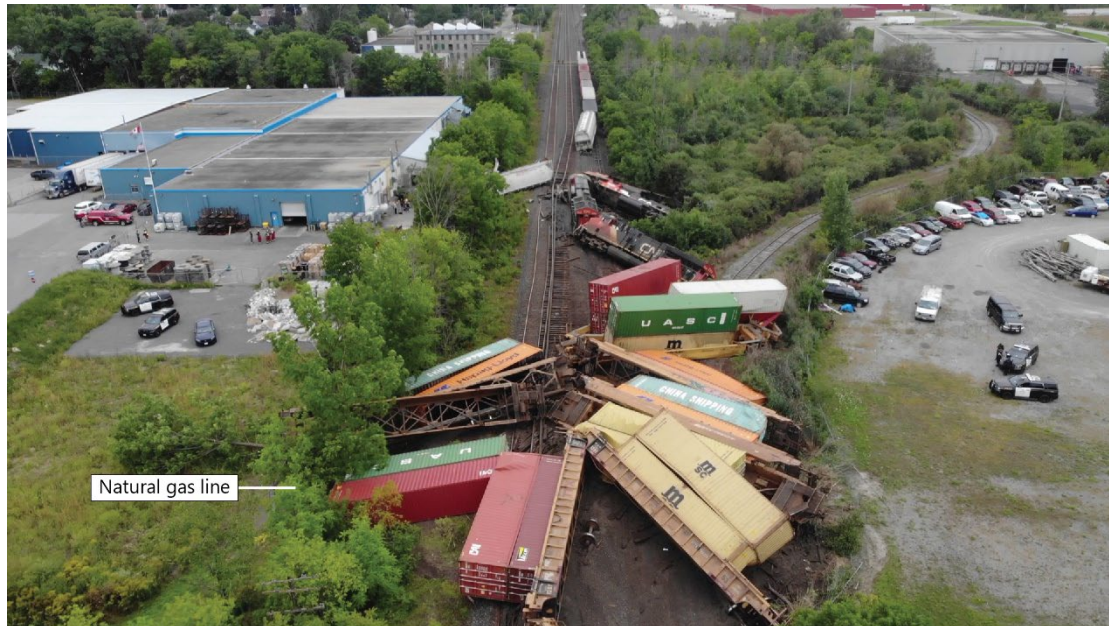
The 2 locomotives on train 149 derailed and sustained significant impact damage. The fuel tank on the lead locomotive of train 149 punctured and released an undetermined amount of diesel fuel, but the fuel did not ignite. One of the 14 derailed intermodal car bodies came to rest within a few feet of a natural gas line adjacent to the track, near a residential area (Figure 5), but it did not strike it.

Figure 5. Derailed intermodal car and container near a natural gas line (Source: Ontario Provincial Police, with TSB annotations)

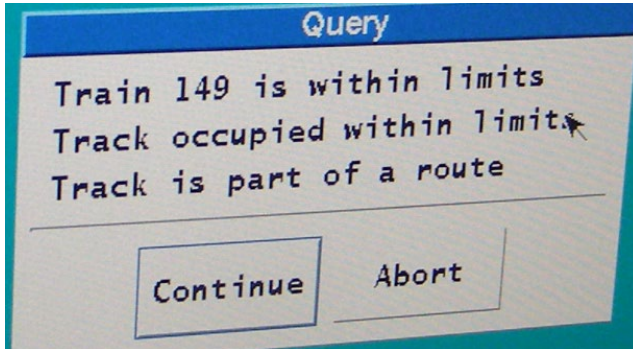
Figure 6. Prompt displayed by the RTC II software when a rail traffic controller initiates a Rule 568 permission and the track is already occupied; in this occurrence, the track was occupied by train 149 (Source: TSB photo of CN's software)

In contrast, when RTCs use the same software to process a request for a track occupancy permit<sup>25</sup> when there is a train within the proposed limits, the software requires the input of a location report confirming that the train has already passed the location where the employees will enter the main track. If this report is not provided, the software aborts the authority.

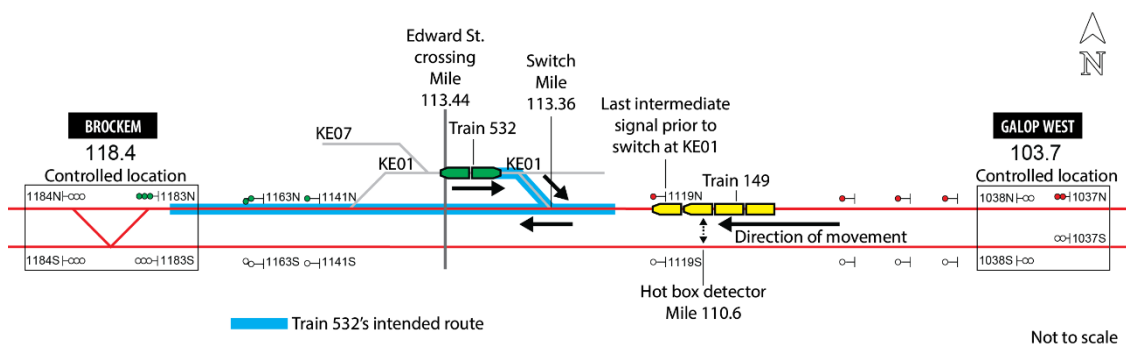
In this occurrence, the crew of train 532 contacted the RTC to request a Rule 568 permission to enter the north main track of the Kingston Subdivision at a hand-operated switch located at Mile 113.36. A Rule 568 permission covers the entire controlled block for the requested location—in this instance, a 14.7-mile block from controlled signal 1037N to controlled signal 1184N (Figure 7).

Figure 7. Schematic showing the controlled block for which the Rule 568 permission was issued to train 532, the location of the trains at the time the Rule 568 permission was made complete, and the direction of each train's intended movement (Source: TSB)

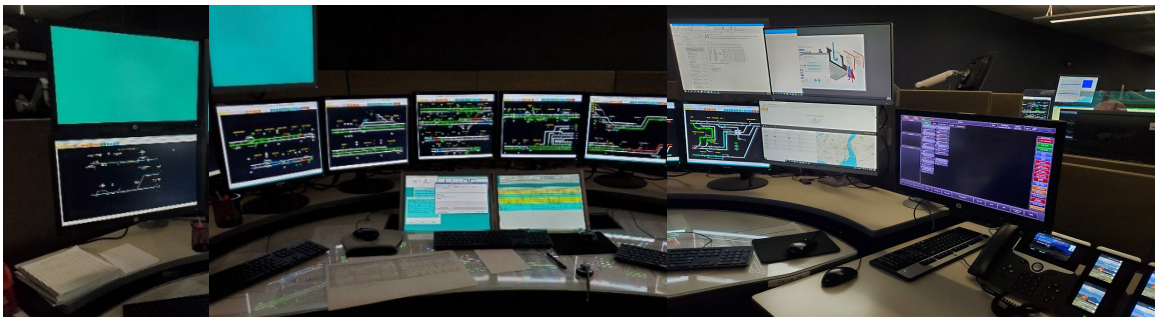
On desk ED, there are at least 12 screens that the RTC may monitor and use, depending on the needs of the shift and personal preference (Figure 8).

Figure 8. Rail traffic controller workstation for the Kingston Subdivision – desk ED\* (Source: TSB)

\* On the day of the occurrence, desk ED was used to control a larger territory than shown in the picture.
