# RAIL TRANSPORTATION SAFETY INVESTIGATION REPORT R21S0048

## MAIN-TRACK TRAIN DERAILMENT

Canadian Pacific Railway Company  
Freight train 603-897  
Mile 32.75, Lanigan Subdivision  
Silton, Saskatchewan  
16 October 2021

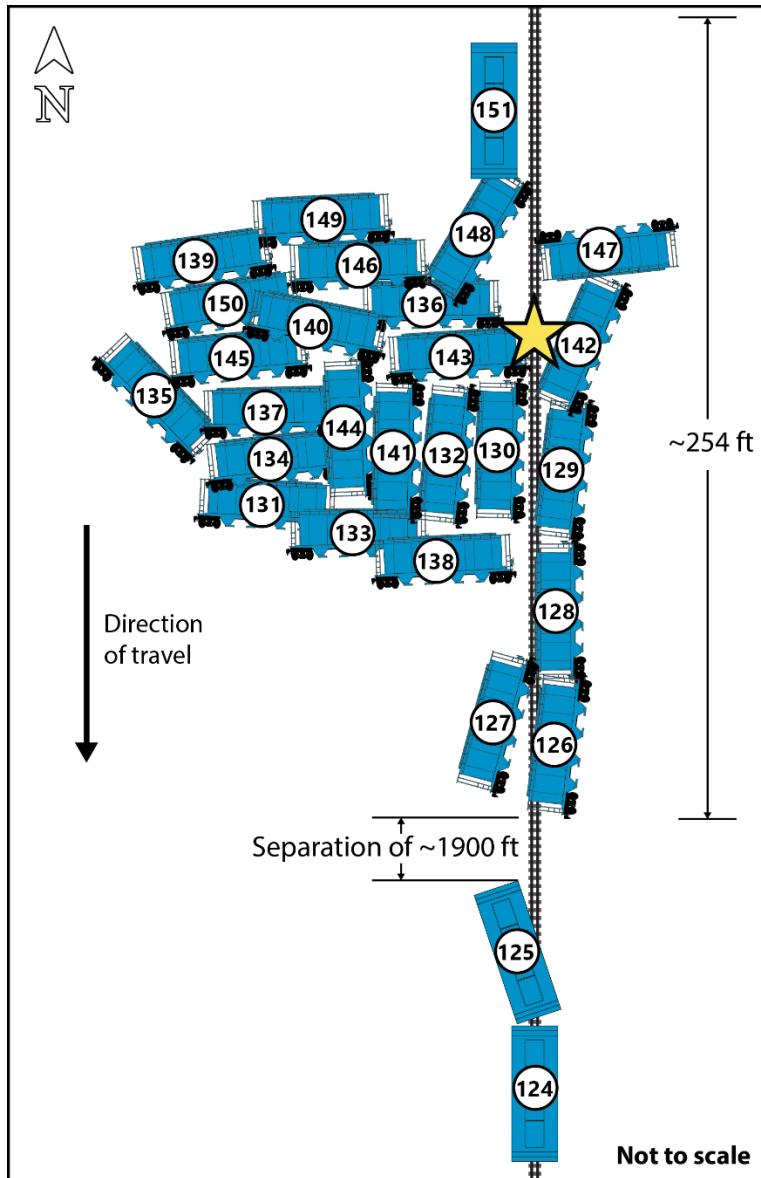
There were no visible wheel impact marks present on the track infrastructure leading up to the derailment location. However, significant track damage was observed extending southward up to the first derailed car (the 125th car, ITFX 33257). Only the trailing truck of that car was derailed to the west side of the track; the car remained coupled to the head end of the train as it was dragged for about 2100 feet. About 2100 feet of track was damaged or destroyed.

The next 25 derailed cars, the 126th to 150th cars from the head-end locomotive, came to rest clustered in a large pile, over a distance of 254 feet, near Mile 32.75 (Figure 4). The 151st car from the head-end locomotive was the last car to derail but remained upright.

Figure 4. Accident site diagram illustrating where the cars came to rest, with the star indicating the suspected point of derailment (Source: TSB)

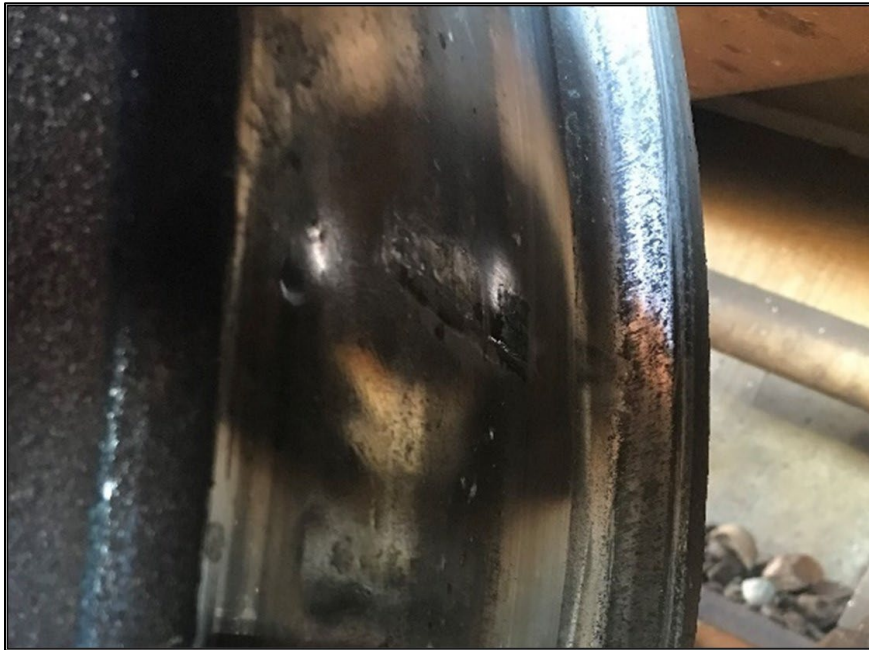
The last car of the head-end portion of the train that did not derail was the 124th car, CITX 151689. Inspection of this car revealed that the trailing R1 wheel tread (west side) displayed impact damage (Figure 5). At the occurrence temperature of  $-4\text{ }^{\circ}\text{C}$ , a rail break would create a gap of 2 to 3 inches (51 to 76 mm) if the rail were properly stressed.<sup>4</sup> Such a gap would display extensive rail end batter from all the wheels in the head end of the train

striking the gap. There was no impact damage to the wheels on any cars prior to the 124th car.

Figure 5. Car CITX 151689 R1 wheel tread impact damage (Source: CP)

Examination of the trailing R1 (west side) wheel tread of the 124th car, which was the last car of the head-end portion of the train that did not derail, displayed impact damage that was consistent with the wheel tread having contacted an exposed rail head cross-section of the broken rail. At the occurrence temperature of -4 °C, a rail break would create a gap of 2 to 3 inches (51 to 76 mm) if the rail were properly stressed. Therefore, extensive rail end batter from wheels striking the gap would occur. The fact that the wheels of the preceding cars and locomotive did not exhibit any impact marks suggests that the rail was intact prior to the train's arrival and that it broke under the 124th car.

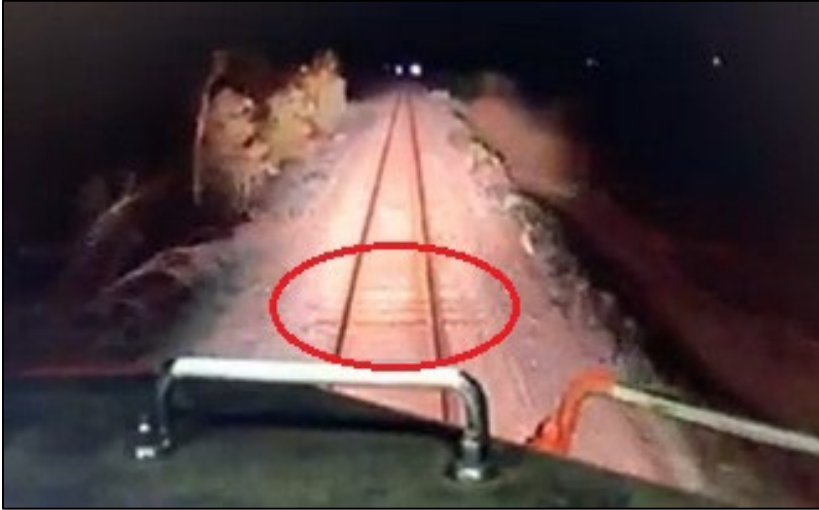
Although the head-end locomotive forward-facing video from train 603-897 did not show any anomalies on the rail surface, the external microphone did pick up a sound anomaly (noise) and the video showed that the locomotive dipped slightly to the right (Figure 6) as it traversed the suspected point of derailment in the vicinity of Mile 32.75. Neither the occurrence train crew nor the preceding crew reported any abnormalities while traversing that location.

Figure 6. Still image captured from the forward-facing video camera on the head-end locomotive showing the location where the locomotive dipped slightly to the right on the west rail (circled) (Source: Canadian Pacific Railway Company)

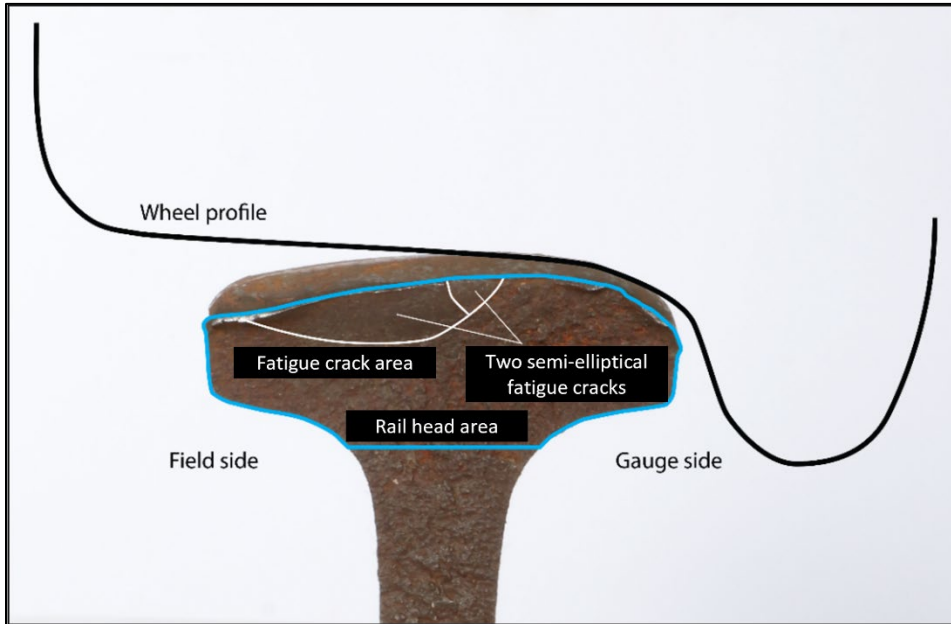
Examination of the fracture surface revealed 2 separate semi-elliptical flat and smooth fatigue cracks that grew over time due to repeated loading. The 2 cracks eventually merged and created a larger semi-elliptical crack that measured about 0.39 inch (10 mm) deep and covered 15% of the total area of the worn rail head. The remaining portion of the fracture surface was composed of coarser features with some faint chevrons, indicating that the fatigue crack propagated down to the base of the rail in a sudden overstress.

These types of fractures are categorized by Sperry as transverse/compound fractures. They initiate from rail surface conditions.<sup>11</sup> Once initiated, these cracks grow slowly to a size of 10% to 20% of the head area due to repeated loading from passing trains, and then they propagate suddenly.

The rail head running surface displayed a slight downward taper toward the field side. No similar taper was observed on the gauge side. The observed taper on the field side (Figure 7) suggests that this rail had been transposed, i.e., previously installed on the east side before being installed on the west side. According to CP track maintenance personnel, it was transposed during major rail work on the subdivision in 2007; however, there are no specific records indicating the origin of the rail.

Figure 7. Rail 1 fracture surface showing the 2 semi-elliptical fatigue cracks; wheel profile added to show effect of wheel tread contact on transposed rail (Source: TSB)

The west rail broke under normal service conditions when pre-existing fatigue cracks, representing about 15% of the total area of the rail head, propagated down to the base of the rail in a sudden overstress.

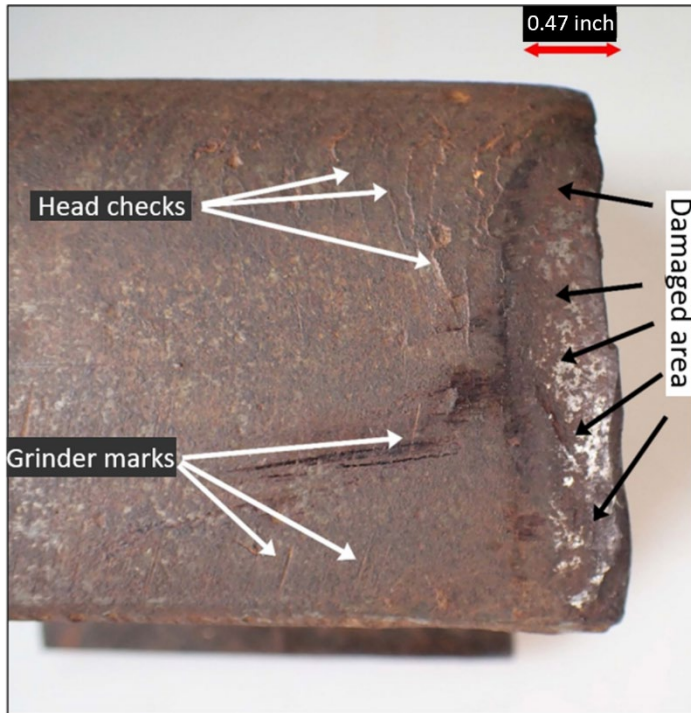
The top view of the rail running surface displayed minor head checks on the gauge side of the head and rail grinding marks on the field side of the head. There was impact damage, likely due to contact with freight car wheel treads, that extended across the rail head running surface, but there was no widening (horizontal expansion) of the rail head (Figure 8).

Figure 8. Rail 1 top view showing head checks, grinder marks, and a damaged area (Source: TSB)

The damaged area of the Rail 1 fracture surface contained a depression that was located about 0.47 inch (12 mm) longitudinally from the fracture surface and gradually got deeper as it approached the fracture surface. The depression measured about 0.24 inch (6 mm) at its deepest point.

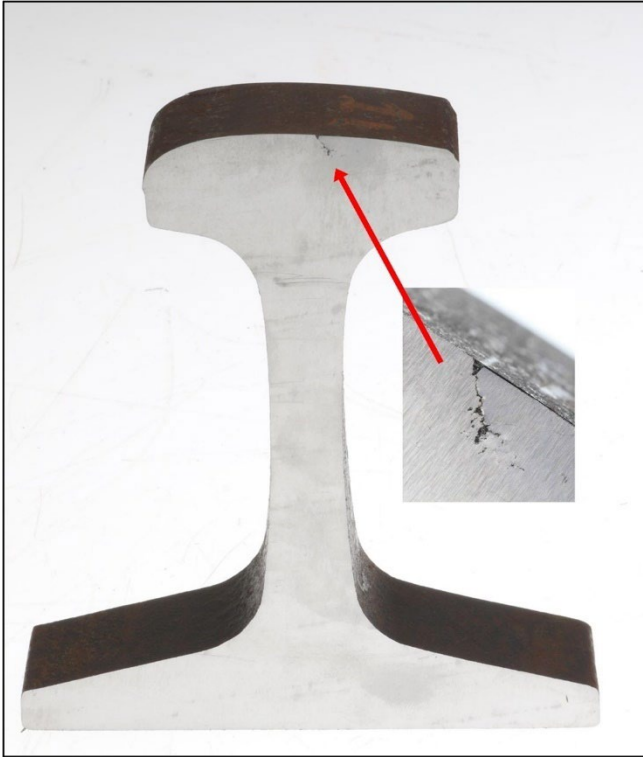
Subsequently, Rail 1 was cut vertically about 1.2 inches (30 mm) away from, and parallel to, the fracture surface. On the cut surface of the cross-section, a small vertical crack was observed extending from the rail running surface to a depth of about 0.24 inch (6 mm) (Figure 9).

Figure 9. Rail 1 cross-section showing the crack (Source: TSB)

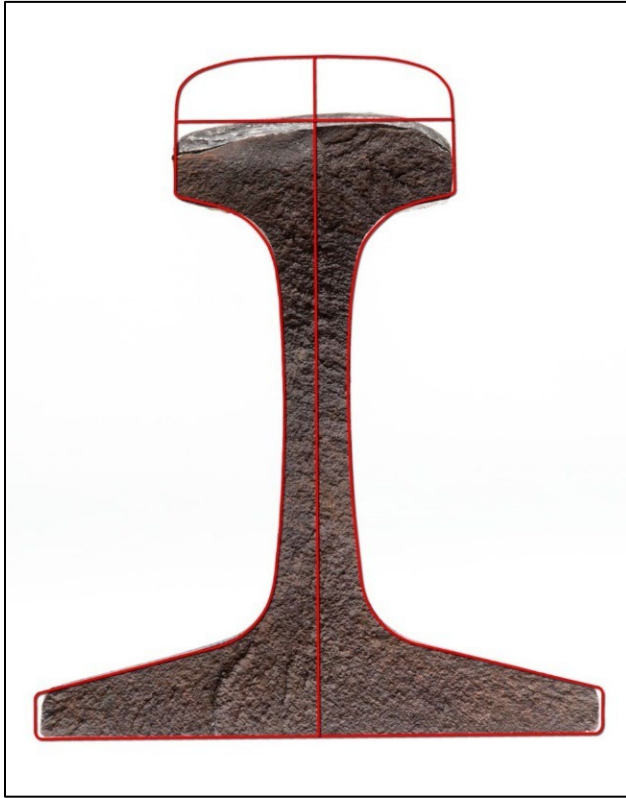
The measured vertical head wear for Rail 1 was 9/16 inch (14 mm) while the gauge face wear was minimal. According to the CP requirements, the maximum head wear permitted for 115-pound rail is 11/16 inch (16 mm). To illustrate the extent of the rail head wear, a new 115-pound rail cross-section was superimposed on the Rail 1 cross-section (Figure 10).

Figure 10. New 115-pound rail cross-section superimposed on the Rail 1 cross-section (Source: TSB)

The rail head wear permitted by CP for 115-pound rail is 11/16 inch (16 mm) and the measured vertical head wear for Rail 1 was 9/16 inch (14 mm). The rail head running surface was also slightly tapered towards the field side. The investigation determined that the rail had been transposed in 2007. Although the rail head wear was still within allowable limits, the amount of wear made it more susceptible to fatigue crack initiation and propagation. Furthermore, the presence of a small vertical fatigue crack extending from the rail running surface to a depth of about 0.24 inch (6 mm) in a section of Rail 1 located 1.2 inches (30 mm) away from, and parallel to, the fracture surface suggests that multiple cracks were probably present in this section of rail. Such cracking, which can propagate over time on a heavily worn rail head, such as the occurrence rail, could be indicative of rail approaching the limit of its service life.

Although the head wear of the rail that broke was within CP's allowable service limits, the amount of head wear increased the level of stresses acting on the rail from wheel loading,

which led to a reduced fatigue life of the rail and made it more susceptible to failure due to fatigue cracking.
