RAIL TRANSPORTATION SAFETY INVESTIGATION REPORT R21V0144

LOCOMOTIVE ENGINE FIRE

Canadian Pacific Railway Company
Freight train 880-066
Mile 54.3, Cranbrook Subdivision
Elko, British Columbia
08 July 2021

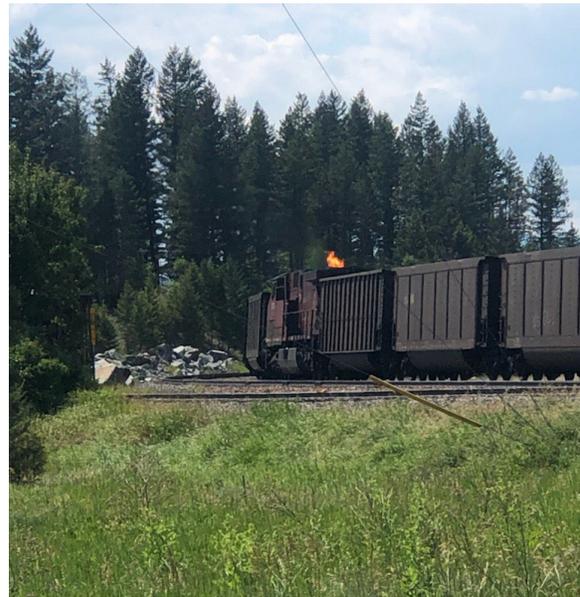
Figure 2. Exhaust stack fire on the mid-train remote locomotive (Source: Elko resident)

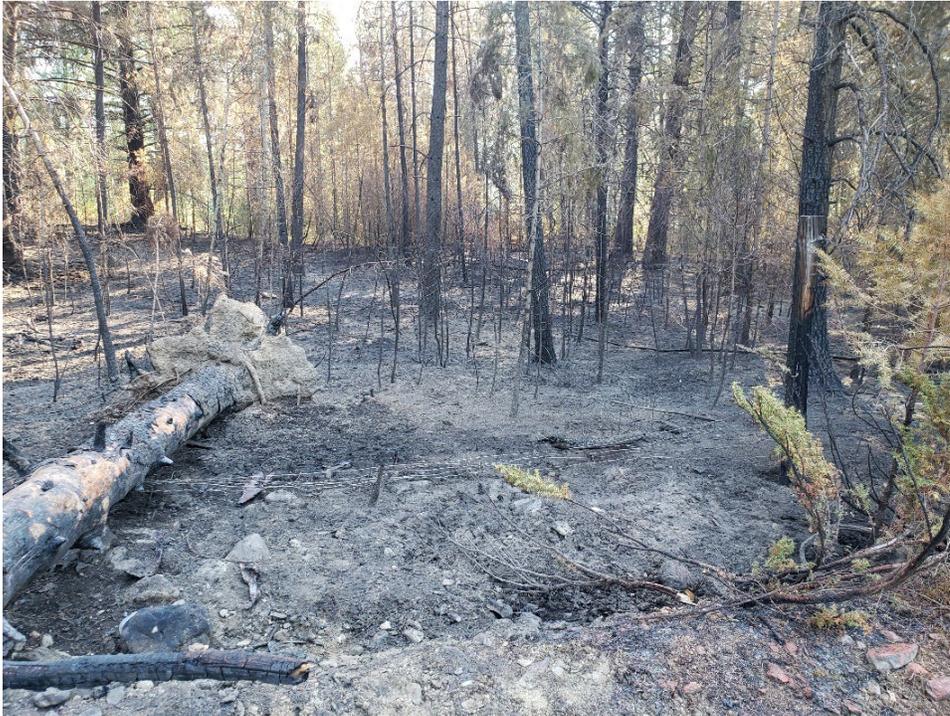
The fire grew to approximately 1.2 hectares in size and extended beyond the CP ROW, to the private property of a local farmer. The fire was extinguished about 3.5 hours later. The fence along the ROW was damaged, as well as some surplus ties; the damage to the local farmer's property was limited to vegetation (Figure 3).

Figure 3. Damage from the trackside fire near Caithness (Source: TSB)

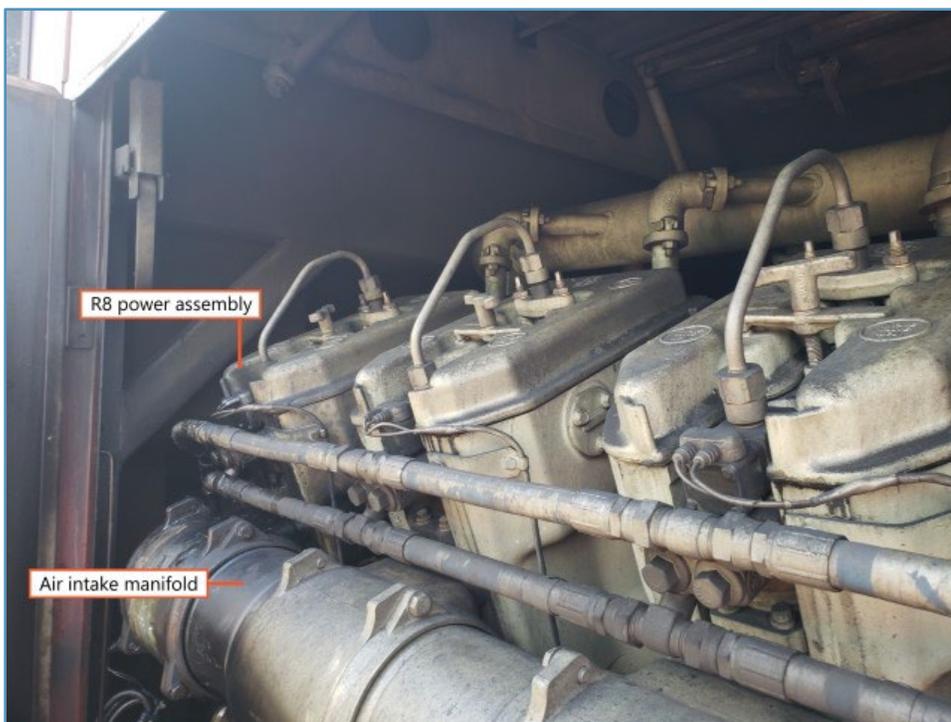
The inspection determined that the R8 power assembly (the 8th power assembly on the right side) failed. A rocker arm on this power assembly was found broken, and both the power assembly housing and the air intake manifold were damaged. An exhaust valve was found broken with its head badly damaged and the valve stems were bent on the remaining exhaust valve and both intake valves. The fuel injector tip was found broken off. In addition, valve seat recession⁹ was noted on the failed valve.

Figure 4. Air intake manifold and R8 power assembly on locomotive CP 9779 (Source: TSB)

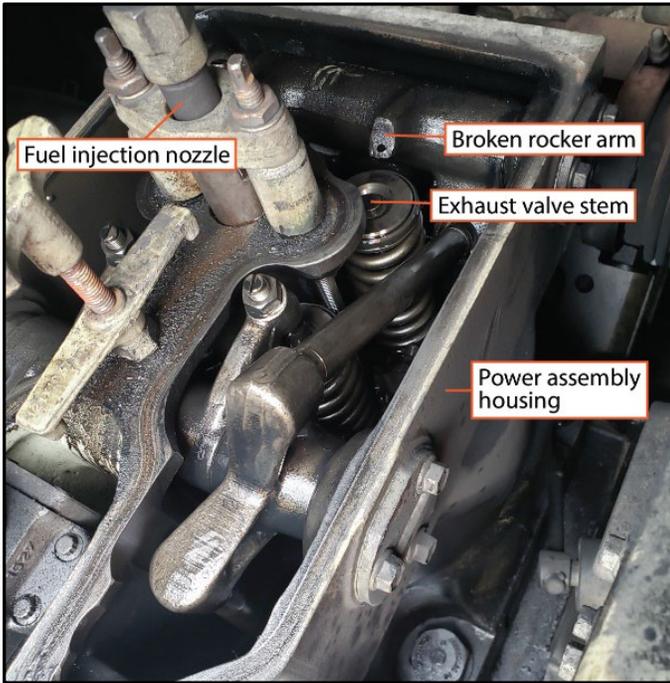
Figure 5. Broken rocker arm in the R8 power assembly on locomotive CP 9779 (Source: TSB)

The head of the exhaust valve broke off and dropped into the combustion chamber while the engine was in operation, breaking the tip off the fuel injector.

Subsequent mechanical examination of the locomotive found a broken rocker arm on the R8 power assembly. An exhaust valve was found broken with its head badly damaged and the stems on the remaining exhaust valve and both intake valves were bent. The fuel injector tip was found broken off. It was determined that an exhaust valve, which showed evidence of valve seat recession, had failed; its head dropped into the combustion chamber while the engine was in operation, breaking off the tip of the fuel injector. As evidenced by the bent valves stems on the remaining valves, the rocker arm failed either after or during its associated valve's impact with the broken exhaust valve head. The air intake manifold was also damaged. This resulted in a loss of pressure in the air supplied to the 8 cylinders on the right-hand side of the diesel engine and, consequently, the fuel-air mixture supplied to these cylinders contained more fuel than normal. In addition, the broken fuel injector continued to deliver unatomized fuel to the combustion chamber and hence out through the open exhaust valve port.
