# RAIL TRANSPORTATION SAFETY INVESTIGATION REPORT R23Q0022

## **MOVEMENT EXCEEDS LIMITS OF AUTHORITY**

Quebec North Shore and Labrador Railway  
Ore train W039  
Mile 128.3, Wacouna Subdivision  
Mai, Quebec  
22 February 2023

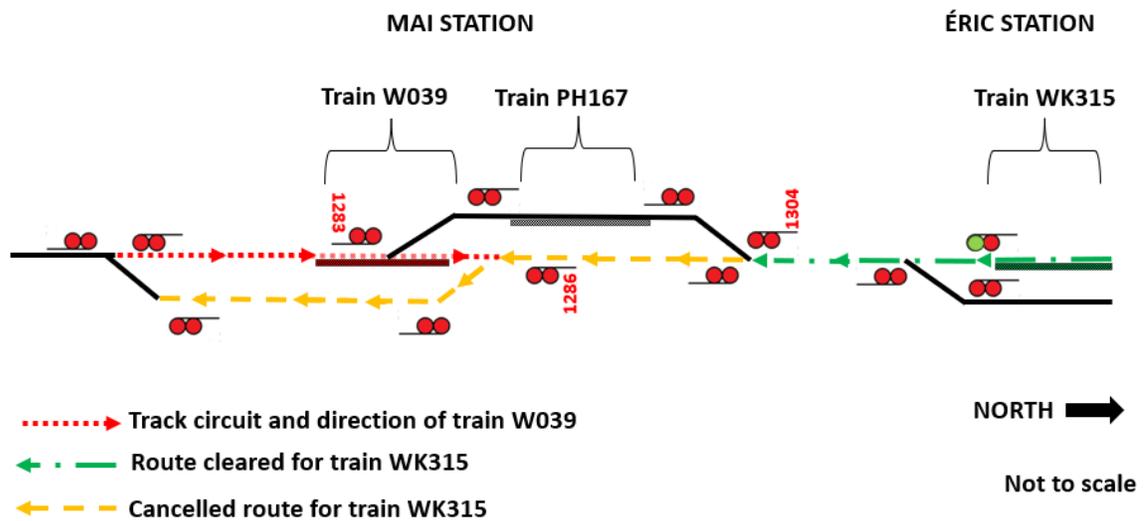
When the train stopped beyond signal 1283, the track circuit in the next controlled block<sup>11</sup> was interrupted, resulting in the cancellation of signals 1304 and 1286 governing the route of work train WK315 (Figure 3).

Figure 3. View of the centralized traffic control circuit showing the location and route of the 3 trains at the Mai and Éric stations at the time of the occurrence (Source: TSB)
