MARINE TRANSPORTATION SAFETY INVESTIGATION REPORT M23C0032

CREW MEMBER INJURY DURING MOORING OPERATIONS

Roll-on/roll-off ferry *Atlantic Vision*

23 March 2023

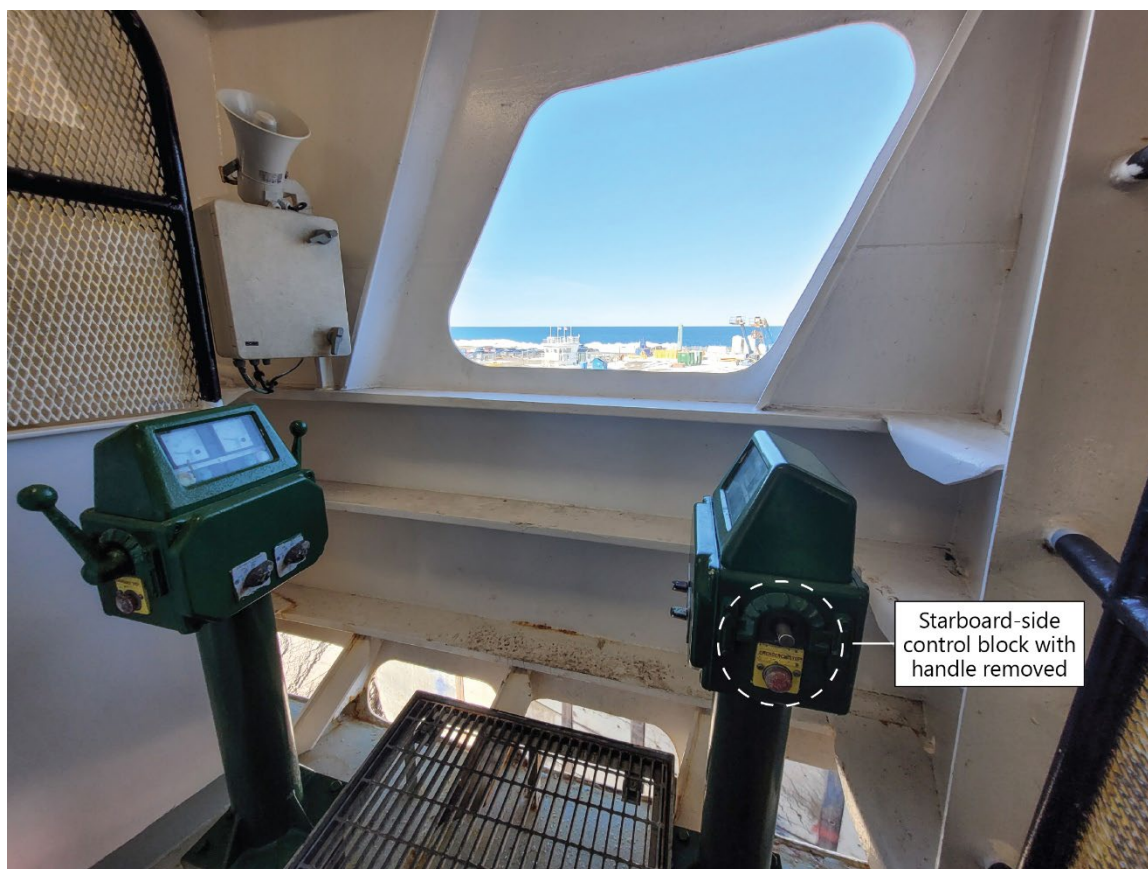
Figure 5. View of the starboard-side control station showing control blocks for the port-side equipment (left) and starboard-side equipment (right) (Source: TSB)

At the time of the occurrence, the starboard-side controls for the starboard combination windlass and mooring winch would only operate on the slower speed setting, and the handle for the controls had been removed to prevent use until repairs were completed (Figure 5). The port-side controls for the starboard combination windlass and mooring winch still worked at both speeds. There was no direct line of sight from these controls to the winch due to the vehicle ramp at midship.

Following the occurrence, Marine Atlantic Inc. replaced the obsolete components in winches W1, W2, and M5, and repaired the issue with the winch W1 controls.

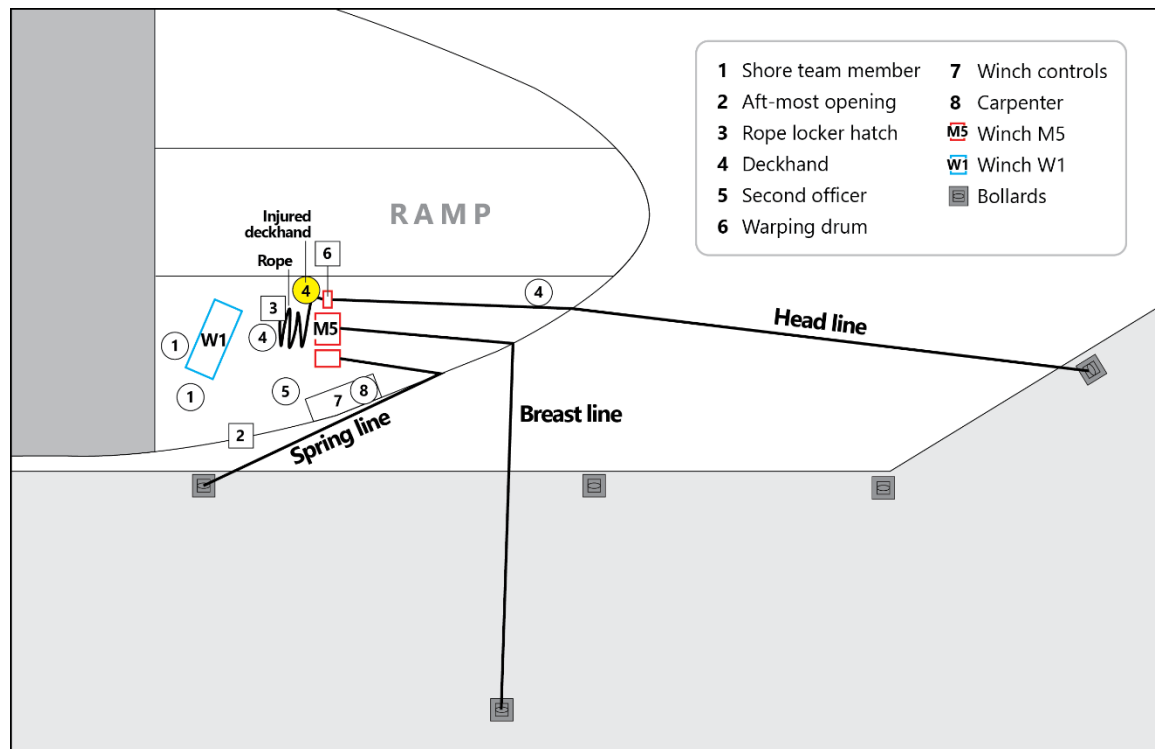
Figure 7. The *Atlantic Vision's* mooring configuration while alongside the public wharf and approximate locations of individuals at the forward mooring station (Source: TSB)

The second officer remained beside winch M5 and began disengaging the drum holding the spring line so that only the breast line and head line would winch in. The carpenter was at the winch controls, 1 deckhand was forward near the roller fairlead used by the head line, 1 deckhand was tending to the head line on the warping drum, and 1 deckhand was coiling the slack from the head line on the deck (Figure 7). The unused portion of the head line was stored in the rope locker under the deck. The 2 shore team members at the forward mooring station were standing near winch W1 underneath fan outlets that generated a significant amount of noise.

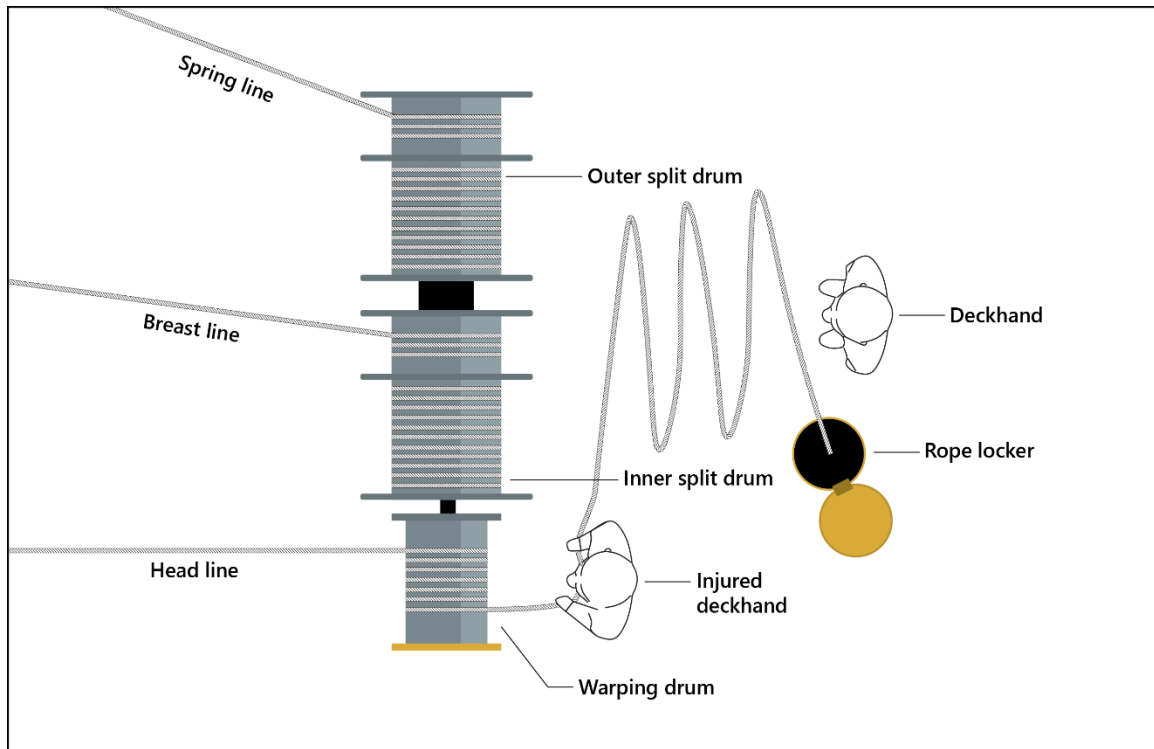
Figure 8. Position of the injured deckhand relative to the warping drum just prior to the occurrence
(Source: TSB)

At 1508:51, the head line rapidly pulled through the warping drum and struck the deckhand on the head, destroying his hard hat and seriously injuring him (Figure 8).

As the submerged end of the head line was drawn into the bow thruster and began wrapping around its propeller shaft, the rest of the line came under tension because it was still on the mooring winch warping drum. The tension caused the head line to start slipping on the warping drum. The deckhand noticed that the head line was slipping but, without having any information about the developing situation, perceived this to mean that the vessel was moving away from the dock. He made an additional turn on the warping drum; however, the tension on the head line continued to build as the line wrapped around the rotating bow thruster shaft. Once the tension reached a critical point, the head line pulled out of the rope locker and through the warping drum, striking the deckhand and seriously injuring him.

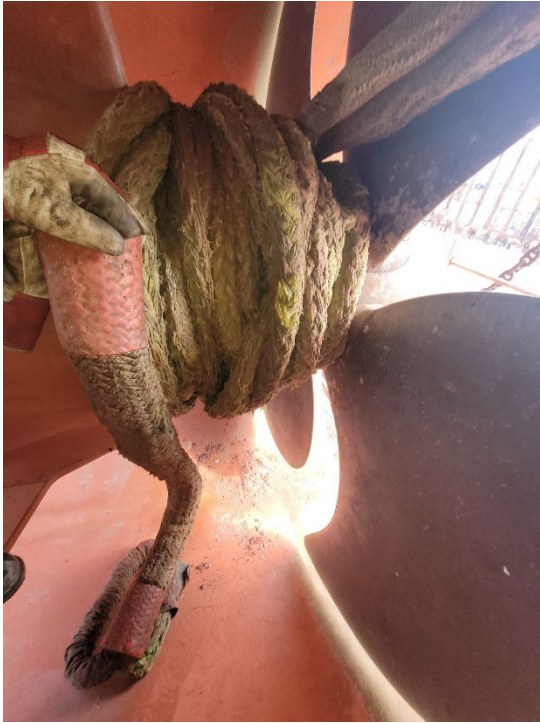
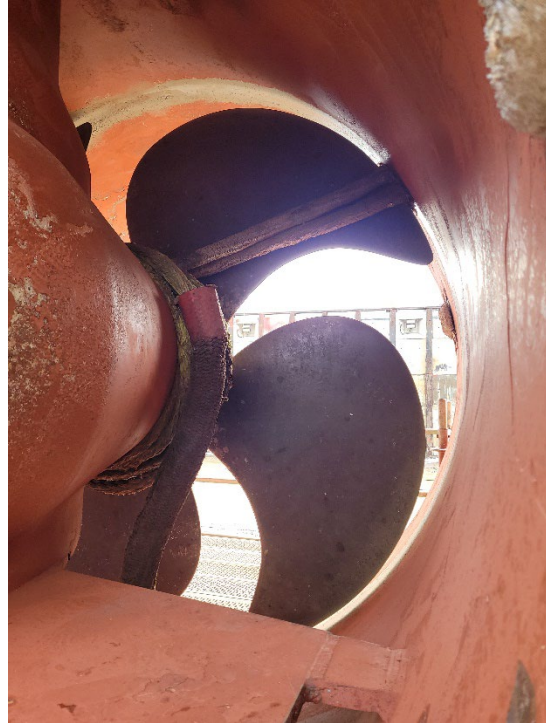
Figure 9. Close-up of mooring line wound around bow thruster (Source: Groupe Océan)

The forward bow thruster was rendered inoperable until the mooring line wound around it was cut and removed (figures 9 and 10).

The vessel's bow thruster drew in the head line and caused it to wrap around the thruster's propeller shaft.

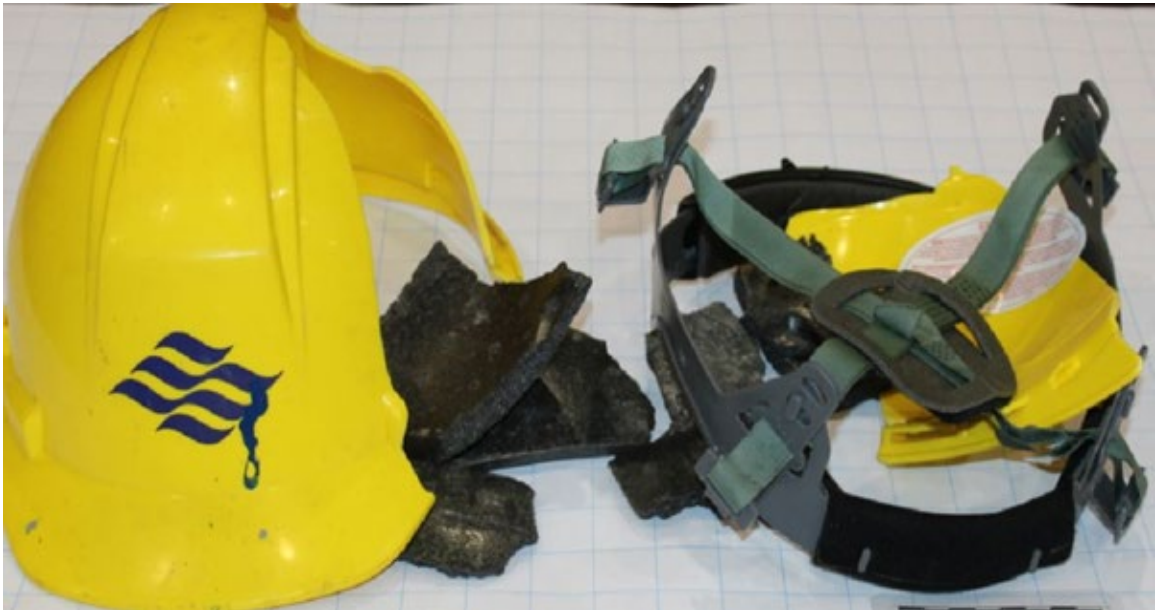
Figure 11. Occurrence hard hat (Source: TSB)

The laboratory analysis determined that, at the time of the occurrence, the hard hat was in a serviceable condition and was well maintained. The hard hat conformed with CAN/CSA Z94.1-15, a standard published by the Standards Council of Canada that applies to protective headwear. Conformance with CAN/CSA Z94.1-05 is required by the *Maritime Occupational Health and Safety Regulations*.¹⁶

The laboratory analysis could not conclusively quantify the force that was applied to the hard hat during the occurrence. However, the analysis could reasonably demonstrate that the whip velocity was likely over the maximum for an impact to the crown or side of the hard hat. As a result, the hard hat shell broke while absorbing a significant amount of energy (Figure 11). This reduced the energy that was transmitted to the hard hat suspension assembly.

The crew member's use of an appropriate hard hat likely prevented a more serious injury.
