RAIL TRANSPORTATION SAFETY INVESTIGATION REPORT R23M0050

MAIN-TRACK TRAIN DERAILMENT

Canadian National Railway Company
Freight train L59411-30
Mile 32.7, Sussex Subdivision
Near Dunsinane, New Brunswick
30 October 2023

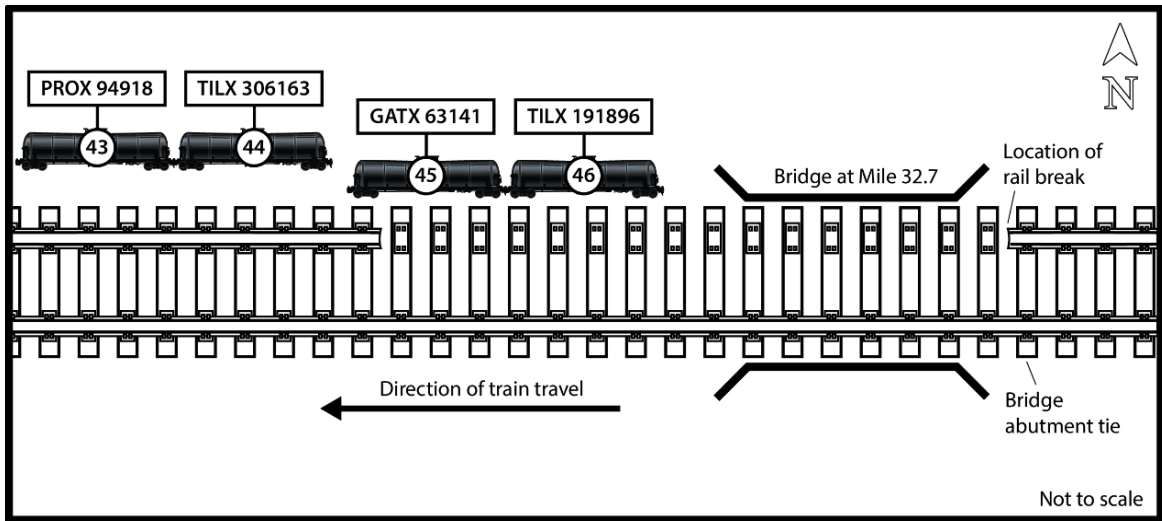
The 4 cars that derailed, in positions 43 to 46,³ were tank cars carrying dangerous goods.⁴ They had derailed on the north side of the track, west of a small bridge (Figure 2). Cars in positions 43 and 44 had remained coupled together and were on their side, while cars in positions 45 and 46 had remained coupled together and had overturned. Visual examination of the tank cars showed that there were no breaches to the tank shells.

On-site examination also noted that a section of the north rail had broken into multiple pieces at the eastern side of the bridge, beginning around the bridge abutment tie where the rail transitioned from roadbed to bridge structure and extending over the first 3 ties of the bridge. The bridge abutment tie and the last 2 wooden ties of the roadbed east of the section of the rail break were split and the tie plates had cut into the wooden ties.

Figure 2. Site diagram (Source: TSB)

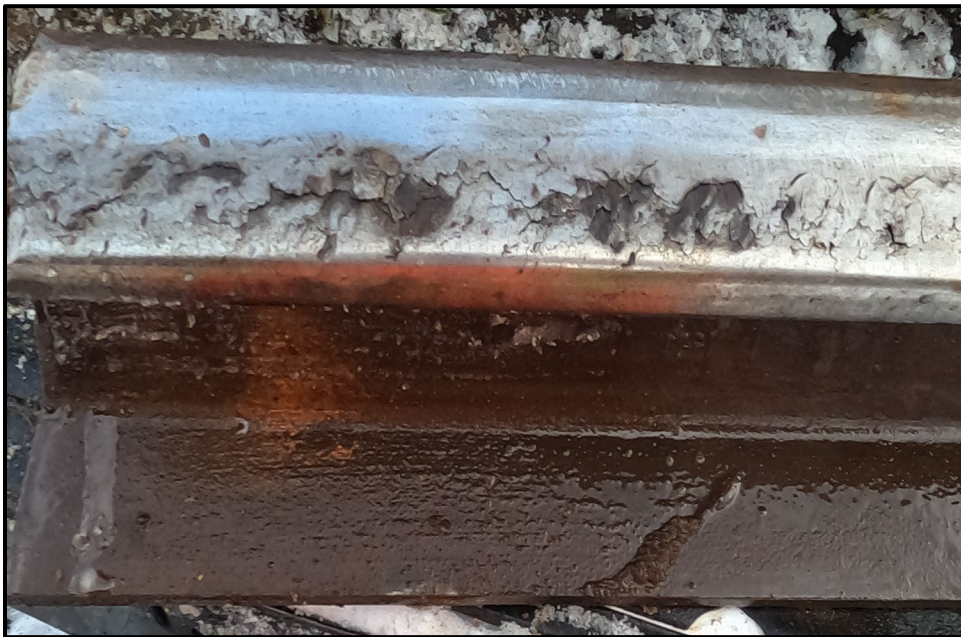
The condition of the rail observed on site showed that the north rail on the bridge had extensive head checking along its rolling surface (Figure 3).

Figure 3. Recovered broken rail with head checking (Source: TSB)

The section of the north rail that broke was 100-pound continuous welded rail. It was manufactured by Dominion Steel and Coal Corporation in 1951. This section of rail had extensive head checking and did not have any recent grinding marks. In contrast, the undamaged roadbed rail located east of the broken section had a smooth rolling surface with marks indicative of recent rail grinding having been performed.

The extensive head checking on the rail that broke likely contributed to the initiation of the TDDs.

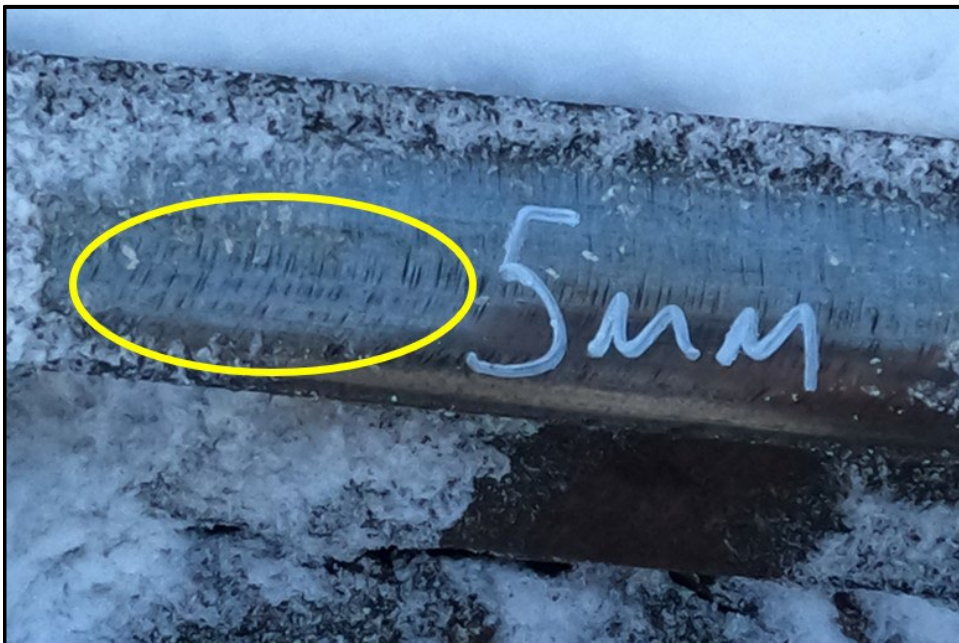
In contrast, the undamaged north rail on the roadbed approaching the bridge showed a smooth rolling surface with marks consistent with recent grinding activity (Figure 4).

Figure 4. North rail from the roadbed approaching the bridge showing grinding marks, circled in yellow (Source: TSB)

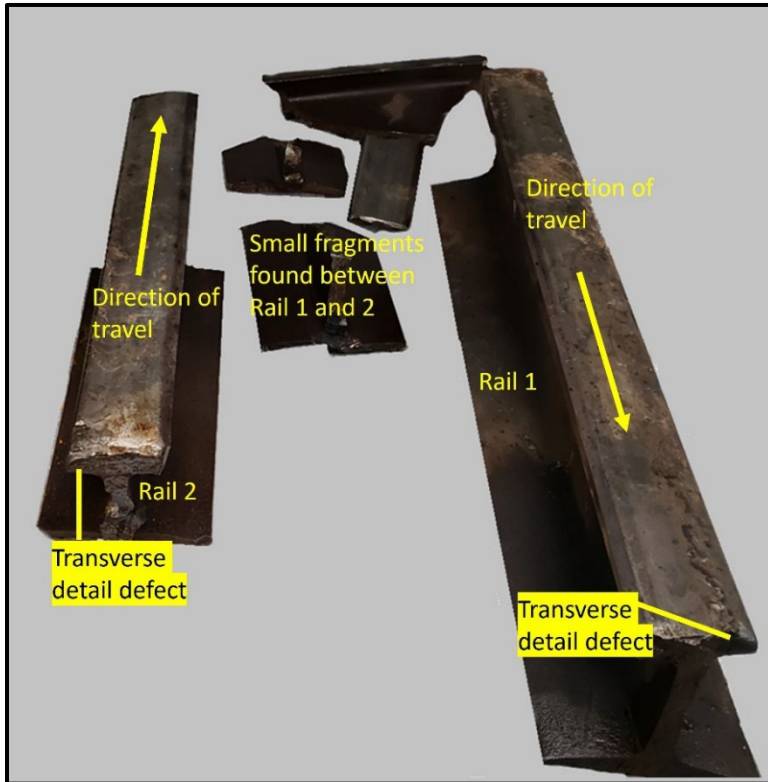
The recovered pieces of the broken north rail that were sent to the TSB Engineering Laboratory are shown in Figure 5. The piece labelled Rail #1 corresponds to the eastern section of the north rail around the bridge abutment tie. The piece labelled Rail #2 corresponds to the western section of the north rail on the bridge. The smaller fragments were found between Rail #1 and Rail #2.

Figure 5. Rail pieces recovered from the occurrence site (Source: TSB)

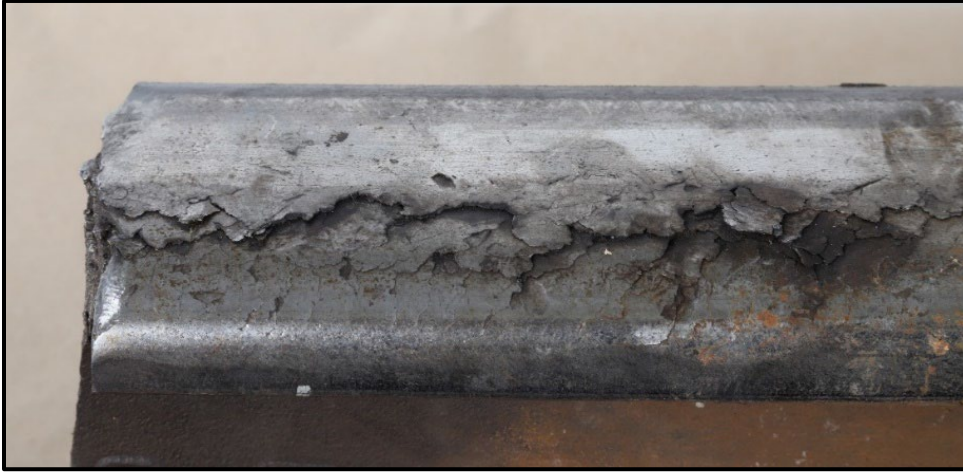
- The rail was manufactured by Dominion Steel and Coal Corporation in 1951.
- The rail showed extensive head checking along the gauge side of the rolling surface (Figure 6).
- The head of the rail had approximately 6 mm of wear and was within CN acceptable wear limits.
- Rail #1 contained a type of transverse detail defect (TDD) on its broken end initiating from the upper gauge side for approximately 0.5 inch through the head of the rail (Figure 7). The defect was approximately 15% of the total cross-sectional head area, likely initiating from the head checking condition.
- Rail #2 also contained a smaller detail fracture on one of its broken ends in the upper gauge side corner of the head (Figure 8).
- Both defects had the features and appearances associated with fatigue cracking.

Figure 6. Head checking on Rail #1 (Source: TSB)

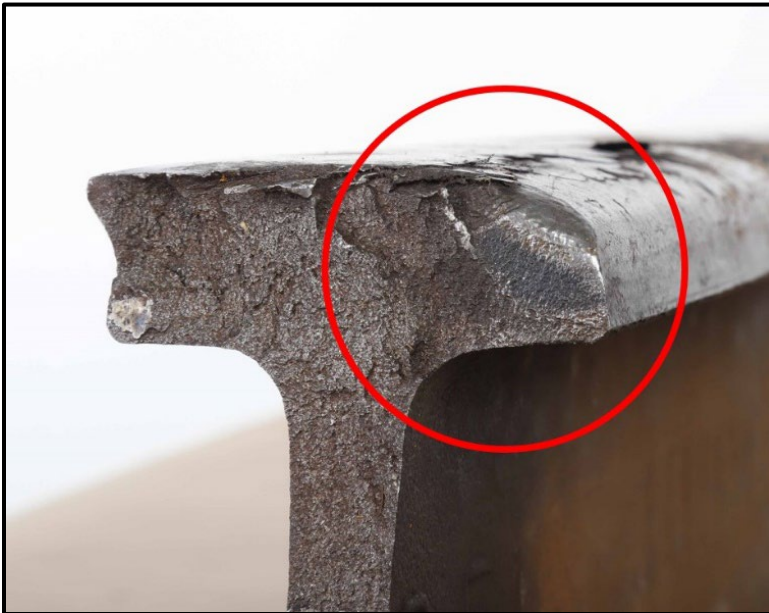
Figure 7. Detail fracture on Rail #1 (Source: TSB)

According to TSB laboratory analysis, a type of transverse detail defect (TDD), likely a detail fracture from head checking, was present in the rail head of Rail #1 (the eastern section of rail around the bridge abutment tie) and Rail #2 (the western section of rail on the bridge).

The TDDs in the broken north rail section likely originated from head checking and then transitioned into transverse fatigue cracks. The north rail then failed in sudden overstress once the reduced cross-sectional area of the defect-free rail head was reduced to the point it could no longer handle the applied load.

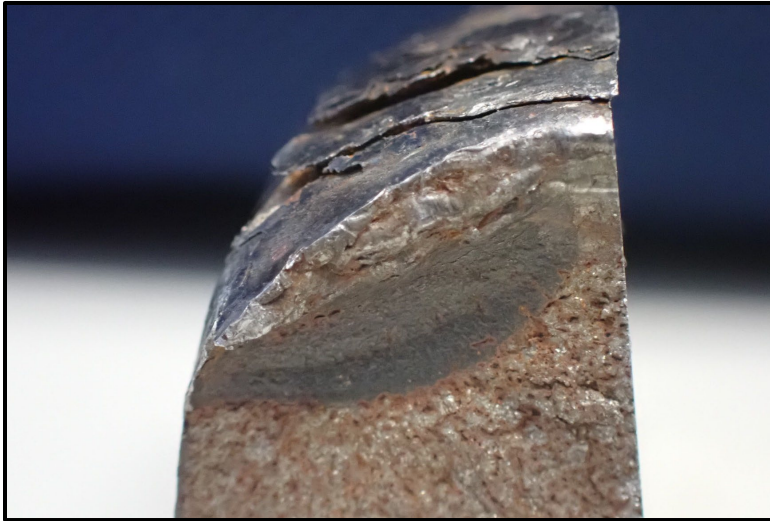
Figure 8. Detail fracture on Rail #2 (Source: TSB)
