AIR TRANSPORTATION SAFETY INVESTIGATION REPORT A23W0096

LOSS OF CONTROL AND COLLISION WITH WATER

Cooking Lake Aviation Academy Inc.
Diamond Aircraft Industries Inc. DA20-C1, C-FRZG
Cooking Lake Aerodrome (CEZ3), Alberta, 20 NM E
11 August 2023

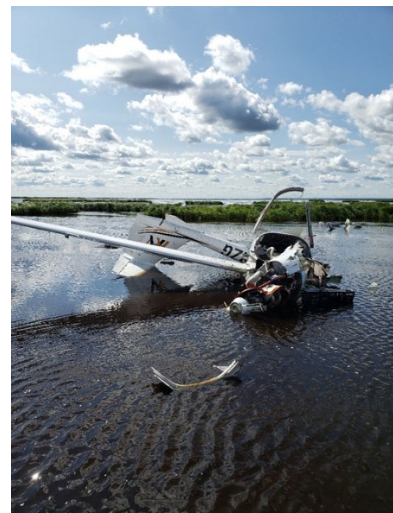
The fuel tank, located in the fuselage aft of the cockpit, fractured during the accident during the breakup of the aircraft's cockpit area. Approximately 16 U.S. gallons of the fuel that remained in the tank at the time of impact leaked out at the accident site. All aircraft components were located at the accident site.

Figure 4. Accident site, looking south (Source: TSB)

The left wing had sheared from the fuselage, but the pushrods controlling the ailerons were still attached to the cabin. The tail of the aircraft broke just aft of the cabin, but the rudder control cables remained attached to the forward fuselage.

The flight-control system was verified and was noted to be continuous between those sections that had failed in overload due to impact forces. The flaps were determined to be in the up position.

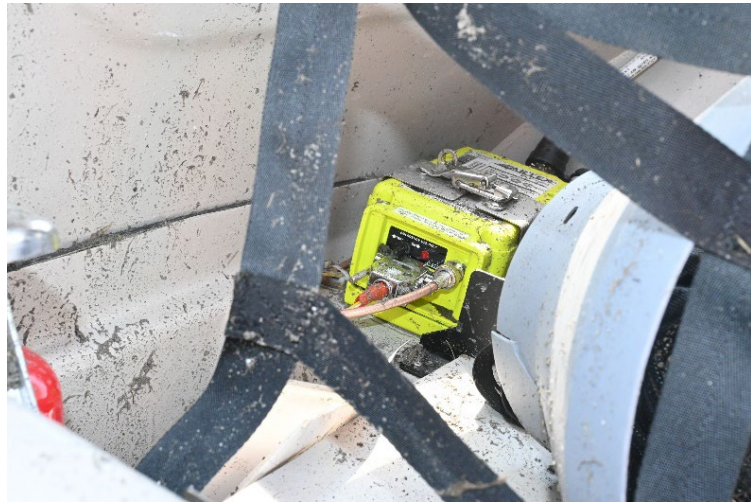
The ARTEX ELT 1000 has a 3-position switch on the body of the ELT that allows for selection of Test/Reset, ARM, and ON. The ELT, which was held securely in position, was found on its mounting bracket with the

wiring harness and antenna cable attached. The ELT switch was found in the ARM position. Although the aircraft came to rest in shallow water, the ELT and its connections were not submerged.

Figure 5. The occurrence aircraft's ARTEX ELT 1000 installation, looking aft at the right side of the baggage compartment, behind the right seat (Source: TSB)

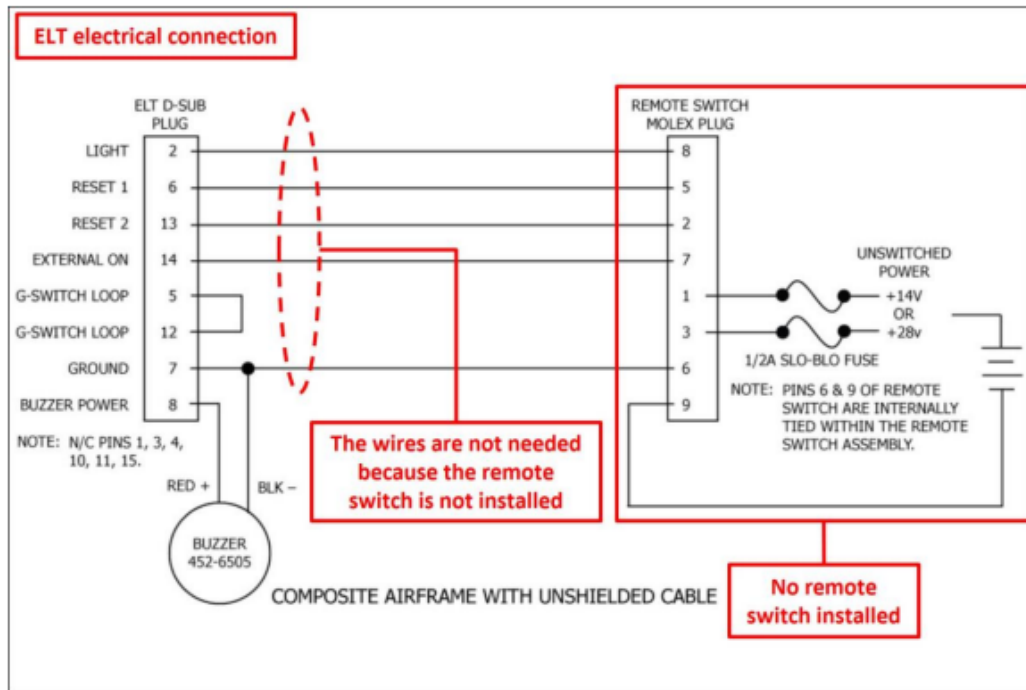
In normal operation, the ARTEX ELT 1000 is ready to activate when the switch on the ELT is set in the ARM position. A connection jumper (also called the G-switch loop), which enables the G-switch circuitry to function (Figure 6), is installed by the airframe manufacturer between Pin 5 and Pin 12 on the D-SUB connector. If the ELT movement causes the G-switch acceleration threshold to be exceeded, the ELT will activate. When the D-SUB connector is removed, the ELT can be handled without the possibility of automatic activation.

Figure 6. Emergency locator transmitter installation wiring diagram (Source: ARTEX Products / ACR Electronics, Inc., *ARTEX ELT 1000 Emergency Locator Transmitter Description, Operation, Installation and Maintenance Manual*, Y1-03-0259 Rev. AA [15 January 2021], Figure 23: Typical 5-Wire Installations for Composite Airframes, p. 51, with TSB annotations)
