# AIR TRANSPORTATION SAFETY INVESTIGATION REPORT A24A0046

## COLLISION WITH TERRAIN

Privately registered  
Earthstar Aircraft eGull (basic ultralight), C-IRAY  
Weyman Airpark (CCG3), New Brunswick, 1.25 NM SE  
19 July 2024

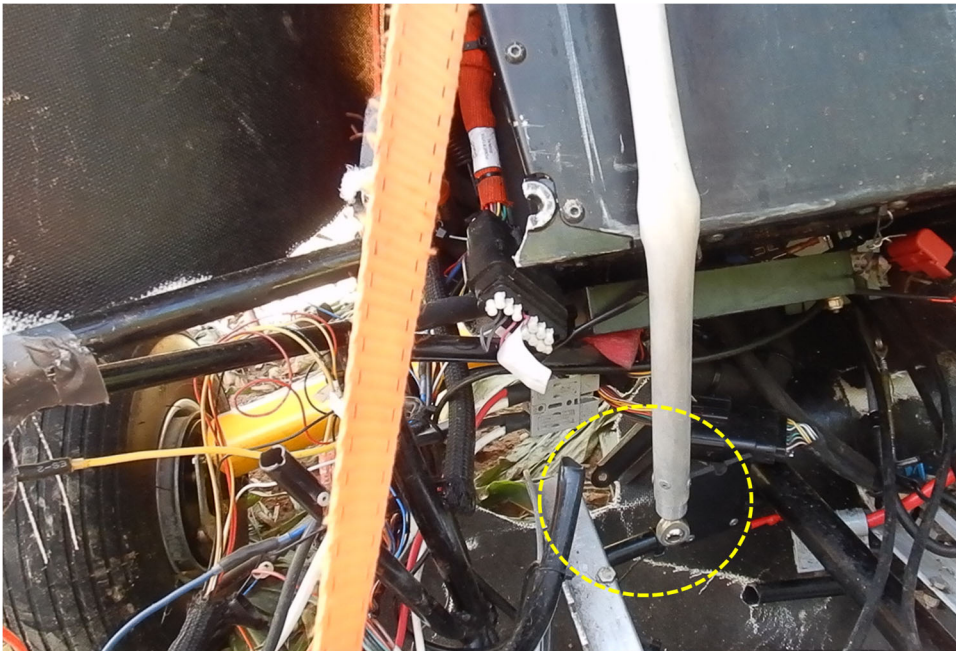
During the examination of the wreckage, it was discovered that hardware at the attachment between the control column bellcrank and the lower end of the aileron push tube assembly was missing (Figure 2). A bolt with the correct diameter and length was found in the wreckage; however, the matching nut was not found. There was no deformation present on either the bolt or the attach hole of the bellcrank, or damage to the aileron push tube rod end, indicating that the bolt likely fell out before the aircraft impacted the ground. The disconnected aileron push tube would have prevented aileron control, which would have made controlling the aircraft difficult.

**Figure 2. Wreckage, with push tube rod end and control column bellcrank circled**  
(Source: TSB)

Given that the design, construction, and maintenance of ultralights are not regulated, it is important that aircraft owners understand that they are responsible for ensuring that their aircraft are built and maintained for continued safe flight.
