# AIR TRANSPORTATION SAFETY INVESTIGATION REPORT A23Q0038

## **CONTROLLED FLIGHT INTO TERRAIN**

Canadian Helicopters Limited – Hélicoptères Canadiens Limitée  
Bell 206L (helicopter), C-GLQY  
Vallillee Lake, Quebec  
07 April 2023

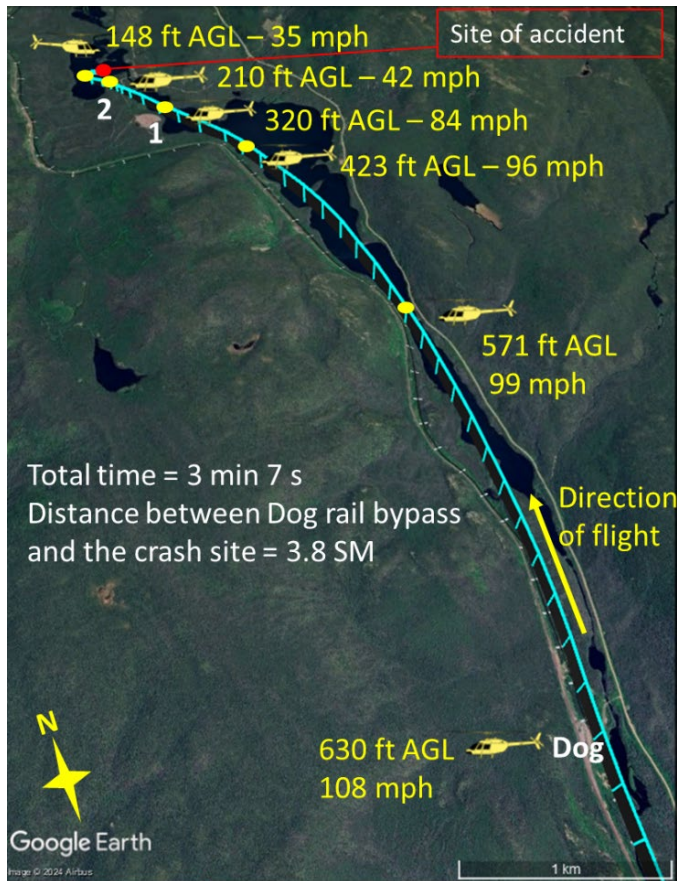
Figure 2. Flight path of the occurrence helicopter, according to data from the satellite flight-tracking system (Source: Google Earth, with TSB annotations)

Furthermore, the helicopter's height continued to decrease after the Dog rail bypass, and its speed was suddenly reduced when the helicopter reached the northern part of Vallillee Lake (Figure 2). Thirty seconds elapsed between the time when, according to estimates, visibility was suddenly reduced to approximately  $\frac{3}{4}$  SM (Figure 2, point 1) and the last point recorded before the helicopter began to turn around (Figure 2, point 2).

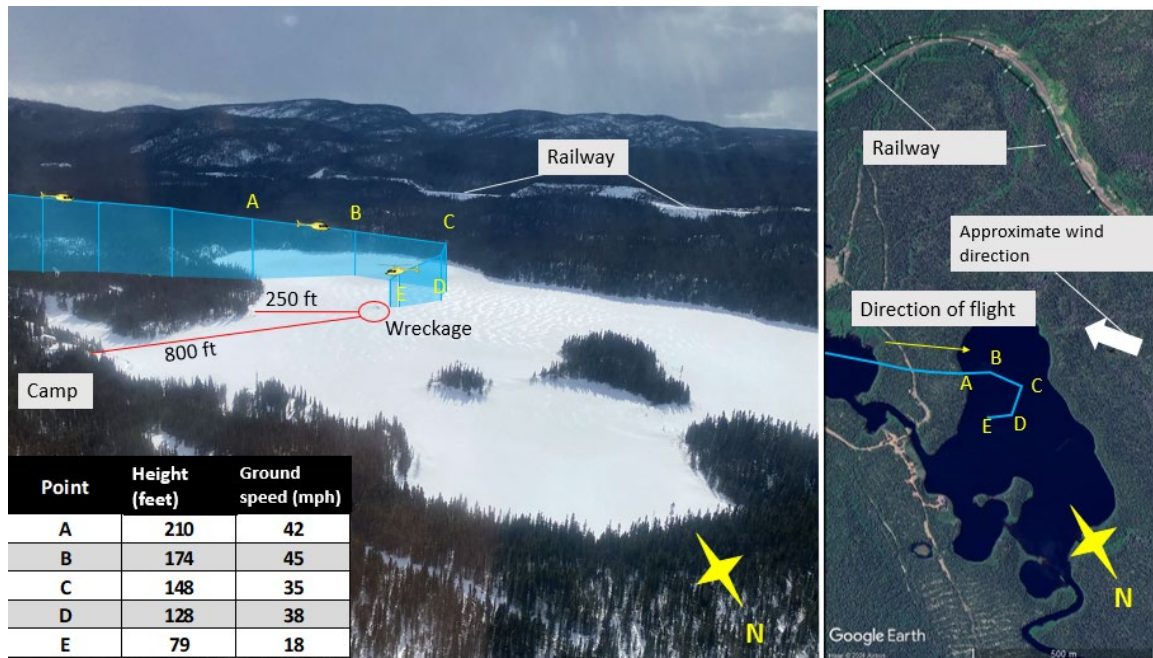
Figure 3 shows the helicopter's height and ground speed along the flight path as it was flying over the frozen lake. The investigation was unable to determine whether the descent was noticed by the pilot and intentional when he began crossing the lake. The pilot lost visual references between point A and point B (Figure 3), 5 seconds after he began crossing the lake (Figure 3, point A).

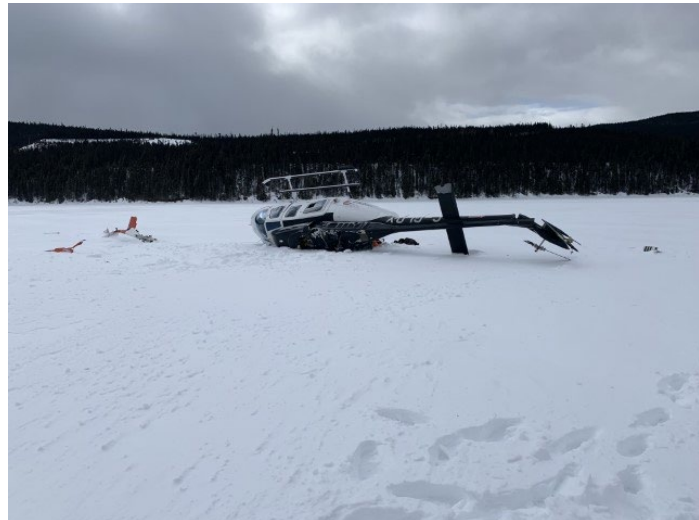
Figure 4. Photo of the wreckage taken the day of the occurrence (Source: Canadian Helicopters Limited – Hélicoptères Canadiens Limitée)

The helicopter was substantially damaged as a result of impact forces and there was no fire.

The helicopter was lying on its left side, with the nose pointing south-southeast (Figure 4). The integrity of the cockpit was not compromised. The main rotor head and 2 blades had separated from the mast and were lying in front of the wreckage. The tail fin and tail rotor were partially torn from the tail boom. The landing gear was deformed. The right aft cross tube had broken off at the attachment point and the left aft cross tube had stayed in the belly of the helicopter.

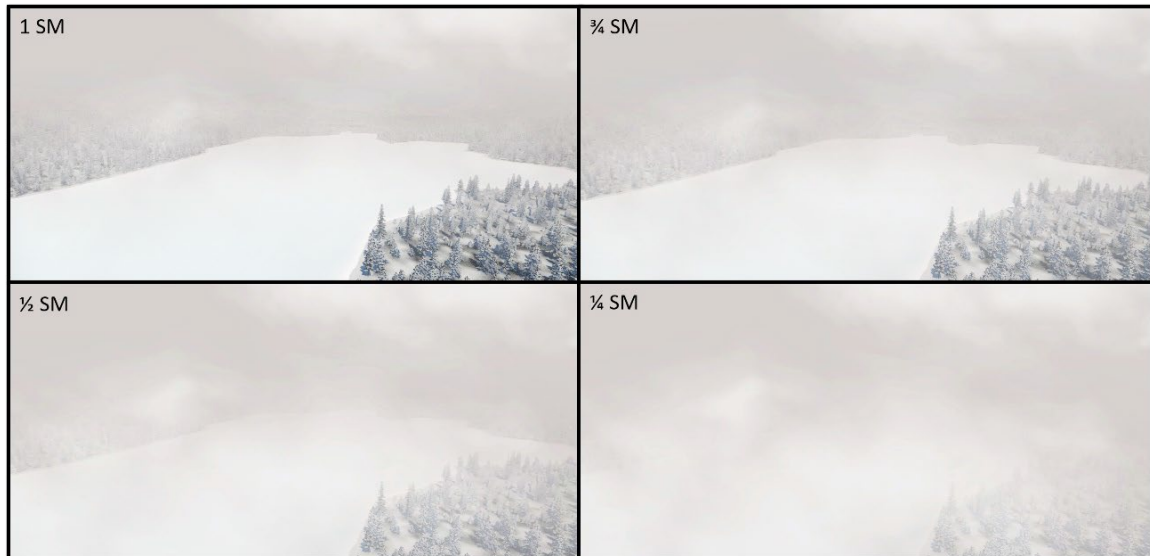
Figure 5 shows simulated views from the cockpit under various visibility conditions (1,  $\frac{3}{4}$ ,  $\frac{1}{2}$ , and  $\frac{1}{4}$  SM), when the helicopter was about to begin flying over the lake where the accident took place, at a height of 200 feet AGL. Before crossing the lake, the pilot had estimated that visibility was approximately  $\frac{3}{4}$  SM.
