AIR TRANSPORTATION SAFETY INVESTIGATION REPORT A24Q0104

COLLISION WITH WATER

Privately registered
Airbus AS350 B2 (helicopter), C-GGLM
Lac d'Elvert, La Vérendrye Wildlife Reserve, Quebec
18 August 2024

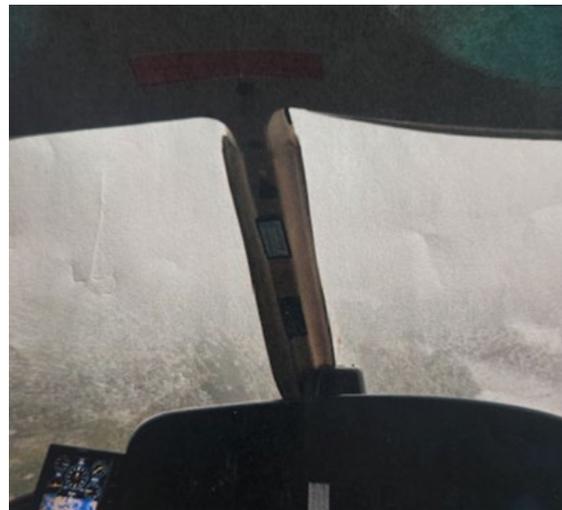
At approximately 1600, given the poor weather conditions, the pilot landed at Le Domaine, a rest area and lodging site for hunting and fishing enthusiasts owned by the Société des établissements de plein air du Québec. One of the passengers took a photo with their cellphone while in flight before landing at Le Domaine, which showed that forward visibility was very low due to heavy rain (Figure 1). Text messages exchanged between an individual on the ground and this passenger confirmed that weather conditions were poor during the flight.

Figure 1. Photo taken during the occurrence flight before landing at Le Domaine (Source: Third party, with permission)

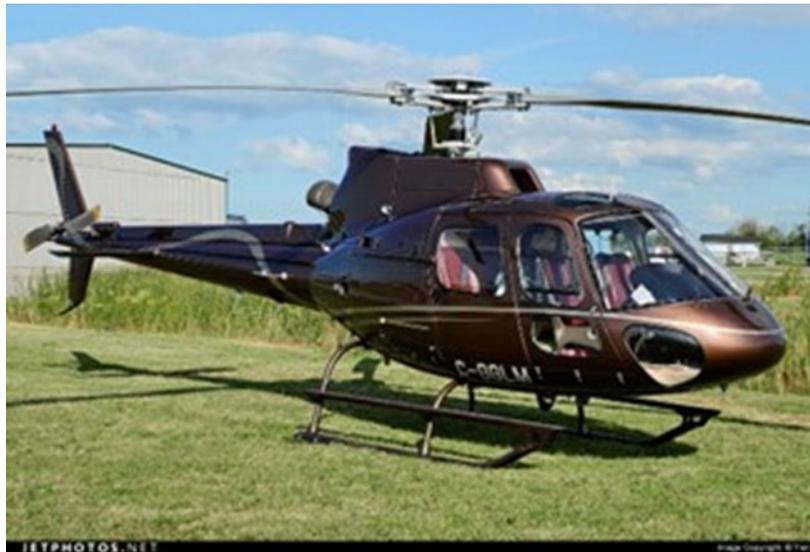
Figure 2. Occurrence helicopter (Source: JetPhotos)

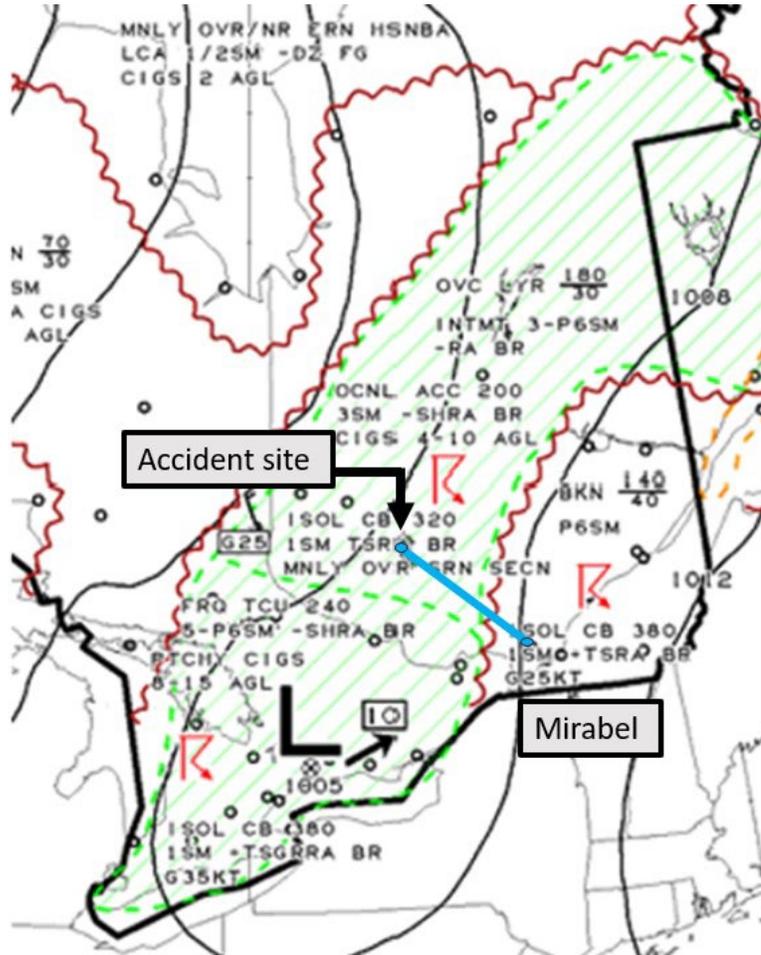
Forecasts for the area along the flight route, available on the graphic area forecast Clouds and Weather Chart (Figure 3) and Icing, Turbulence and Freezing Level Chart, indicated the following conditions starting at 1400 for the planned route:

- Overcast ceiling at 3000 feet above sea level (ASL) with tops at 18 000 feet ASL, visibility varying between 3 SM and greater than 6 SM in light rain and mist
- Occasionally, due to altocumulus castellanus clouds, visibility of 3 SM in light rain showers and mist, reducing the ceiling to between 400 and 1000 feet AGL
- Isolated cumulonimbus clouds, reducing visibility to 1 SM in thunderstorms, rain, and mist, primarily in the southern portion
- Moderate mechanical turbulence from the surface to 3000 feet AGL due to low-level wind shear

Figure 3. Graphic area forecast Clouds and Weather Chart, valid at 1400 on 18 August 2024, with depiction of the occurrence flight (Source: NAV CANADA, with TSB annotations)

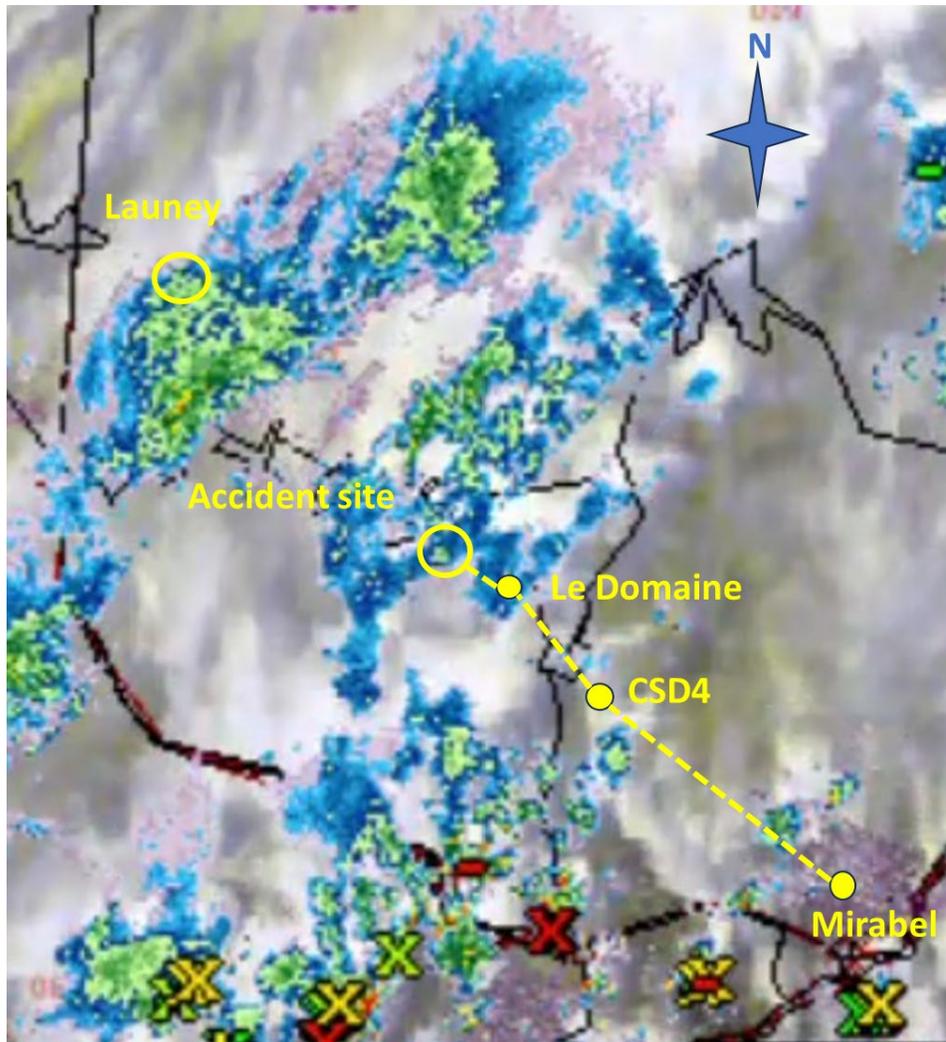
According to the radar image at 1700, there were rain showers in the area where the helicopter was flying at the time of the occurrence (Figure 4).

Figure 4. Radar image of lightning and precipitation at 1655 on 18 August 2024, with depiction of the occurrence flight. According to the image, rainfall intensity was between 0.7 and 2.7 mm/h at the accident site (Source: Environment and Climate Change Canada, with TSB annotations)
