MARINE TRANSPORTATION SAFETY INVESTIGATION REPORT M24A0269

FIRE AND ABANDONMENT

Fishing vessel *Elite Navigator*
130 nautical miles east-northeast of Fogo Island, Newfoundland and
Labrador
17 July 2024

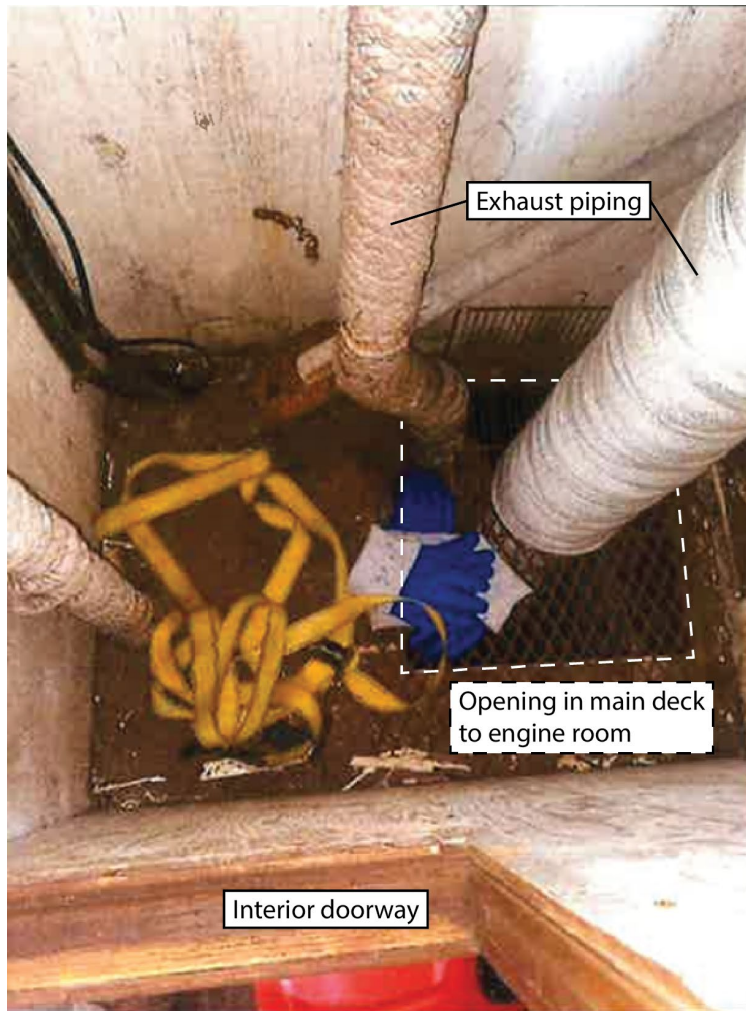
At approximately 1930, an alarm sounded in the wheelhouse. The master checked the alarm panel and determined that it was from a smoke detector in the engine room. The master looked at the video camera that monitored the engine room, but there was no smoke visible. The master then went to one of the engine room access hatches in the deckhouse and proceeded partway down a ladder into the engine room to check for smoke. Light smoke was now visible. Shortly after, a crew member in the deckhouse yelled that there was a fire in the exhaust trunking (Figure 3).

Figure 3. Photo of exhaust trunking taken in 2020 (Source: Third party, with TSB annotations)

The *Elite Navigator* was not recovered, so it was not possible to determine the exact cause of the fire. The fire was first identified in the exhaust trunking, which contained piping for the main engine and generator exhaust. The exhaust trunking measured approximately 120 cm by 60 cm and was located on the vessel's centreline, just forward of the aft bulkhead in the deckhouse. It was constructed of wood, and the interior bulkheads were covered by painted plywood, which is not fire resistant.

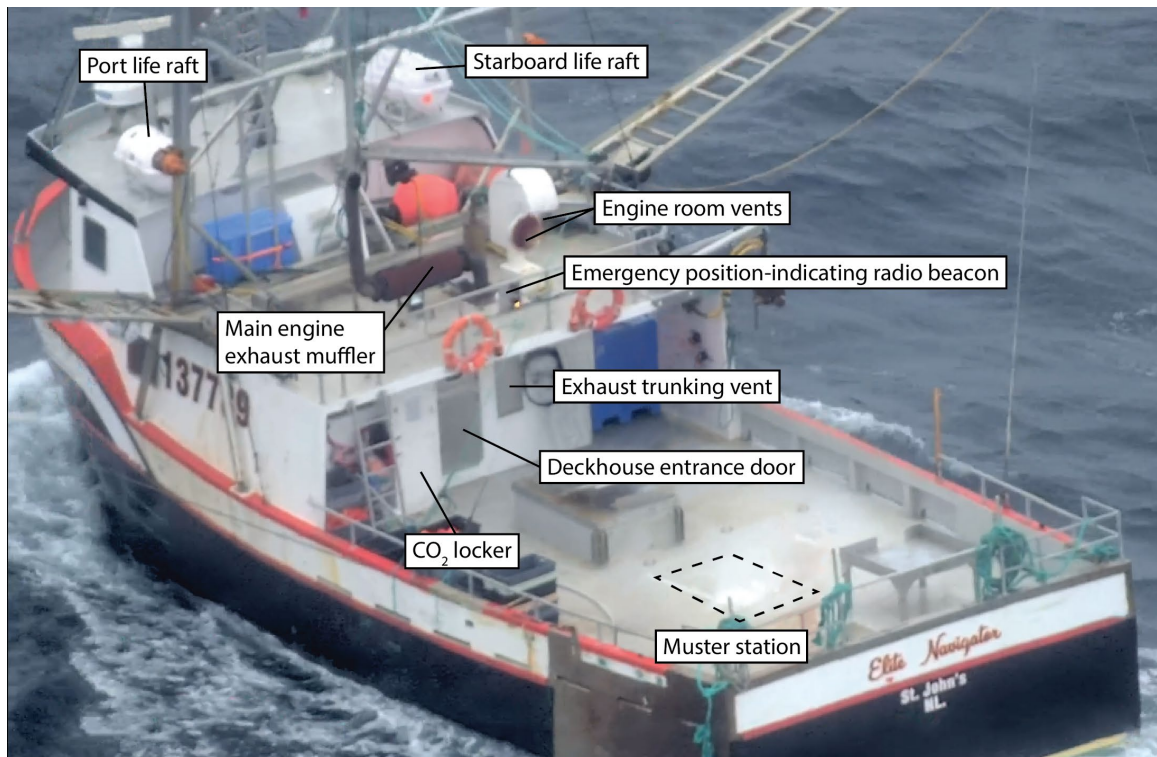
Another crew member grabbed a dry powder fire extinguisher and tried to extinguish the fire through the interior doorway to the exhaust trunking. Meanwhile, the master returned to the wheelhouse and shut down the main engine. The master and one of the crew members then went outside on the main deck and pried the exhaust trunking vent off the back of the deckhouse to get access to the other side of the exhaust trunking (Figure 4). From here, they continued to try to fight the fire with another extinguisher.

Figure 4. Aft view of the *Elite Navigator* from a voyage in 2022 showing exhaust trunking vent as well as other relevant locations and equipment (Source: Fisheries and Oceans Canada, with TSB annotations)
