AIR TRANSPORTATION SAFETY INVESTIGATION REPORT A23W0096

LOSS OF CONTROL AND COLLISION WITH WATER

Diamond Aircraft Industries Inc. DA20-C1, C-FRZG

11 August 2023

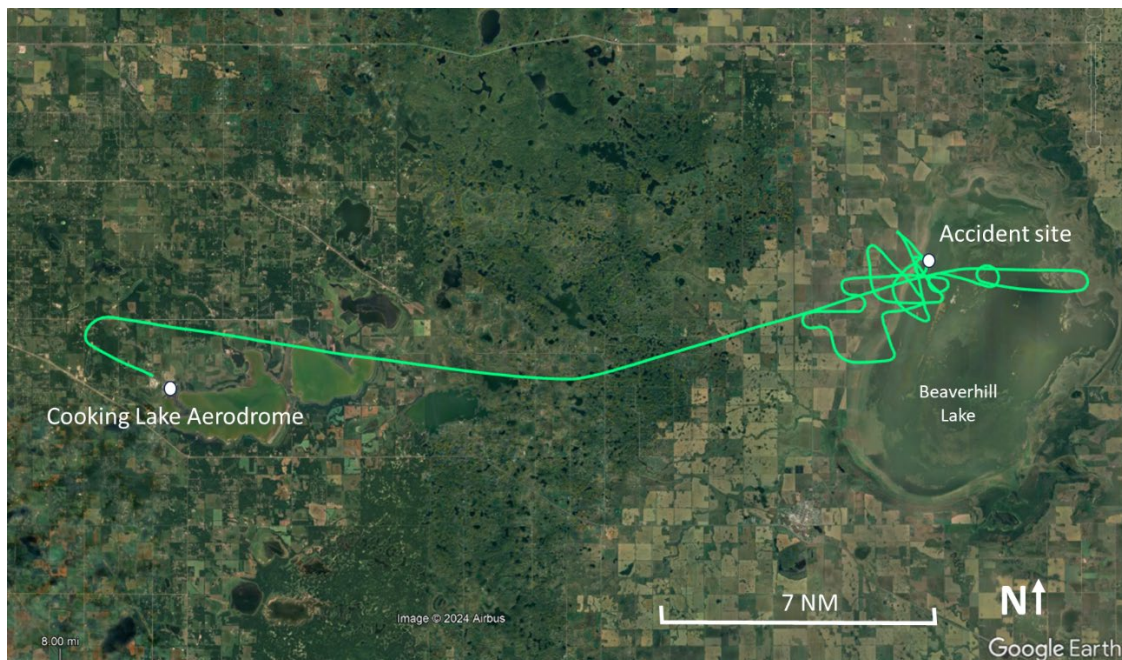
The purpose of that day's training was to review slow flight and stalls, and then introduce spins and spiral dives. Flight-path information (Figure 1) transmitted from the aircraft's automatic dependent surveillance - broadcast (ADS-B) system, which was later retrieved from NAV CANADA during the investigation, was consistent with spiral dive training and spin training.

Figure 1. Occurrence flight path and accident site location (Source: Google Earth, with TSB annotations)

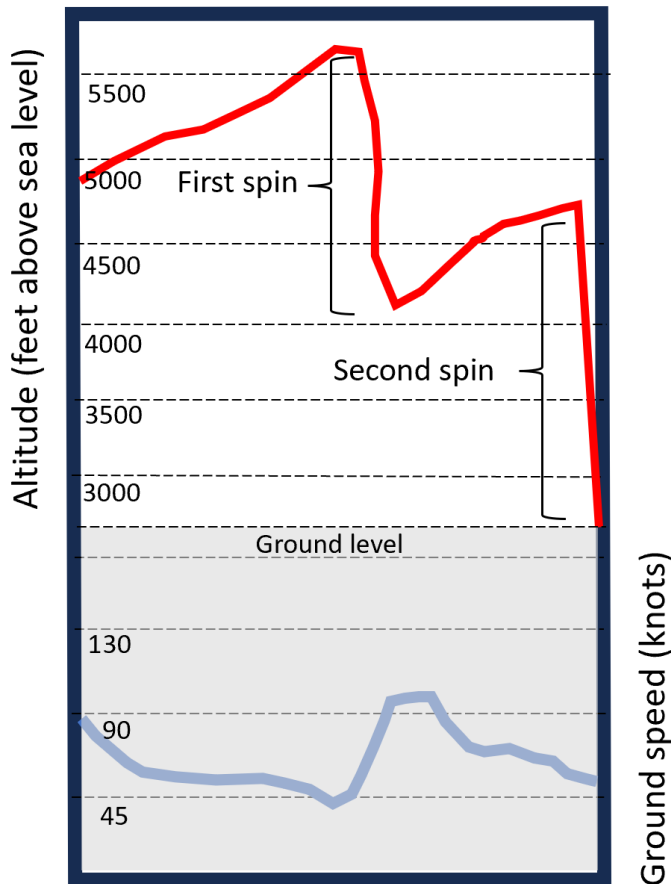
At 1806:13, the aircraft entered the 2nd spin at 4725 feet ASL, which was 2531 feet above ground level (AGL) (Figure 2). The aircraft remained in the spin until it collided with the surface of Beaverhill Lake at 1806:43. There was no post-impact fire.

Figure 2. Graphs showing the relationship between the occurrence aircraft's altitude and ground speed during the 2 spins (Source: TSB)

Considering that the 1st spin recovery required 1575 feet, entering the 2nd spin at 2531 feet AGL may not have afforded enough room for recovery before the recommended height of 2000 feet AGL.

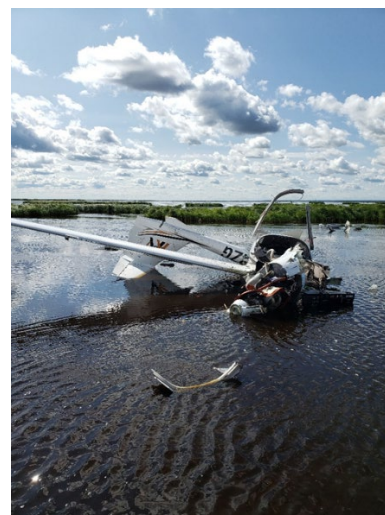
The fuel tank, located in the fuselage aft of the cockpit, fractured during the accident during the breakup of the aircraft's cockpit area. Approximately 16 U.S. gallons of the fuel that remained in the tank at the time of impact leaked out at the accident site. All aircraft components were located at the accident site.

Figure 4. Accident site, looking south (Source: TSB)

The left wing had sheared from the fuselage, but the pushrods controlling the ailerons were still attached to the cabin. The tail of the aircraft broke just aft of the cabin, but the rudder control cables remained attached to the forward fuselage.

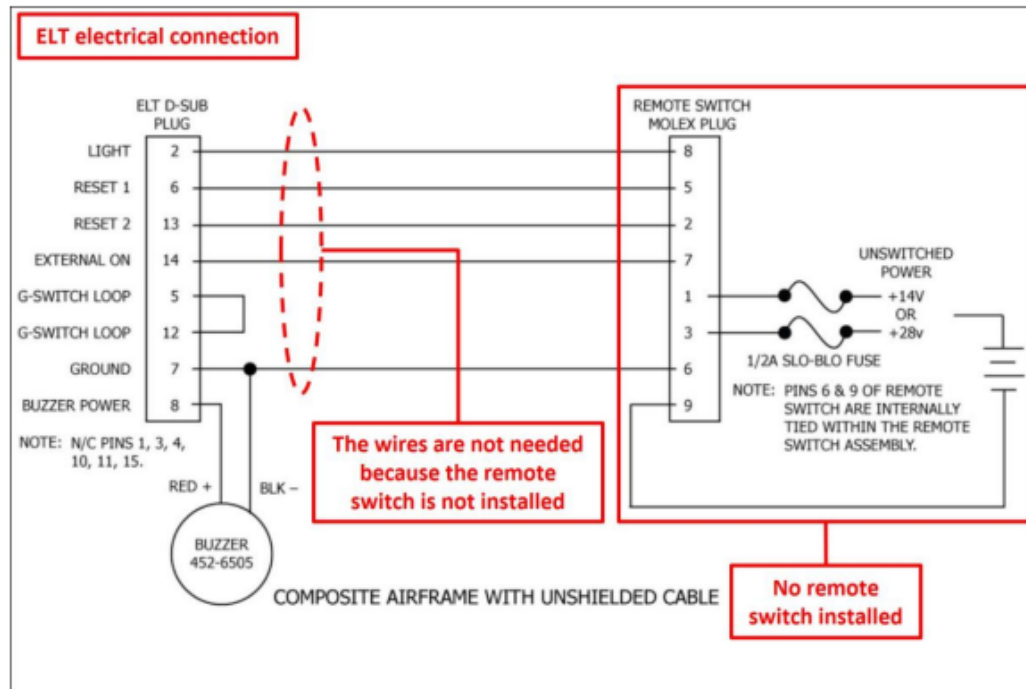
In normal operation, the ARTEX ELT 1000 is ready to activate when the switch on the ELT is set in the ARM position. A connection jumper (also called the G-switch loop), which enables the G-switch circuitry to function (Figure 6), is installed by the airframe manufacturer between Pin 5 and Pin 12 on the D-SUB connector. If the ELT movement causes the G-switch acceleration threshold to be exceeded, the ELT will activate. When the D-SUB connector is removed, the ELT can be handled without the possibility of automatic activation.

Figure 6. Emergency locator transmitter installation wiring diagram (Source: ARTEX Products / ACR Electronics, Inc., *ARTEX ELT 1000 Emergency Locator Transmitter Description, Operation, Installation and Maintenance Manual*, Y1-03-0259 Rev. AA [15 January 2021], Figure 23: Typical 5-Wire Installations for Composite Airframes, p. 51, with TSB annotations)

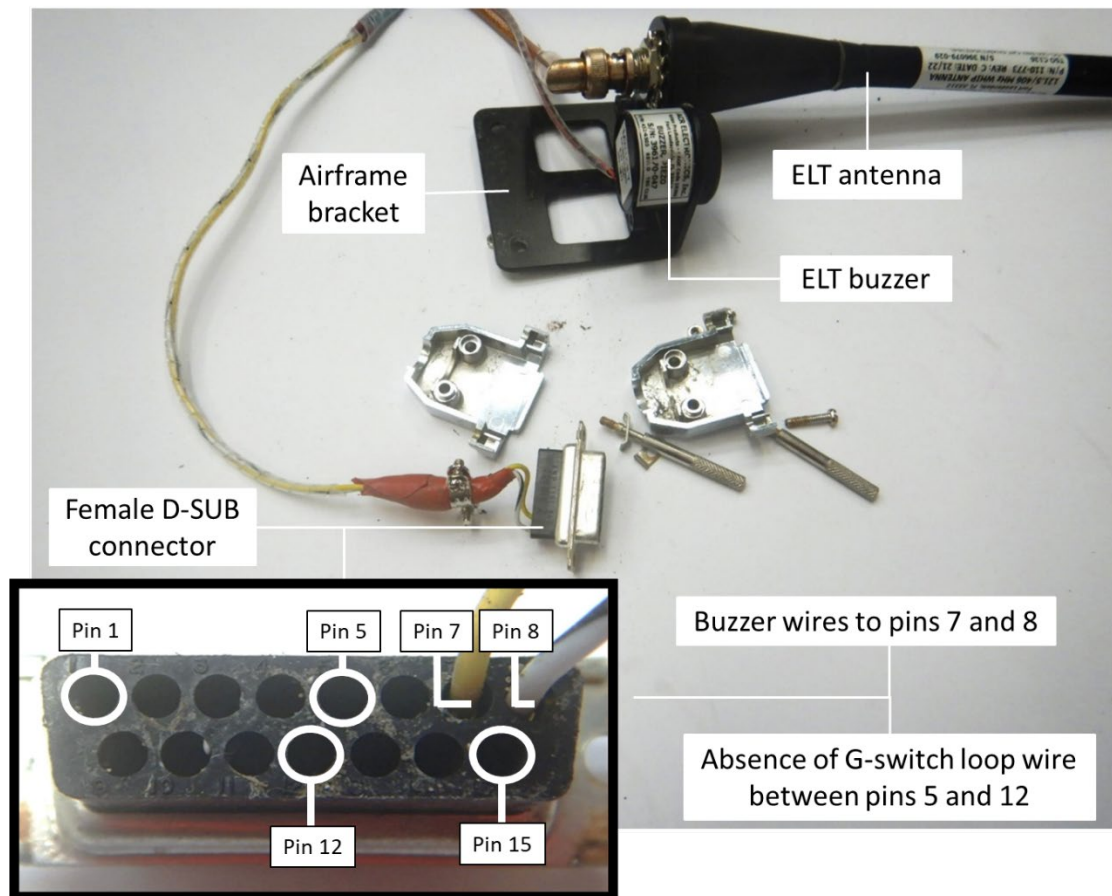
The D-SUB 15-pin connector was dismantled, and examination of the connector revealed that the G-switch loop had not been installed by the aircraft manufacturer (Figure 7).

Figure 7. Disassembled emergency locator transmitter antenna and buzzer from the occurrence aircraft, with a close-up view of the female D-SUB connector showing the missing G-switch loop wire in inset (Source of main image and inset: TSB)

Additionally, the investigation determined that the ELT’s buzzer wiring had been incorrectly installed. The buzzer wiring was reversed and not connected to the pins as shown in the installation drawings.

The ELT on board the occurrence aircraft was serviceable at the time of the occurrence except for the automatic activation function through the G-switch. The ELT did not activate upon impact because the G-switch loop wire was not found installed during a post-occurrence inspection. Consequently, the automatic activation of the ELT through the G-switch was inhibited. It is presumed that the G-switch loop had not been installed by the aircraft manufacturer during aircraft assembly.
