AIR TRANSPORTATION SAFETY INVESTIGATION REPORT A23W0040

COLLISION WITH TERRAIN

Government of Canada, Royal Canadian Mounted Police
Pilatus Aircraft Ltd. PC-12/47E, C-GMPX
Whitehorse/Erik Nielsen International Airport, Yukon
17 April 2023

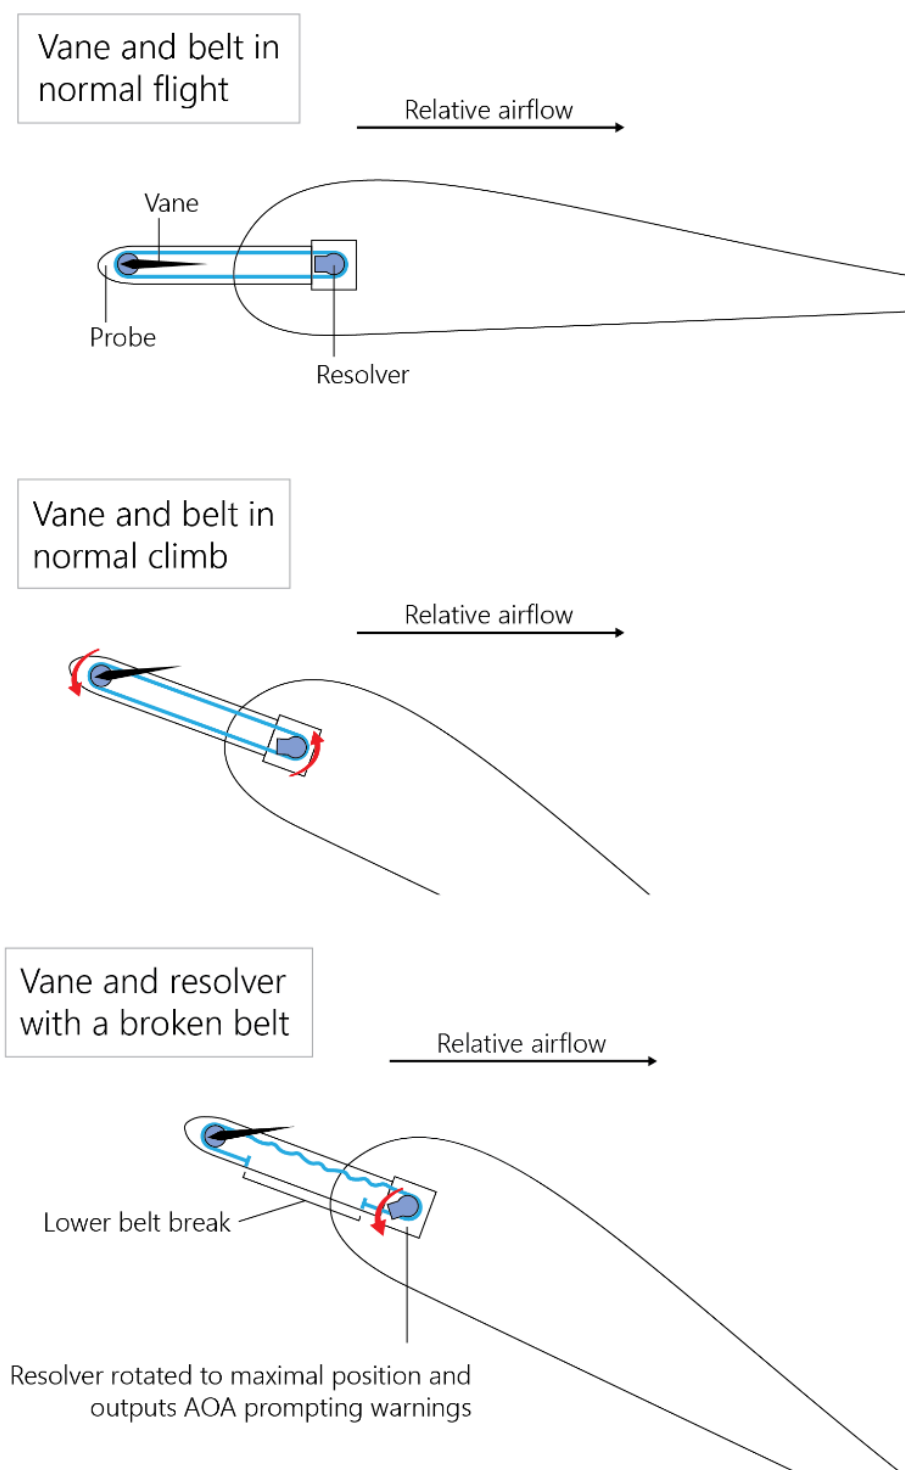
Figure 5. Typical angle of attack vane and belt movement in relative airflow during normal flight and normal climb, as well as during a belt breakage (Source: TSB)

If the lower belt were to be severed or detached from either pulley, the rotation of the vane would not be transmitted to the resolver, and the tensile aligning forces on the belt would be lost. The free rotation angle of the counterweight (as a result of gravitational forces) is greater than its nominal rotational angle range when the belt is intact. Therefore, if there were a broken or detached lower belt in any flight attitude, gravitational forces would cause the counterweight to rotate and drop to a position at the bottom of the resolver.

This extreme rotation would result in the resolver generating an AOA signal in the stall regime. Figure 5 depicts this motion. Within the Pilatus PC-12 fault monitoring system, there is no monitoring for belt continuity, nor is there a record in the data recorders or in any other aircraft system that would indicate which AOA transmitter may be reporting a stall to the AOA computers.

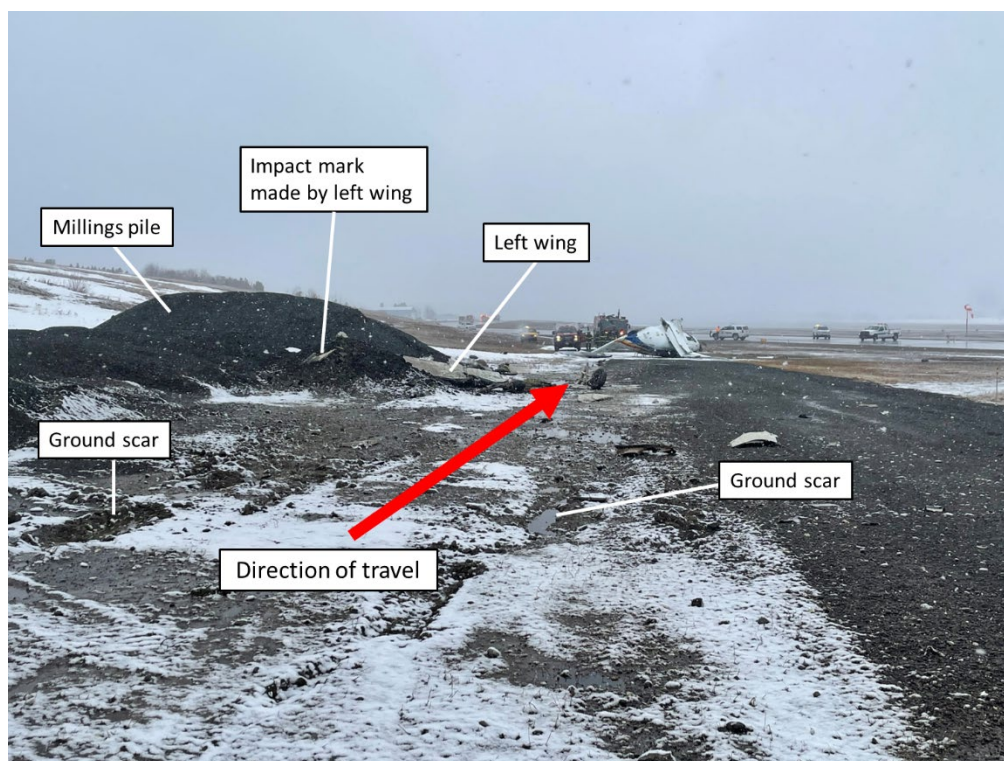
Figure 7. Wreckage path of occurrence aircraft, minutes after the accident (Source: Royal Canadian Mounted Police)

The investigation determined that the aircraft had initially touched down in a right-wing-low attitude, in shallow mud on the otherwise frozen ground, while the pilot was attempting to position the aircraft for landing on Runway 32L. The aircraft then most likely bounced and regained a near wings-level attitude, and shortly afterwards, the left wing impacted the pile of asphalt millings. This impact caused the left wing to separate from the fuselage (Figure 9). The aircraft then rolled onto its left side and slid in that attitude approximately 130 feet across the ground, which was primarily a hard-packed dirt service road.

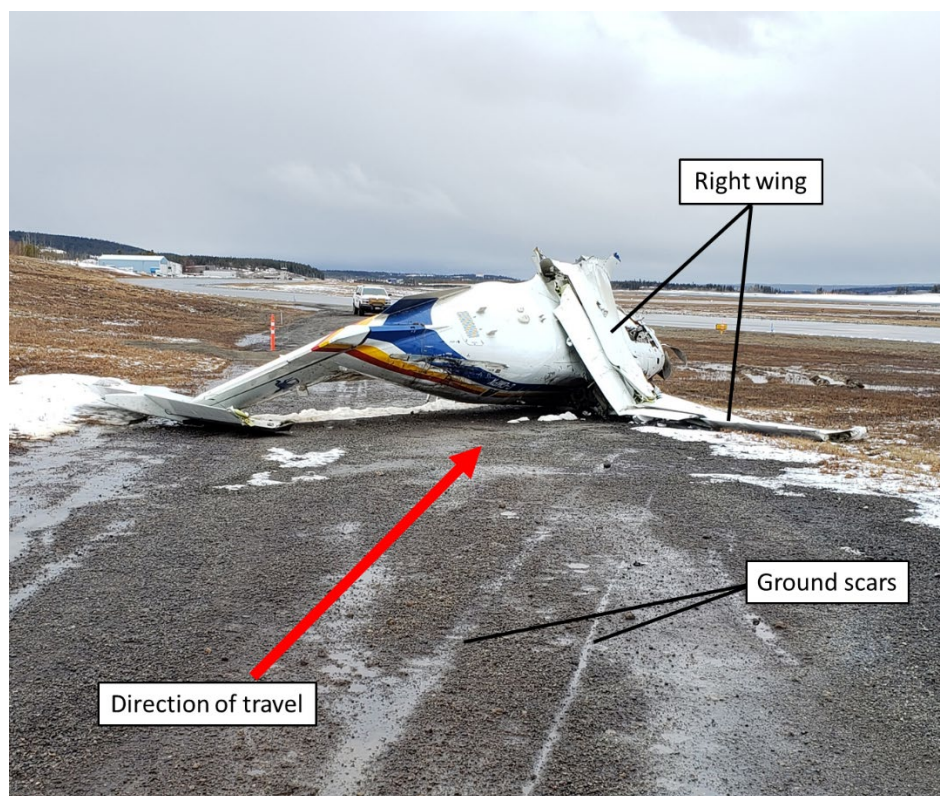
Figure 8. Close-up of main wreckage, taken days after the occurrence (Source: Royal Canadian Mounted Police)

The aircraft's right wing broke at the root and also approximately halfway between the root and the wing tip. The right wing was found lying across the underside of the fuselage and along the ground beside it (Figure 10). During the on-site examination of the wreckage, it was determined that the flaps were in the up position (i.e., at 0°) at the time of impact.

The main fuselage remained mostly intact. The blades on the propeller were twisted and bent in a manner consistent with power being applied at the time of impact.

The landing gear was extended at the time of impact. Upward vertical forces had caused the right main landing gear assembly to puncture the top surface of the right wing. The nose wheel had been forced, by horizontal impact forces, back into the nose wheel well.
