# AIR TRANSPORTATION SAFETY INVESTIGATION REPORT A24P0054

## COLLISION WITH TERRAIN

Privately registered  
Murphy Rebel (amateur-built aircraft), C-FTWO  
Squamish Municipal Aerodrome (Don Patrick Field) (CYSE),  
British Columbia, 12.5 NM SSW  
24 May 2024

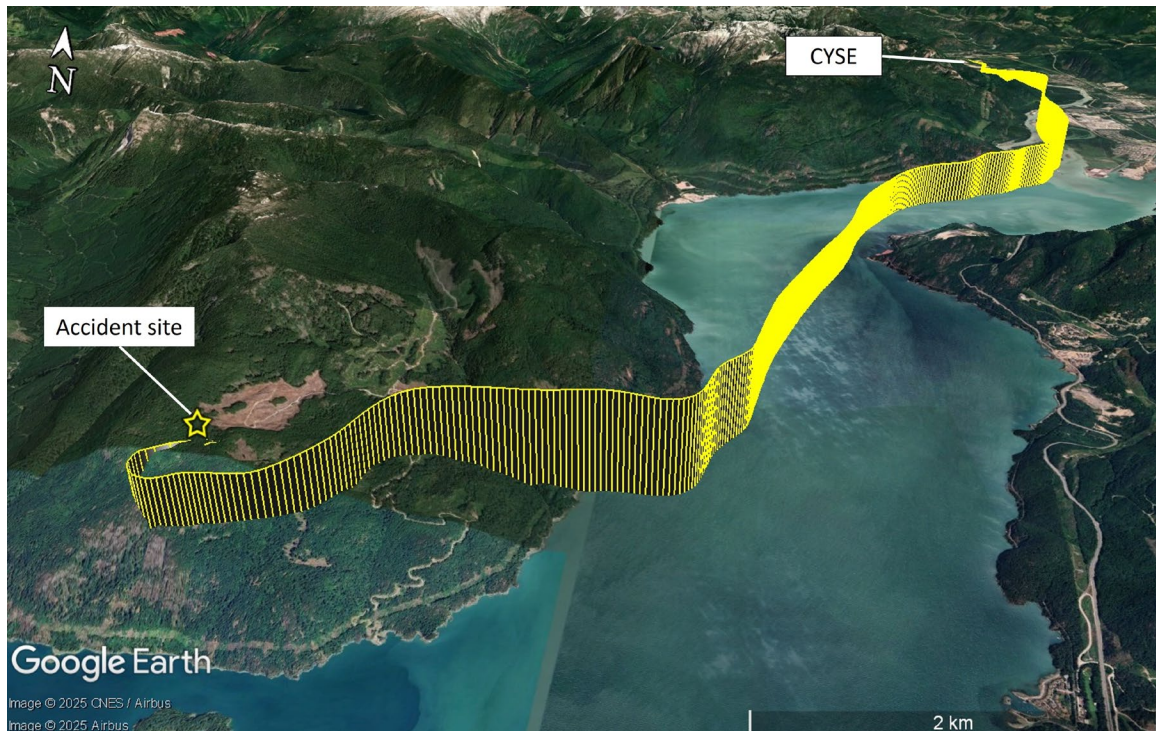
**Figure 1.** Map showing the occurrence aircraft's flight path based on recorded flight data and showing the accident site (Source: Google Earth, with TSB annotations)

At approximately 1720, the aircraft entered a descending, accelerating right turn that resulted in a course reversal of more than 180°. The bank angle is estimated to have been greater than 30°. The aircraft's ground speed then increased from approximately 50 knots to 113 knots while the aircraft descended at a rate of more than 1800 fpm.

The aircraft impacted terrain at an elevation of approximately 2600 feet ASL on an east-northeast heading (Figure 1). Both aircraft occupants were fatally injured. The aircraft was destroyed. There was a post-impact fire, with minimal damage to the environment.

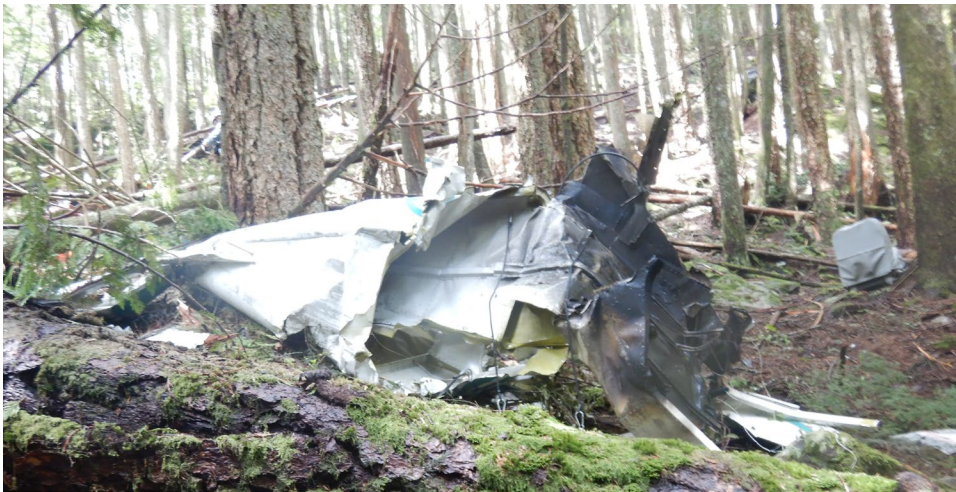
**Figure 3. Aircraft wreckage (Source: TSB)**

The aircraft wreckage was found in a heavily forested area with mountainous, uneven terrain. The aircraft wreckage exhibited signs of a high-energy impact and was found broken up along a 111 m (approximately 364 feet) linear debris trail. Wreckage was consistent with a spiral dive arrested by terrain. The occupiable space within the aircraft was compromised (Figure 3). Investigators were able to confirm that control and lifting surfaces were intact until contact with trees and terrain. The accident was not survivable.
