# MARINE TRANSPORTATION SAFETY INVESTIGATION REPORT M22A0258

## ENGINE ROOM FIRE

Roll-on/roll-off ferry *Holiday Island*  
Wood Islands, Prince Edward Island  
22 July 2022

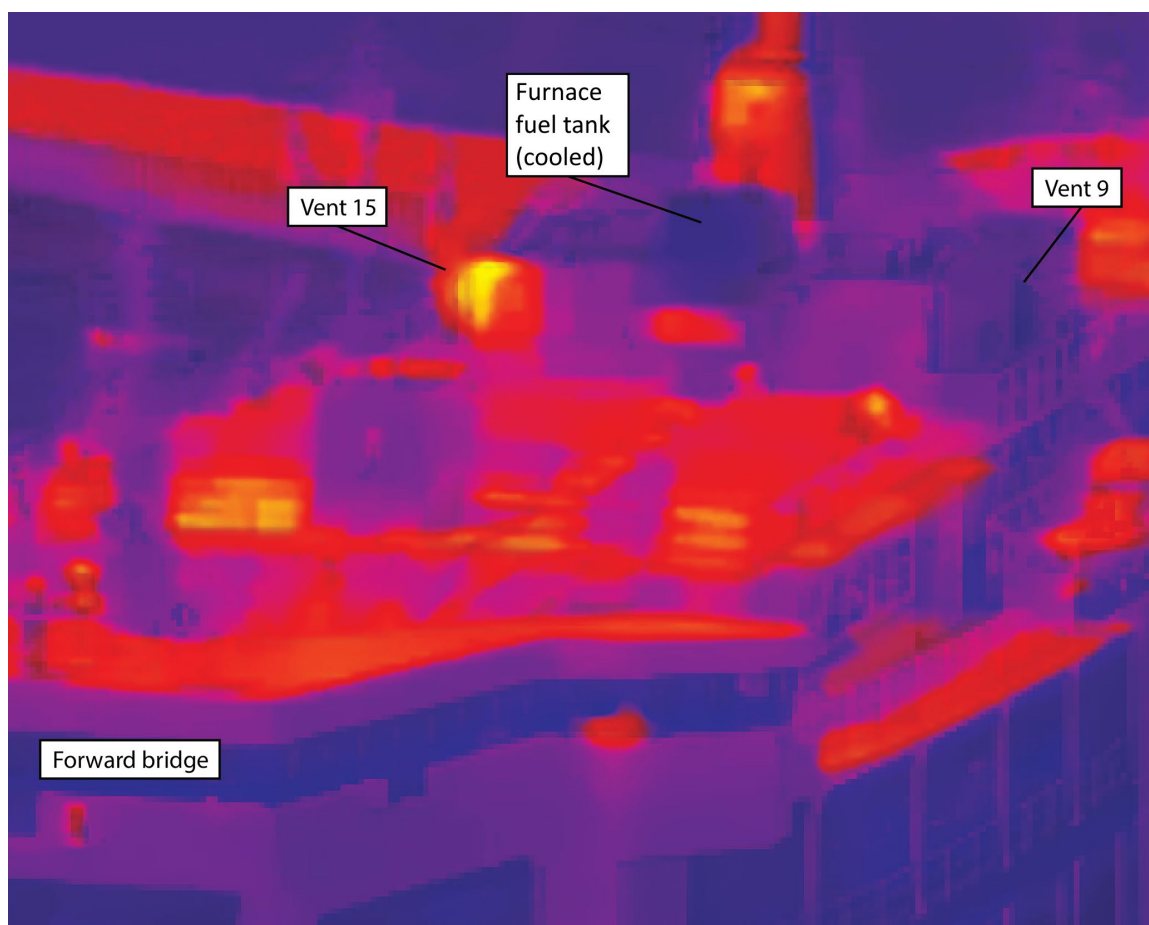
With the additional firefighters, boundary cooling was expanded to the housetop deck and to the funnel deck, where the fuel tank for the accommodations furnace was located. At this time, the assistant engineer and a firefighter observed a significant amount of smoke coming out of the air intake fan for the engine room (vent 15). They attempted to enter the space, but it was too smoky to see and too hot. The firefighters monitored temperatures using thermal cameras on board and with a drone (Figure 5). At the point when firefighters began boundary cooling on the funnel deck, the funnel temperature was approximately 113 °C and the temperature of the furnace fuel tank was approximately 90 °C.

Figure 5. Thermal scan of the centre of the *Holiday Island* showing a cool area around vent 9, as well the furnace fuel tank being cooled by the boundary cooling spray. A hotter area can be seen at vent 15. Note that some areas, such as the deck surface, appear hot because of the heat from the sun. (Source: North River Fire Department [PEI] with TSB annotations; thermal image superimposed on image of vessel)

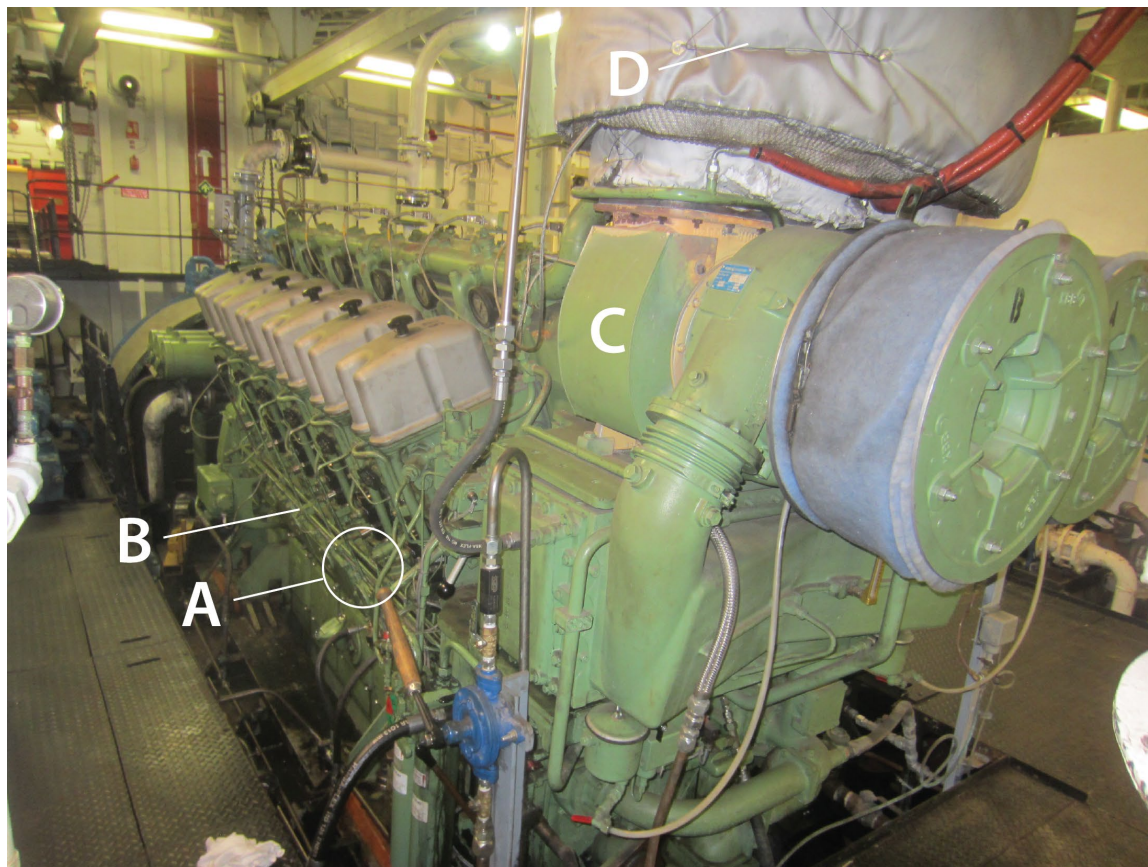
Figure 6. The aft engine before the occurrence, showing the location of the repairs (A) to the fuel rail (B), the turbo charger assembly (C), and the exhaust (D). The arrangement is identical to that of the forward engine, where the fire started (Source: Northumberland Ferries Limited, with TSB annotations)

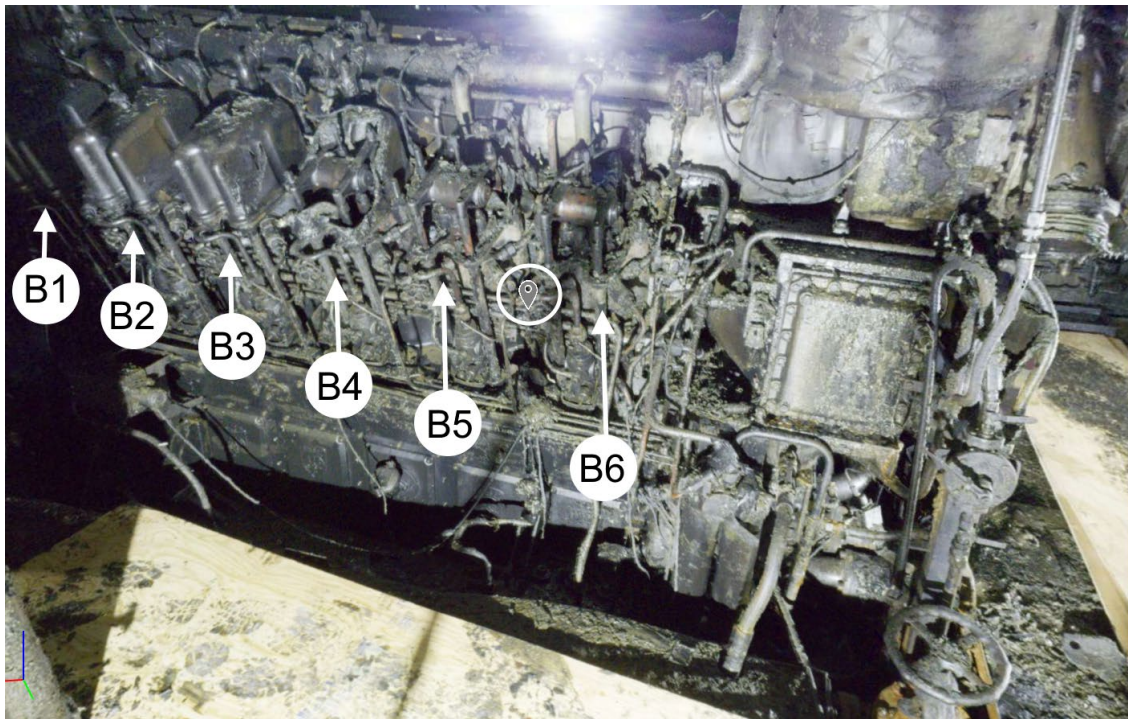
Post-occurrence, the greatest fire damage was observed on the main engine between cylinders B5 and B6 (Figure 7).

Figure 7. The cylinder head covers on cylinders B1 and B2 are intact. The covers on cylinders B3 and B4 are partially damaged and the covers on cylinders B5 and B6 are completely destroyed. The location of temporary repair to the fuel line is circled. (Source: TSB)

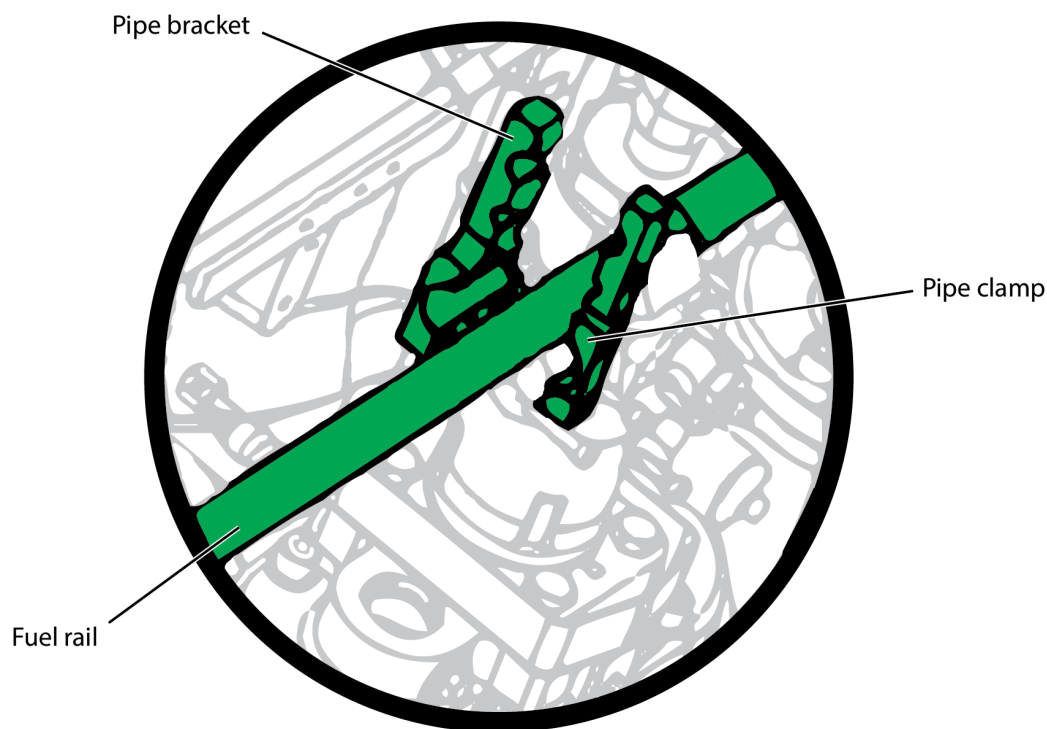
by pipe clamps secured to pipe brackets (Figure 8). The nominal working pressure of the fuel rail was approximately 2.0 to 2.5 bars. The fuel system was last inspected by the RO on 30 May 2021. This inspection included tightness of fittings, fire precaution arrangements (for example, jacketed pipes and their leak detection equipment), flexible hoses, and sounding arrangements. It also included emergency fuel shut-offs and vents.

Figure 8. The fuel rail was supported by pipe clamps secured to pipe brackets. (Source: TSB, based on the Anglo-Belgian Corporation engine manual)

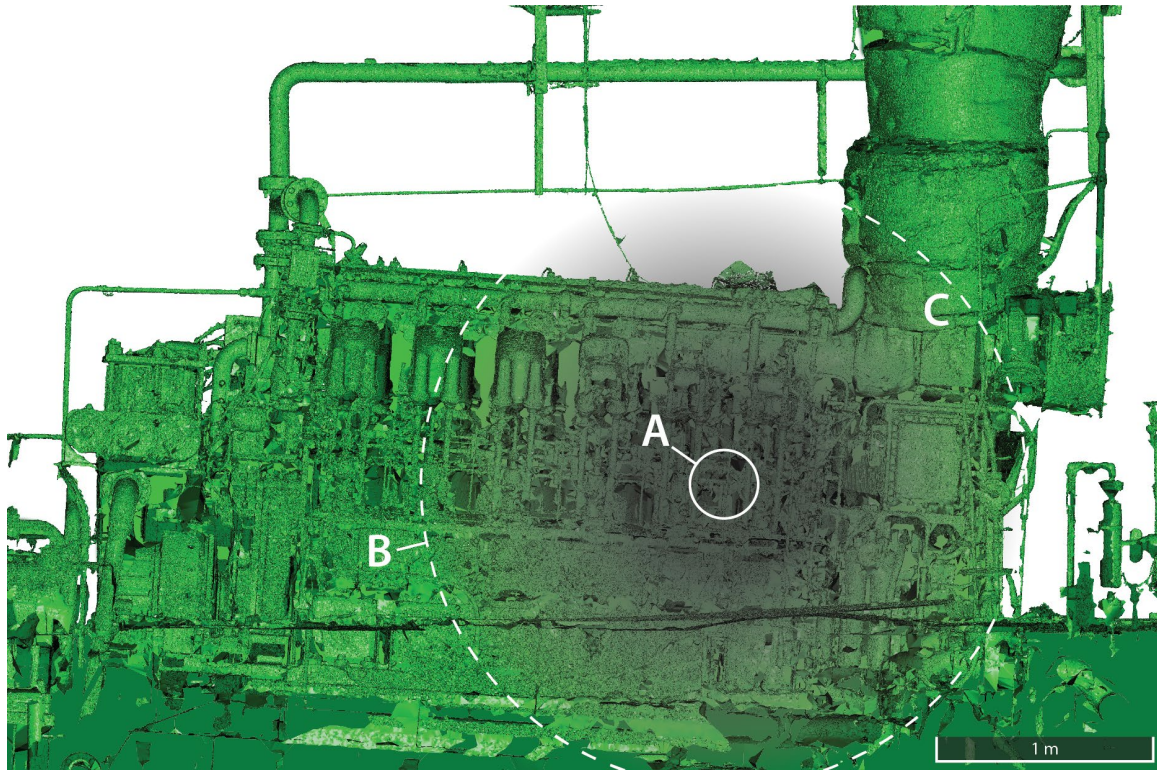
In June 2022, the crew observed a fuel oil leak between cylinders B5 and B6. The source was identified as a damaged location on the fuel rail on the port side of the forward main engine, and a series of temporary repairs was made (see section 1.10.1.2, below). The damaged location<sup>54</sup> was within 80 cm of the turbo charger assembly (Figure 9). The TSB laboratory simulated the final temporary repair with the hose clamped onto the fuel rail and exposed it to temperatures and pressures similar to those in the occurrence. This simulation revealed that fuel could be sprayed from under the ends of the repaired, clamped hose, and that this fuel spray could reach distances greater than 137 cm (see Appendix B for details).

Figure 9. Three-dimensional laser scan of the forward main engine showing the location of the damaged fuel rail (A), the estimated area of fuel spray (B), and the turbo charger assembly (C), the hottest surface on the engine (Source: TSB)

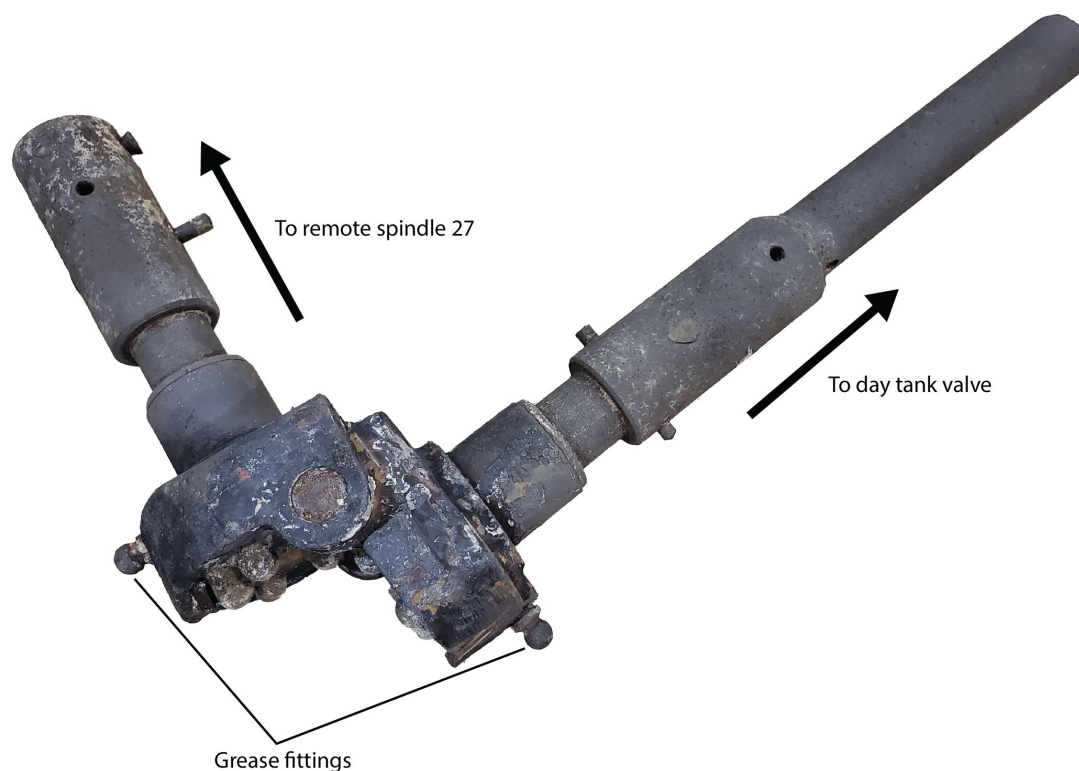
Each extended spindle arrangement had several linkages between the control and the day tank valve. All of these linkages required regular greasing. For the main engine spindle arrangement, the first 90° knuckle below the main deck (Figure 11) had 2 grease fittings; the grease fitting on the side closest to the main deck was not visible from where maintenance was performed and was difficult to access. During post-occurrence examination onboard the vessel, it was observed that the knuckle was seized and would not turn. A knuckle on the main engine spindle assembly was disassembled and examined by the TSB laboratory. The grease recess in the side of the knuckle closest to the main deck was dry and the valve side, closer to the fire, had retained grease.

Figure 11. The opened knuckle in the main engine spindle assembly showing the 2 grease fittings  
(Source: TSB)

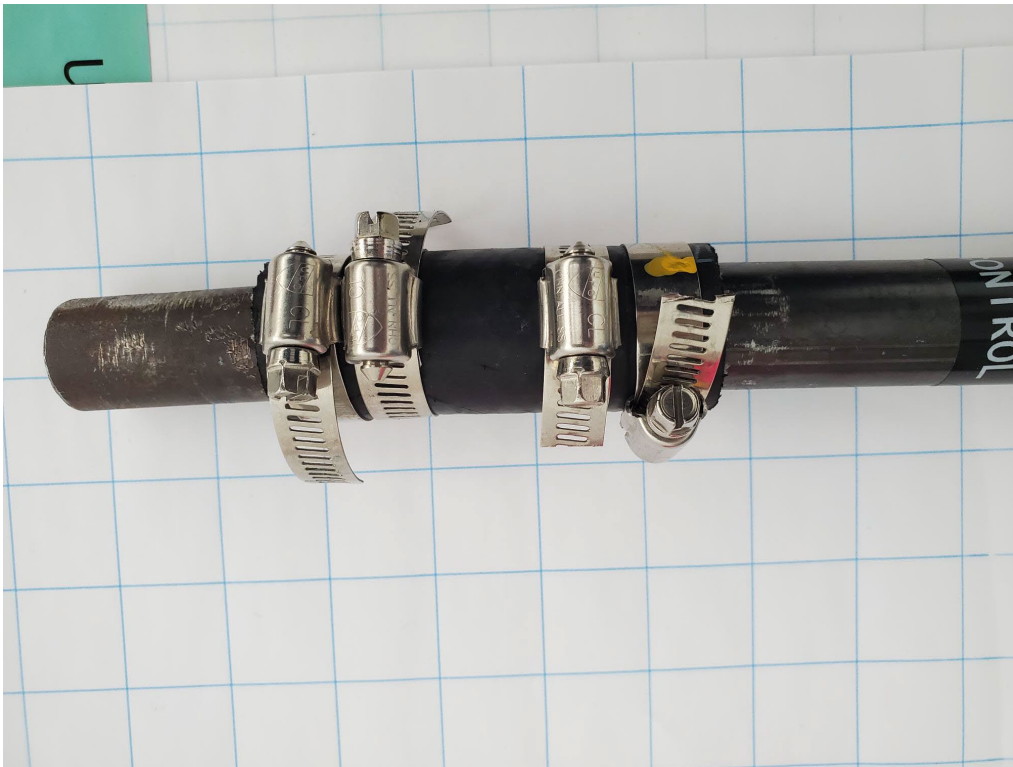
Figure 12. A reconstruction of the final temporary repair (Source: TSB)

On 21 July 2022, after the 1st voyage of the day, a temporary repair was made using a section of heater hose, which was made of a material the manufacturer describes as unsuitable for fuel or oil transfer,<sup>56</sup> secured with 4 worm drive hose clamps (Figure 12). The next 3 voyages that day were delayed by 1 hour or less and the remaining voyages were on time.

When the damage was first identified, a crew member suggested permanently repairing the fuel rail by removing and welding the damaged section of fuel rail, instead of patching it. External consultants also recommended the same repair. A weld would have required taking the vessel out of service for 1 or 2 days.

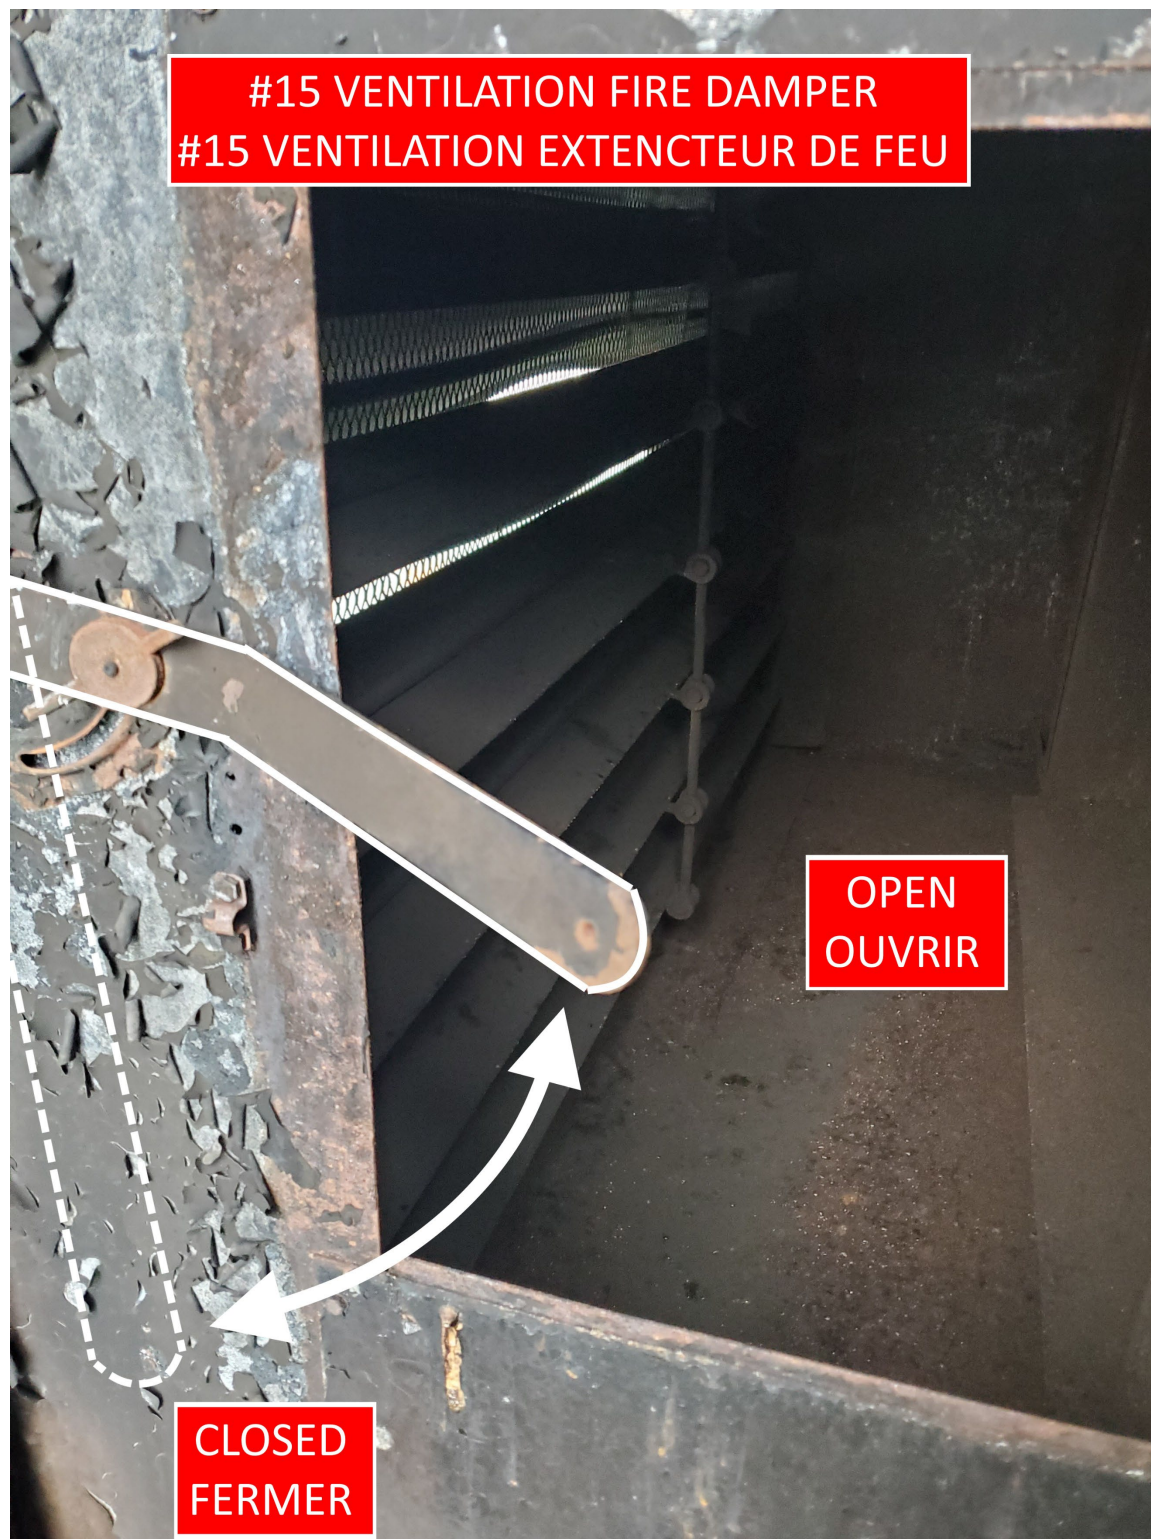
Figure 13. Vent 15, with the damper handle in the open position and an access panel removed. The labels represent the location and appearance of the identification placards that were destroyed by the fire. (Source: TSB)

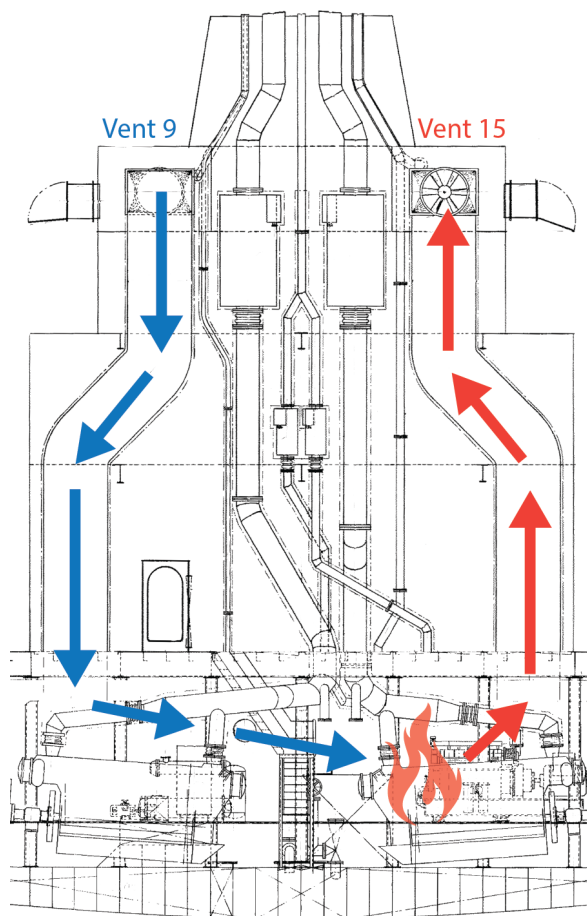
- The guidance posted was not explicit. Consequently, the CO<sub>2</sub> release was delayed, allowing the fire to grow. When the CO<sub>2</sub> was released, the engine room space was not completely sealed. Air continued to enter the space through open vents, likely displacing the released CO<sub>2</sub> and also adding oxygen to the fire. Consequently, the fire continued to burn.

Figure 14. A diagram showing the hot air from the fire leaving the engine room through vent 15 (in red) and the fresh air drawing in through vent 9 (in blue)  
(Source: *Port Weller Dry Docks Ltd.*, with TSB annotations)

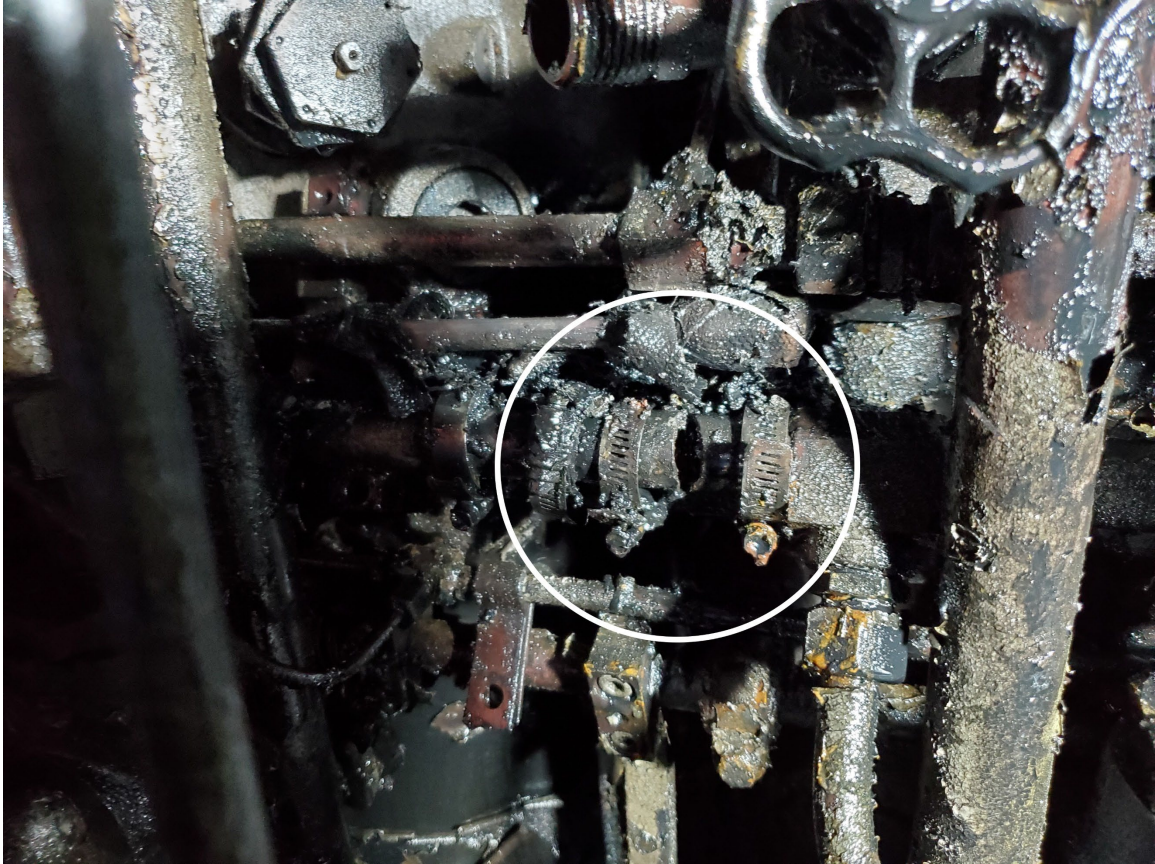
Post-occurrence, the fuel rail repair was observed to be damaged (Figure B1).

Figure B1. The location of the fuel rail repair on the forward main engine between cylinders B5 and B6 (Source: TSB)

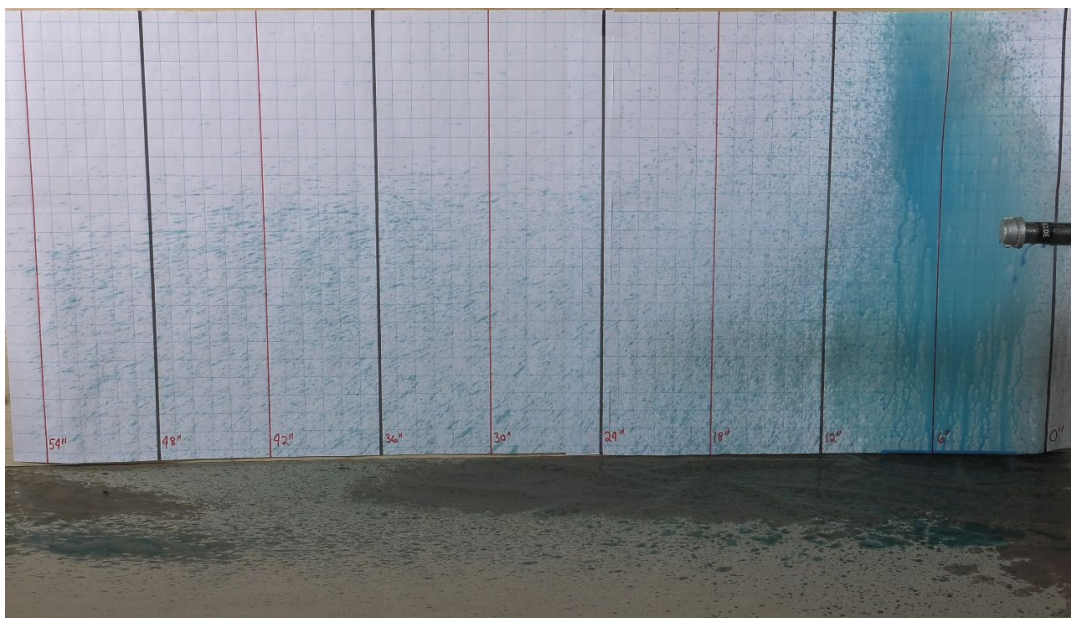
- Immediately next to the clamped hose, a fuel spray was observed to be in a ring-like pattern vertically around the repair location and horizontally sprayed at least 54" from the simulated repair (Figure B2).

Figure B2. Fuel spray test results in 2 dimensions. Note that the spray would be in 3 dimensions, and that spray near an engine may reflect or drip onto nearby surfaces. (Source: TSB)

The TSB laboratory concluded that with the combination of line pressure, exposure to fuel, engine room heat, engine vibration, and a marginally torqued clamp, a sudden leak could have developed.
