AVIATION INVESTIGATION REPORT

A00H0003

LOSS OF SEPARATION / SAFETY NOT ASSURED

MONTREAL, QUEBEC 5NM W

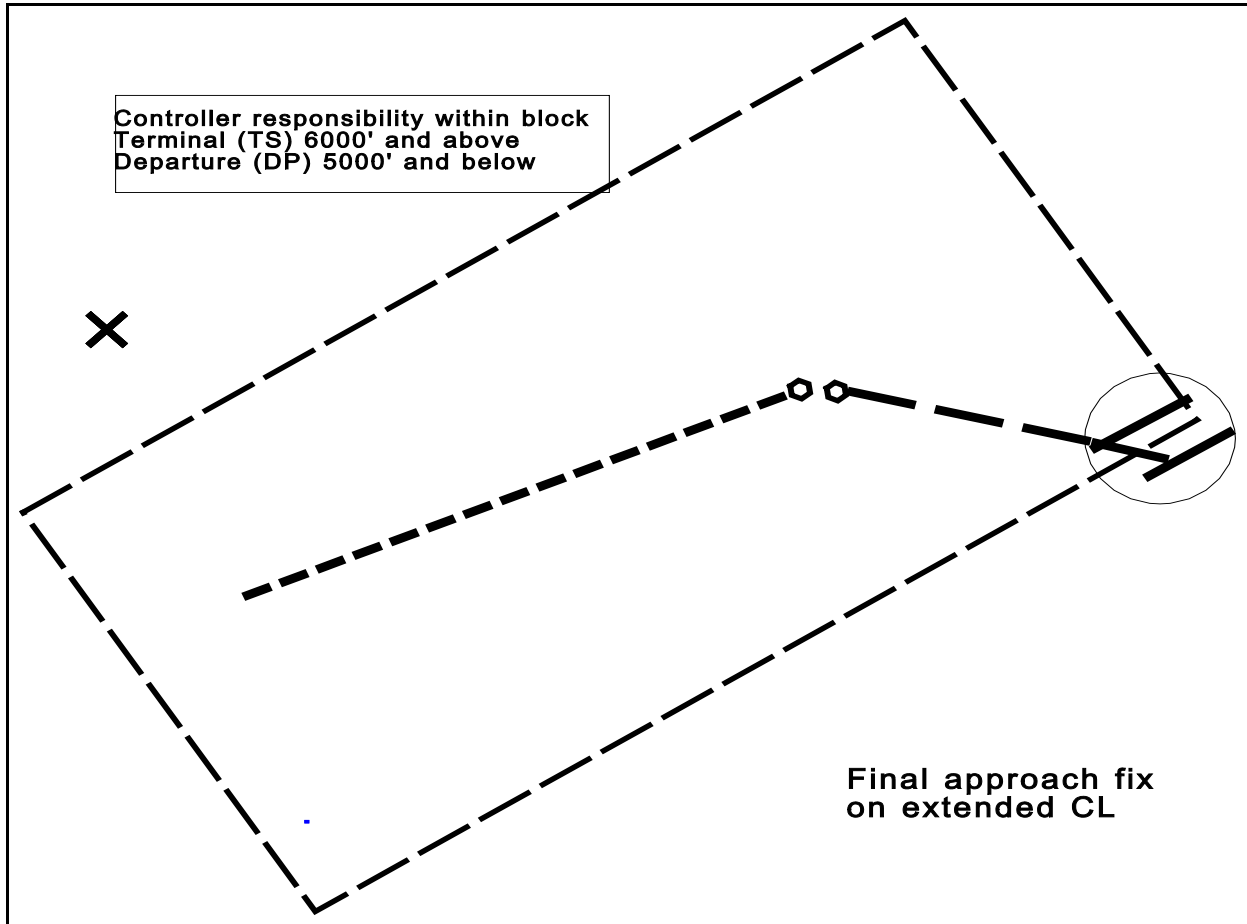
Appendix A - Airspace Diagram

The airspace in the vicinity of the Montreal airports is divided both horizontally and vertically in order to assign control responsibilities to sector controllers. The airspace sector off the departure end of runway 28 is divided vertically, as indicated in Appendix A. According to *Montreal Terminal Operational Procedures*, Annex D, the airspace up to and including 5000 feet is in the jurisdiction of the departure controller; the airspace at 6000 feet and above, as in this occurrence, was in the jurisdiction of the terminal south controller.
