AVIATION INVESTIGATION REPORT

A00P0182

INPUT FREEWHEEL UNIT MALFUNCTION

SIKORSKY S-61N/SP (HELICOPTER) C-GHJU

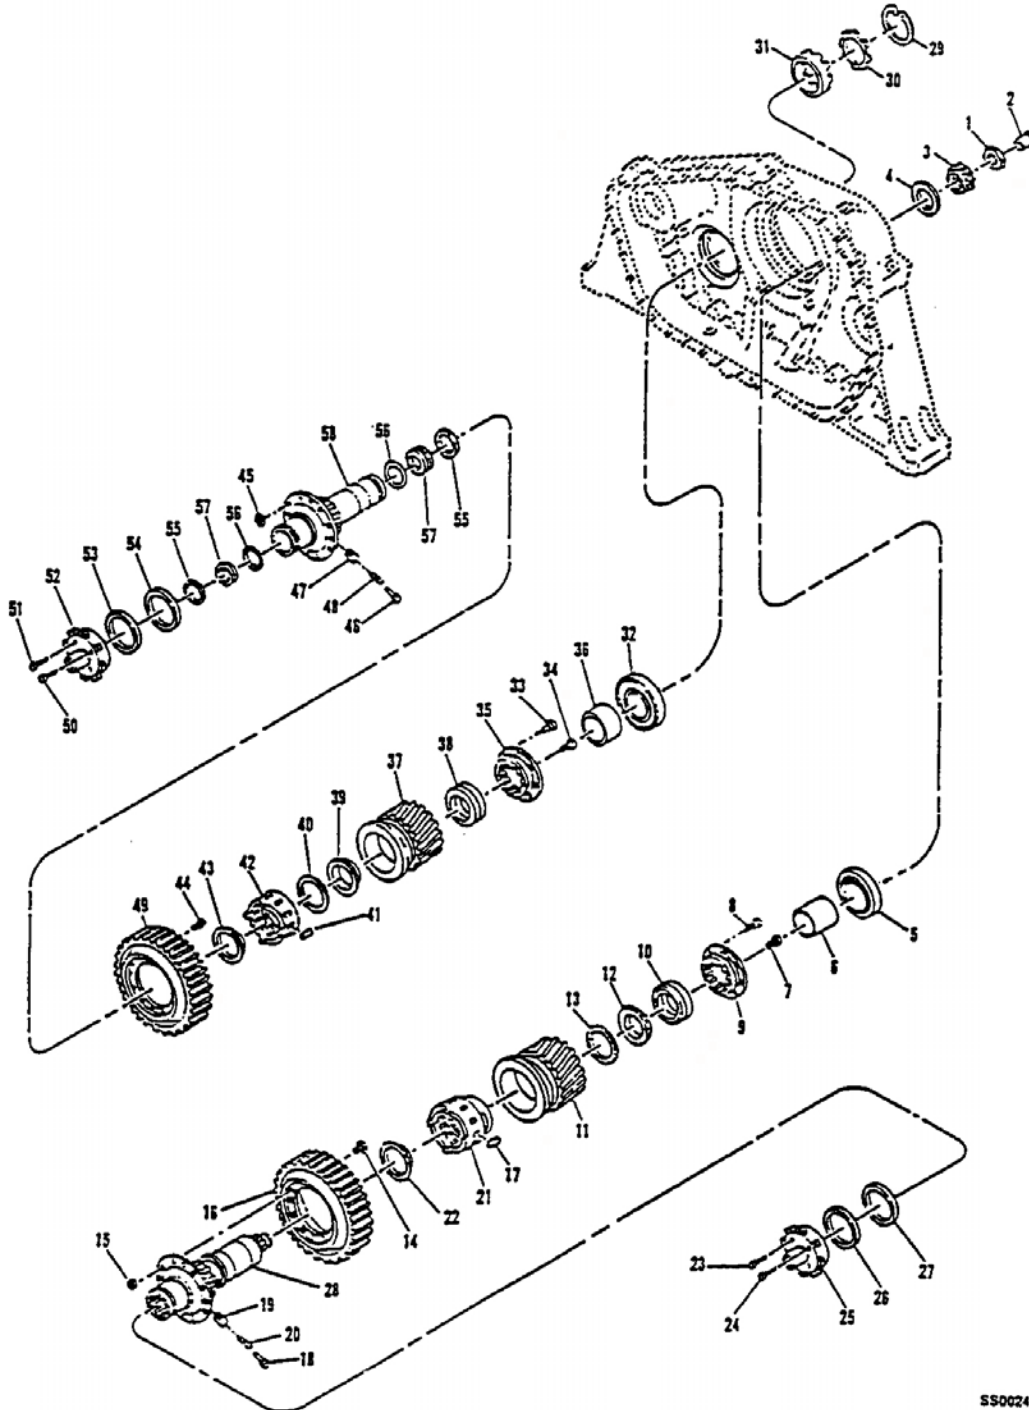
Appendix A - Input Freewheel Unit Assembly

The main-rotor gearbox was removed, disassembled, and examined. With the exception of the No. 2 (right) input freewheel unit (IFWU), no defect was found. The No. 2 IFWU was disassembled and examined (see Appendix A). The IFWU gear housing was found to have been worn well beyond tolerance; the wear was eccentric, and the wear depth was greater than normally seen in a component with similar in-service life.

The maximum permitted internal dimension of an S-61 IFWU gear housing at overhaul is 3.7535 inches. In places, the internal dimension of the No. 2 IFWU housing was 3.7595 inches: the wear was 0.0059 inch greater than the rejection limit. Furthermore, the wear was eccentric and 0.0045 inch out of round. In comparison, the No. 1 (left) IFWU gear housing showed less than 0.001 inch of uniform wear.
