AVIATION INVESTIGATION REPORT

A00Q0133

RUNWAY EXCURSION

CONVAIR LINER 340 (580) C-GFHH

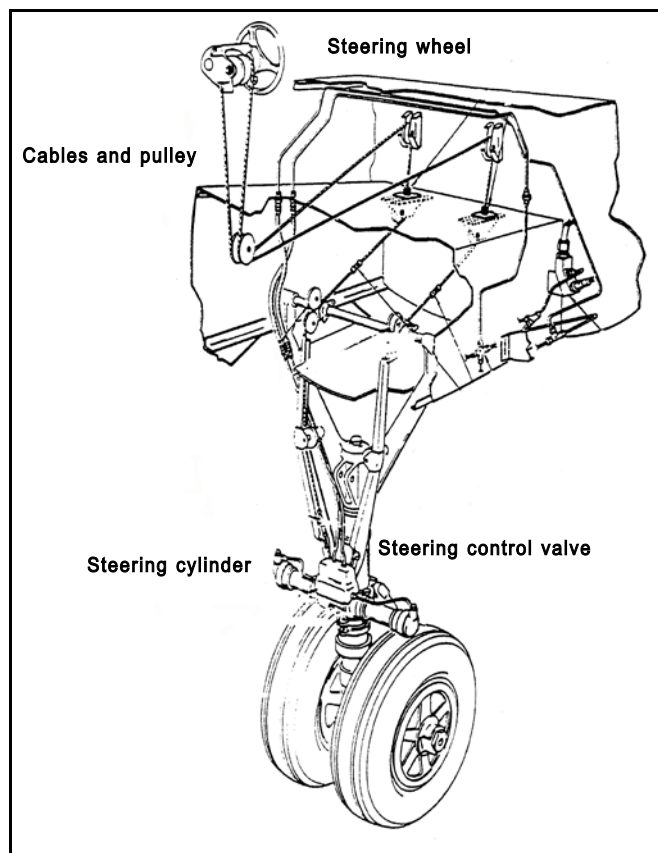
The aircraft's ground steering system (Figure 1) comprises several components, including the nose-gear steering wheel, a system of cables and pulleys, and a steering control valve fitted to a nose-wheel steering cylinder, which is attached to the nose-wheel strut.

The cable and pulley system links the steering wheel to the control valve. When the pilot turns the steering wheel to the left or right, tension is applied to the cables connected to the pulley on the steering control valve. This action determines the direction and the deflection rate of the nose wheel by allowing hydraulic fluid to enter one side or the other side of the nose-wheel steering cylinder; the steering cylinder then deflects the nose wheel through a system of gears.
