AVIATION INVESTIGATION REPORT

A00W0062

RUNWAY INCURSION

CALGARY INTERNATIONAL AIRPORT, ALBERTA

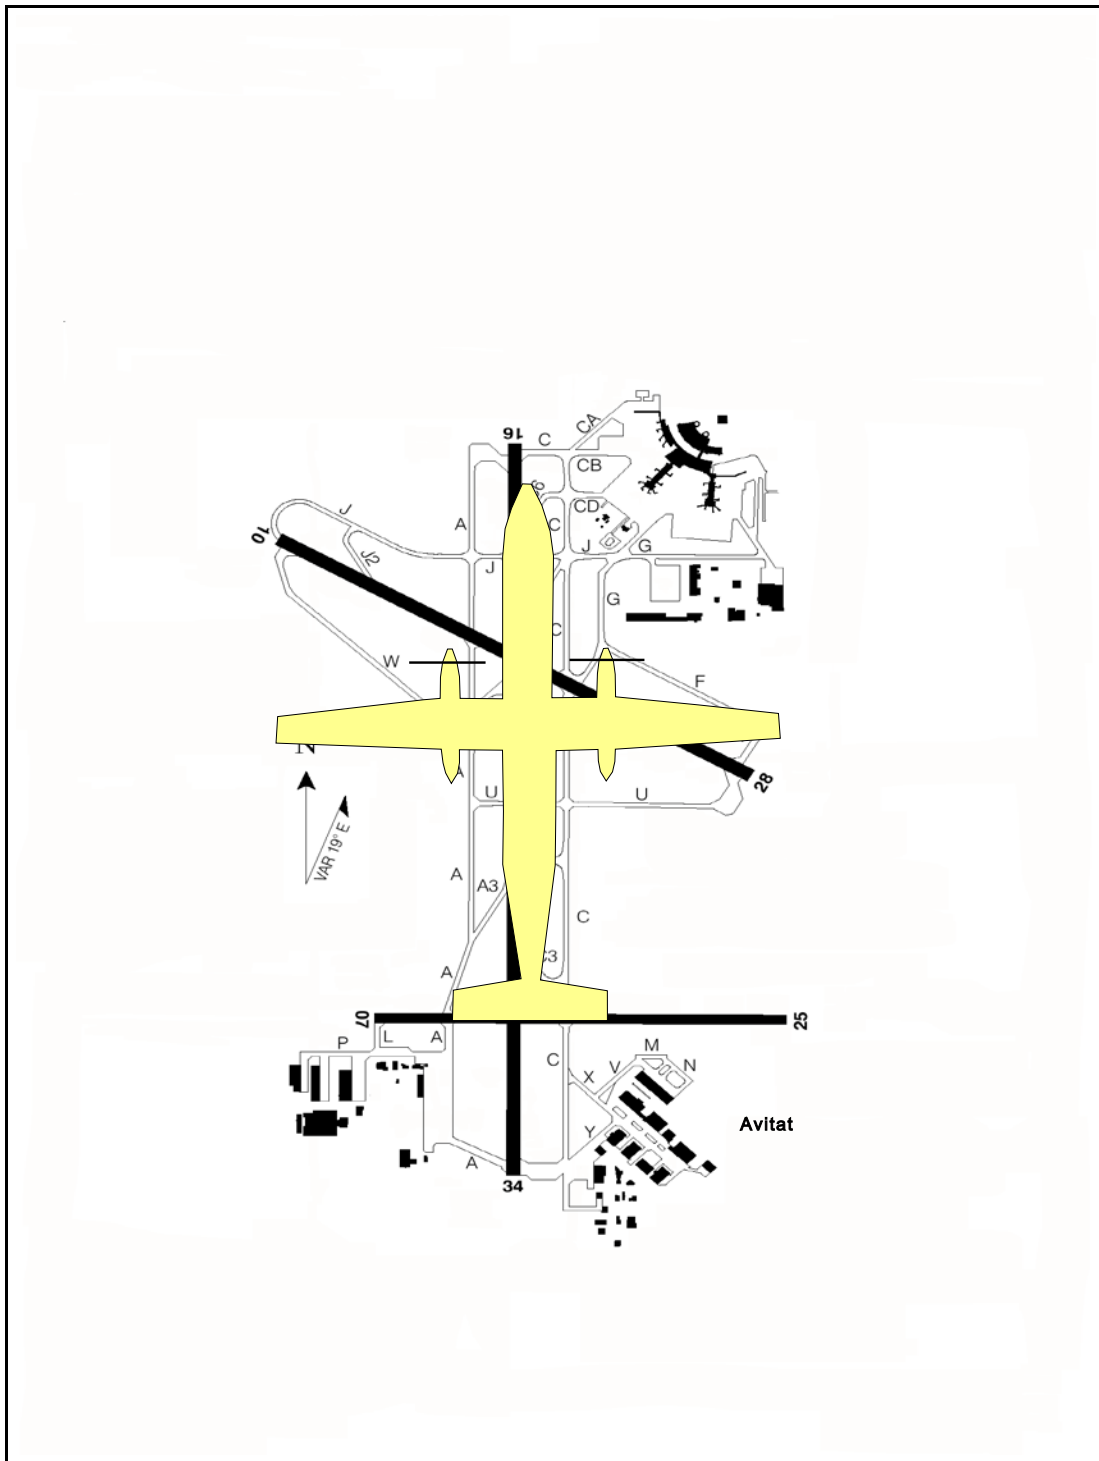
Appendix A - Airport Diagram and Aircraft Positions

When runway 34 is in use, normal traffic flow from the main terminal to runway 34 or the south end of the airport is via taxiways Golf and Charlie. Aircraft landing on runway 34 use one of the short taxiways to exit the runway, and then are routed to the terminal via taxiway Charlie and Charlie Delta. When travelling south, taxiway Golf ends at its intersection with runway 10/28 and taxiway Charlie. Directly in line with taxiway Golf is the one-way taxiway Charlie 2 (see Appendix A). Taxiway Charlie 2 is one-way only, and is to be used as a runway exit by aircraft which have landed on runway 34. International do-not-enter signs are located at the east entrance to taxiway Charlie 2. The signs are illuminated, red and white, and made of reflective material. The area where taxiways Golf, Charlie, Charlie 2, and runway 10/28 converge was identified by some NAV CANADA and Calgary Airport Authority staff as being a known potential area of confusion, especially for

crews not familiar with the airport layout. During the investigation, NAV CANADA and Calgary Airport Authority staff reported that there have been several incidents where aircraft instructed to taxi from Charlie 2 and Charlie northbound taxied from Charlie 2 onto Golf. Controllers also reported that they have provided direction to pilots who appear to be taxiing the wrong way but who, when reminded, can turn onto the correct taxiway without having to backtrack, due to the large paved area at the intersecting taxiways.
