AVIATION INVESTIGATION REPORT

A01C0097

ENGINE POWER LOSS—COLLISION WITH TREES

PIPER PA-28-140 C-FXUF

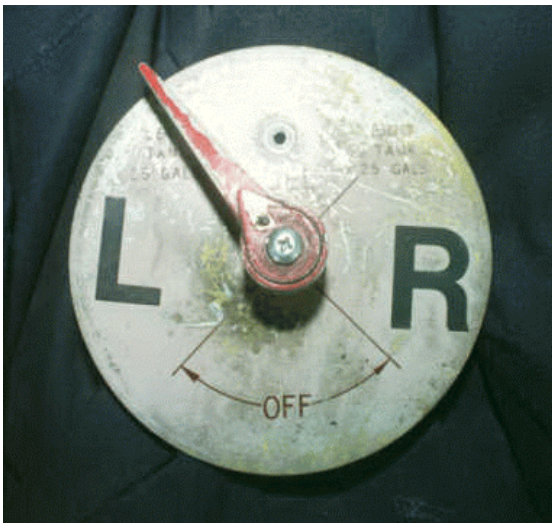
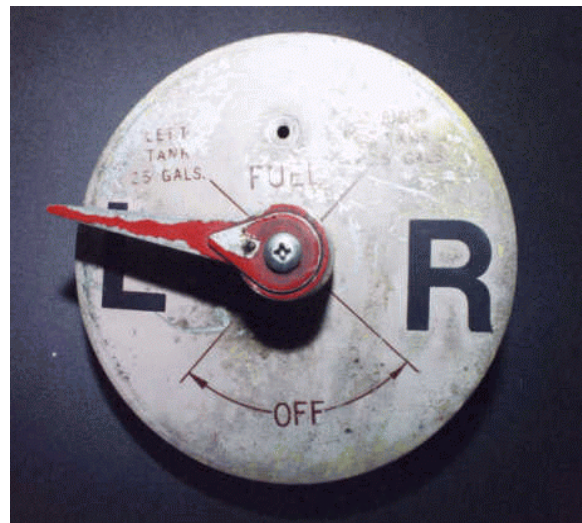
The fuel tank selector has left and right ON positions at 45° up from the horizontal and two OFF positions at 45° down from the horizontal (Figure 1). Two large letters, L and R, had been glued to the selector dial face between the OFF and ON detents on each side. The date at which these letters were installed was not determined. The fuel selector allows fuel to be drawn from either the left or right fuel cell and provides a means to shut the fuel off. Detents in the fuel selector

are provided to assure complete alignment of the galleries with either the left or right fuel cell lines and to provide for fuel shut-off. If the selector is not positioned in the detents for the left or right fuel cell, misalignment of the galleries with the fuel lines results in a restriction of fuel flow. Placing the fuel selector dial over the L would result in fuel flow restriction to less than half of the normal flow (Figure 2). Placing the fuel selector dial in either the 12 o'clock or 6 o'clock position will result in the partial exposure of the right and left fuel galleries.

The pilot had always turned the selector dial straight up to shut off the fuel. On the occurrence flight, the pilot moved the fuel selector dial from the straight up position toward the large letter L (left). The pilot felt that, when he made the selection to the left tank, the detent was positive but that the engagement was different than normal. The pilot had previously experienced a complete engine power loss on the runway because he had positioned the selector beyond the detent of the right fuel cell selection.

When fuel selection was made to the left tank, the selector was most likely moved over the letter L and not engaged in the left tank detent. There was enough fuel flow to continually sustain idle power and the power settings for the run-up. When power was increased during the take-off roll, the required fuel flow was only available for a limited time. The reduced fuel flow was enough for the aircraft to become airborne; however, with the continued high-power setting, the engine required more fuel than the restricted selector would allow. As a result, the engine lost power.

1. The fuel selector was most likely set to the L and not in the detent, resulting in fuel flow less than that required to sustain high engine power.
2. The engine lost power after take-off because of fuel starvation.

1. The position of the letters L and R on the fuel selector dial face did not represent accurate left or right fuel tank selections.
2. The aircraft was not equipped with shoulder harnesses. The use of a shoulder harness would probably have reduced the pilot's injuries during the forced landing.
