AVIATION INVESTIGATION REPORT

A01C0115

LOSS OF SEPARATION

10 JUNE 2001

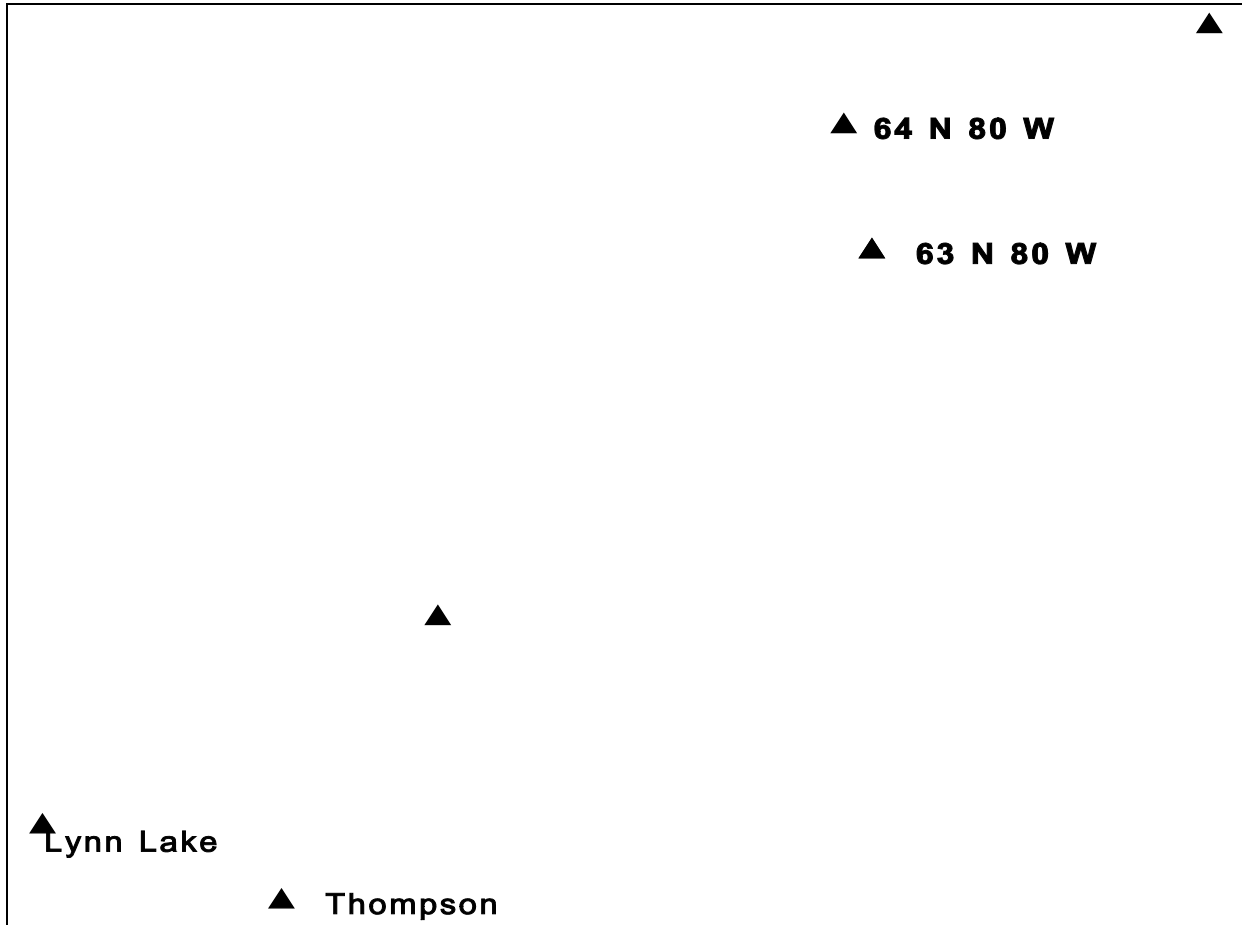
*Appendix A—Aircraft Routes*

During this period of intense control activity, the two controllers decided to reroute SAS938 from its flight-planned route because of a traffic conflict. This reroute was passed to SAS938 at 2319. SAS938 then followed the new clearance tracking north of Churchill (see Appendix A) to 64° north / 80° west and on to 65° north / 70° west. KLM602, which was about 13 minutes behind SAS938, remained on the flight-planned

route over Churchill to 63° north / 80° west and then to 65° north / 70° west. The controller entered the change into NADS. Because both flights would enter airspace controlled by Edmonton ACC, the TL data controller contacted the NU sector controller at approximately 2330 with an SAS938 estimate. However, the TL controller did not advise the NU controller of the change in SAS938's routing, and the NU controller entered the original flight-planned route into his NSiT. The two flights then flew into NU sector at FL330 and mach .82.
