AVIATION INVESTIGATION REPORT

A01P0111

AIR PROXIMITY—SAFETY NOT ASSURED

12 MAY 2001

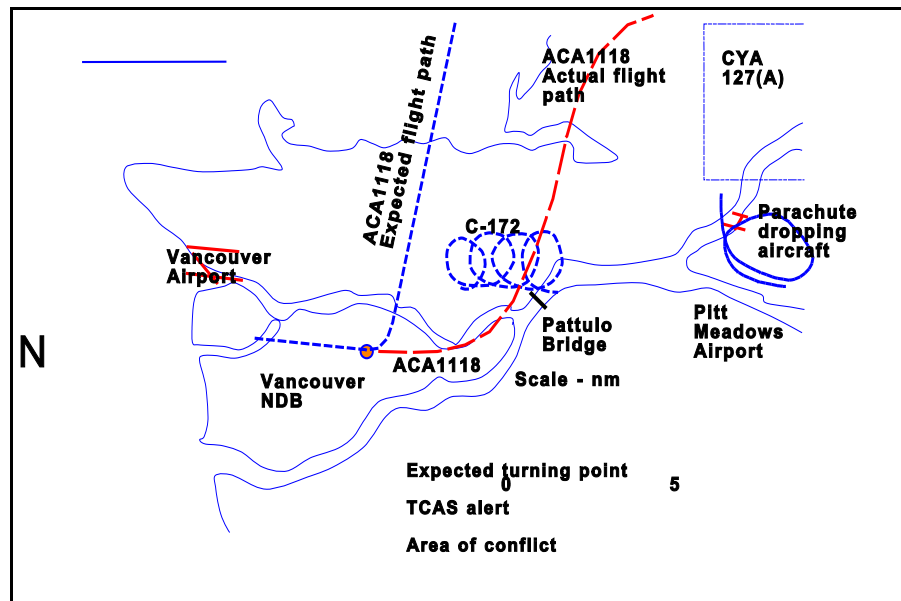
The new departure north controller's plan was to turn the A320 north so as to pass west of the VFR Cessna and avoid the other VFR aircraft operating near Pitt Meadows. Previous experience with other jet aircraft on departure from this runway led the controller to anticipate that the A320 would reach 3000 feet approaching the NDB and start the left turn. The controller judged that a turn near the NDB would have provided ample spacing between the A320 and the Cessna.

The departure controller's first ATC instruction was at 1641:41 Pacific daylight time¹ for ACA1118 to turn to a heading of 360° for traffic when reaching 3000 feet. (See Appendix A for a chronology of the events.) The pilot correctly acknowledged this instruction. However, the A320 did not begin to turn north where the controller had anticipated—near the NDB—and the controller recognized a developing traffic conflict. At 1642:16, he instructed the A320 to turn further left to 350°, which the pilot acknowledged. About 15 seconds after passing 3000 feet, about 2.5 nm past the NDB, the A320 began to turn left, to the north. At 1642:30, the controller informed the Cessna pilot about the conflicting A320 traffic. At no time did the Cessna pilot see the approaching A320.
