AVIATION INVESTIGATION REPORT

A01P0171

LOSS OF SEPARATION AND RISK OF COLLISION

VANCOUVER AREA CONTROL CENTRE—NOOTKA SECTOR

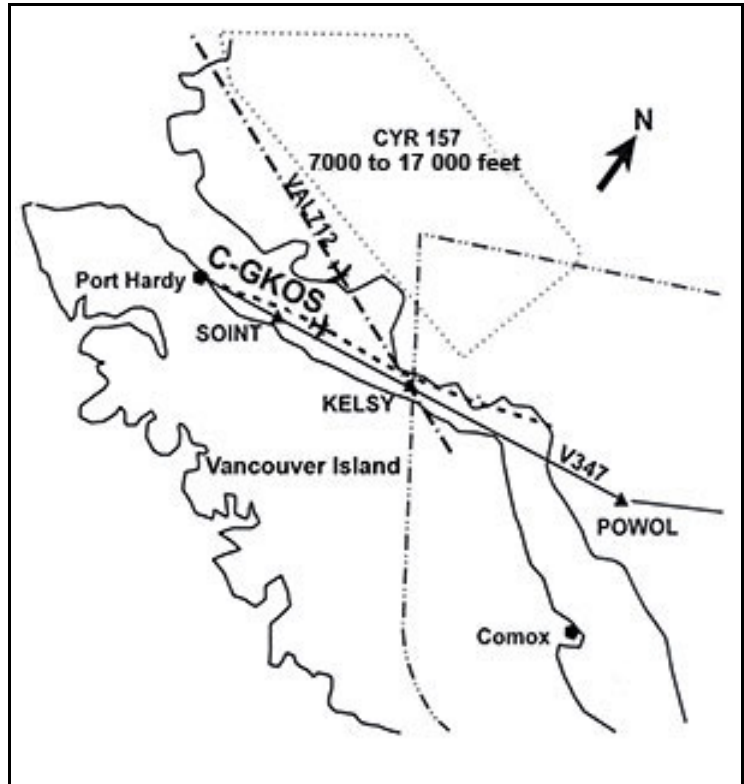
Air traffic control radar data show that the two aircraft were on a collision course of constant relative bearing until 10 seconds before the Comox controller advised the radar controller about the proximity of VAL712. At this point, the collision geometry began to change as C-GKOS increased its speed during normal climbout profile acceleration.

This incident occurred in the Nootka sector airspace (Figure 1), which is adjacent to military terminal airspace controlled by the Comox military terminal control unit at 19 Wing Comox.³ In this military terminal area, regulations require a minimum spacing between aircraft of 3 nm horizontally or 1000 feet vertically, but in the Nootka sector, 5 nm is required. A formal agreement between the Department of National Defence and NAV Canada further defines the responsibilities and the procedures applying to all aircraft transiting the two airspaces.⁴ In part, the arrangement requires that aircraft be separated by at least 5 nm when entering Comox airspace. In this incident, the required spacing between the two aircraft was not met and was unintentionally reduced to 0.8 nm at the same altitude.
