AVIATION INVESTIGATION REPORT

A02A0098

LOSS OF CONTROL / COLLISION WITH GROUND

BELL HELICOPTER TEXTRON 212 C-GDVG

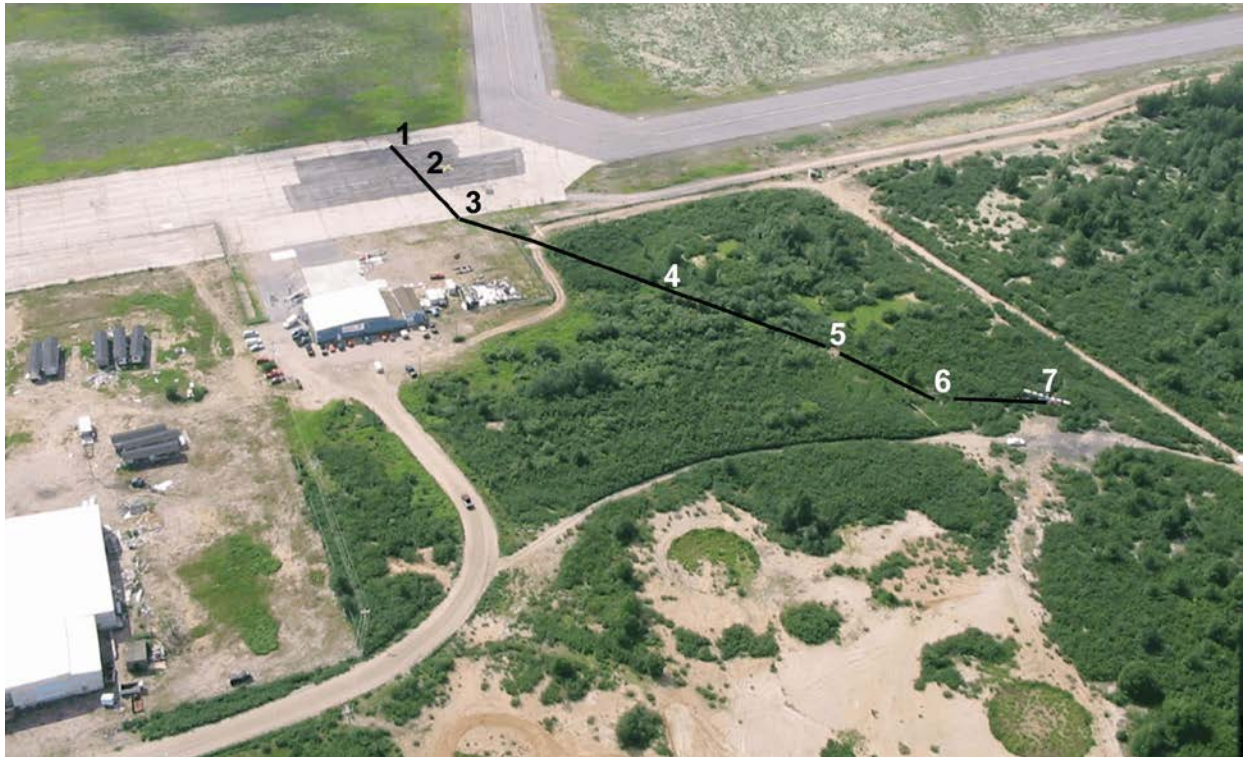
## *Appendix A – Accident Area*

### Accident sequence

1. Load pick-up
2. Load strikes ramp
3. Load strikes other sling road
4. Swatch cut digs in
5. Tow bar digs in
6. Trailer comes to rest
7. Helicopter comes to rest
