AVIATION INVESTIGATION REPORT

A02A0107

RUNWAY OVERRUN

DC-8-63F N441J

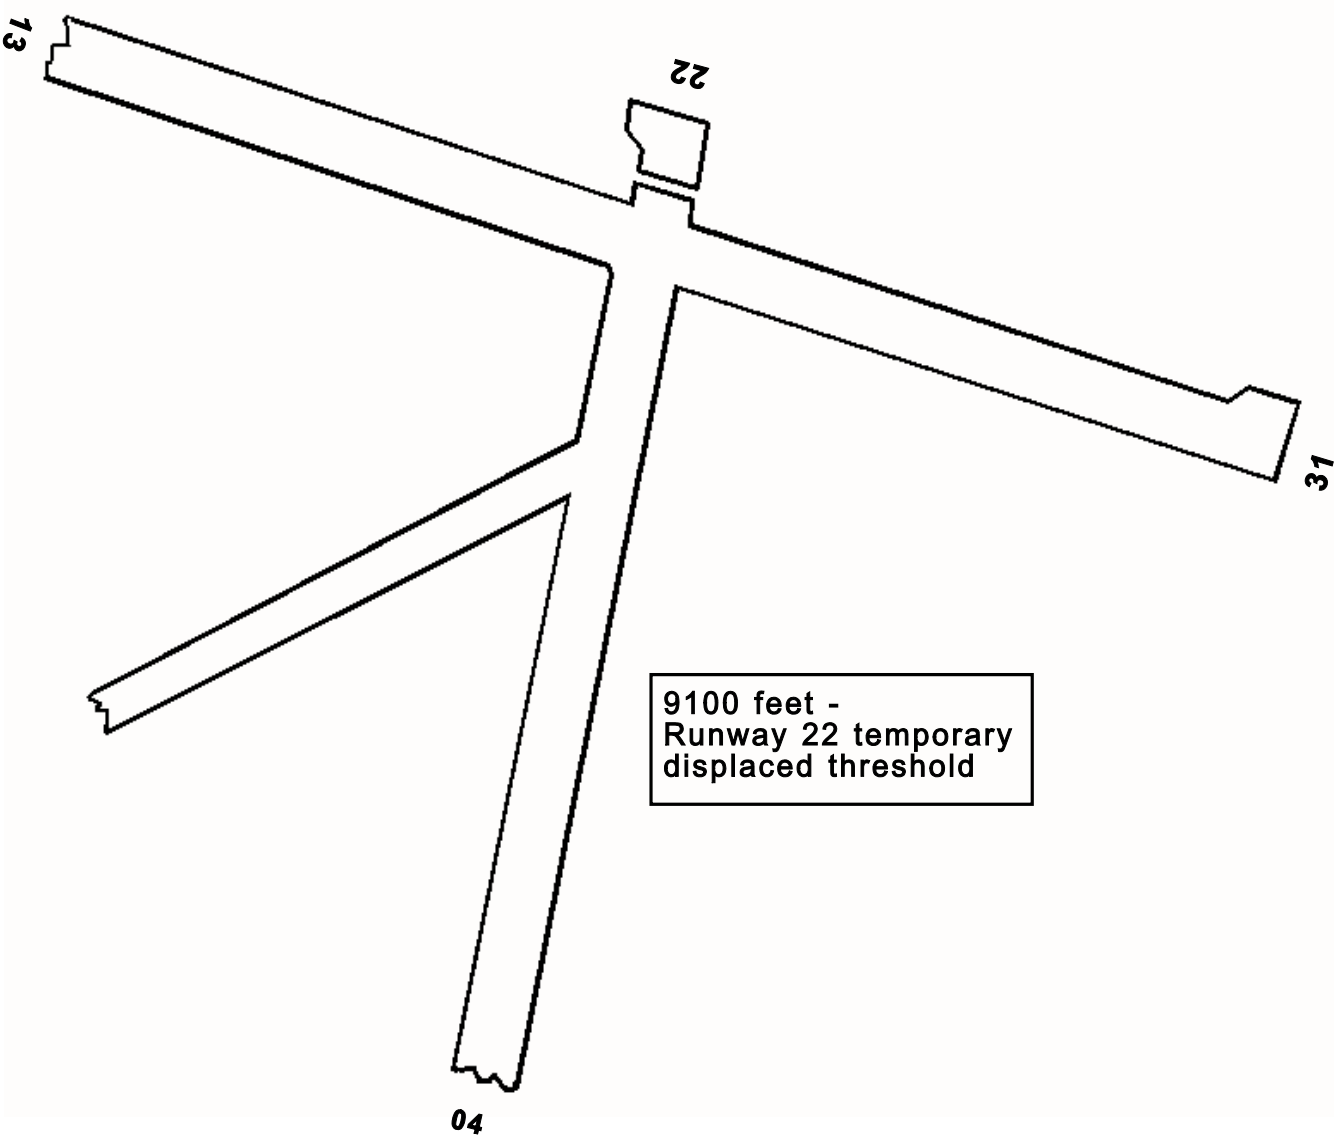
Appendix A - Runway Diagram

After landing, the captain immediately applied reverse thrust and wheel braking; however, the aircraft could not be stopped before the runway end. It struck wooden barricades at the far end of the runway and came to rest between 6400 and 7100 feet from touchdown, 10 000 feet from the runway threshold and 100 feet beyond the barricades (See Appendix A). After determining that there was no damage to the aircraft, the crew taxied the aircraft to the main terminal apron. There were no injuries. The incident occurred at 1135 Newfoundland daylight time.
