AVIATION INVESTIGATION REPORT

A02C0114

IN-FLIGHT ENGINE FIRE / FORCED LANDING

BELL 205A-1 HELICOPTER C-FMQN

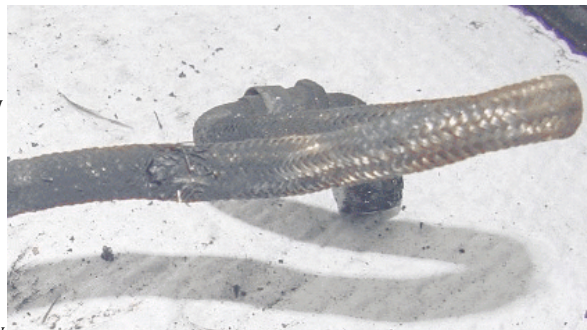
The fire was confined to the engine bay and the baggage compartment, which is directly underneath the engine bay deck. All engine indication electrical harnesses and interfaces were destroyed by the fire. The cap that houses the cooling fan on the starter generator had separated from the generator housing. The cap was retained over the cooling fan by the pinched fuel line. The cooling fan blades were missing. The cap is normally held in place by six countersunk screws on the rear of the starter/generator.

Removal of the starter/generator revealed that the hold-down nut at the 12 o'clock position was missing, and the hold-down nut at the 10 o'clock position was backed off approximately 0.125 inch. It was reported that the

retaining nut at the 12 o'clock position had been intentionally left off for ease of starter/generator removal and installation. The end of the starter/generator shaft showed signs of peening, indicating misalignment. The commutator and brushes of the starter/generator produce heat and sparks during normal operation.

The starter/generator and fuel hose assembly were forwarded to the TSB Engineering Branch Laboratory for analysis. The analysis revealed soot on the shoulders of the hold-down nut receptacles, on the attach flange of the starter/generator, at the 12, 10 and 8 o'clock positions. The starter/generator is normally held in place by six hold-down nuts. Analysis of the cooling fan indicated that the fan blades had been abraded away. No indication of a catastrophic failure of the fan blades was found. Analysis of the fuel hose indicates that the steel braid strands failed as a result of chafing.

The soot found on the shoulders of the 12, 10 and 8 o'clock hold-down nut receptacles on the attach flange of the starter/generator indicates that these three hold-down nuts were not fastened during the fire. Without these hold-down nuts being properly tightened, there would be insufficient clamping force holding the starter/generator in place, and it would vibrate. The vibration chafed a hole through the fuel line, allowing fuel to dribble past the cooling fan cap of the starter/generator and onto the commutator. It is likely that heat generated by the starter/generator and sparks emitted by the commutator and brushes acted as an ignition source, resulting in a fire. With power on, the engine produced fuel pressure in the chafed fuel line that kept feeding the fire. It was not determined how the fuel line became trapped between the top of the starter/generator and the diffuser housing.

1. The fuel line to the VIGVA was pinched between the top of the starter/generator cooling fan housing and the diffuser housing.
2. Three starter/generator hold-down nuts at the 12, 10 and 8 o'clock positions were not fastened, allowing the starter/generator to vibrate.
3. Because the fuel line was pinched against the vibrating starter/generator, it chafed through, allowing fuel to enter the starter/generator, which resulted in an engine fire.

Transport Canada is conducting a review of the applicable Bell 205A-1 instructions for continuing airworthiness to determine if action is necessary regarding the instructions for the installation of starter/generators and fuel lines.
