AVIATION INVESTIGATION REPORT

A02O0123

CARGO BAY FIRE

BOEING 767-300 C-GHML

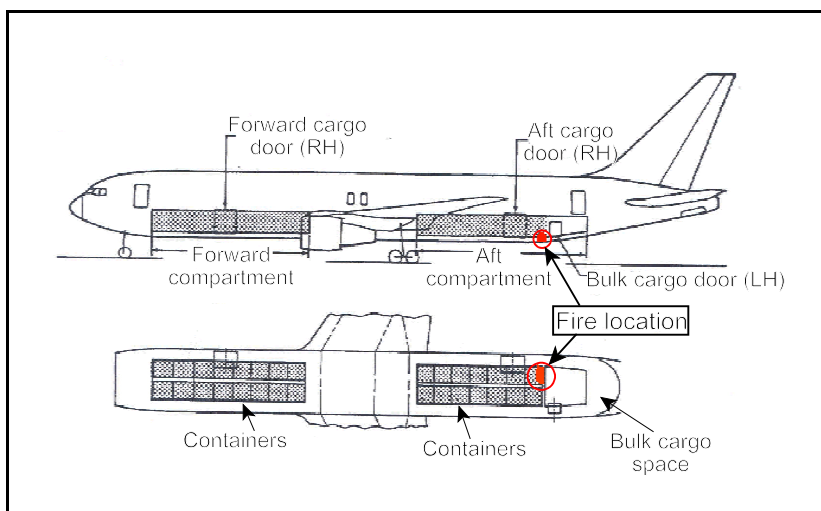
Figure 1. Fire location

The following morning, the Transportation Safety Board of Canada (TSB) was notified of the occurrence. A preliminary examination showed that the B110 heater ribbon, made by Electrofilm Manufacturing Co., on the aft water supply/drain line had failed and ignited the fire.

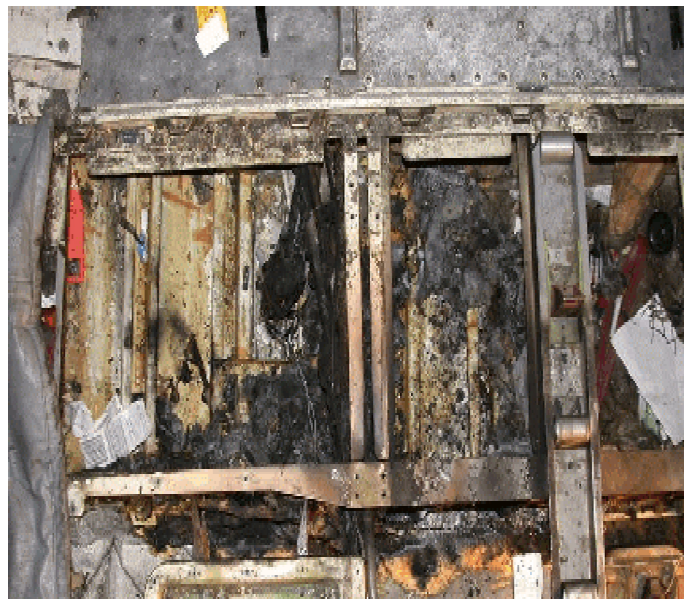
The fire was located below the floor level of the aft cargo compartment in an area defined longitudinally by fuselage station (FS) 1385 and FS 1412 and laterally by left buttock line³ (LBL) 6 and right buttock line (RBL) 50. The fire burned holes through the structural floor beam web at FS 1395, and consumed the thermal acoustic insulation on both sides of the floor beam. Also damaged were the underside of the floor board between RBL 22 and RBL 44, potable water lines, heater ribbons, and associated electrical wiring (see Photo 1).

Photo 1. Fire-damaged area

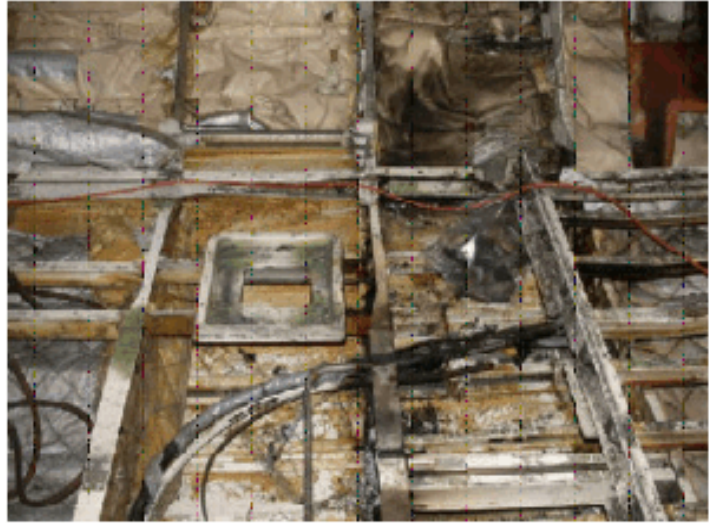
The Electrofilm brand heater ribbon failed aft of FS 1395. The heater ribbon was laid longitudinally along the water line and over the repair site. The heater ribbon overheated and arced at the forward edge of the repair, where the original water line ended and the stainless steel began. This resulted in the heater ribbon burning through the protective tape and the Rubatex foam insulation. Because electrical power was still being provided to the heater ribbon, the failure continued to move forward along the water line toward the source of electrical power.

Photo 3. Fire-damaged area

Approximately eight inches forward of the failure, where the water line passes through the FS 1395 floor beam web, the thermal acoustic insulation blanket mounted on the forward and aft face of the vertical web of the floor beam ignited. At this point, the fire became self-propagating and moved forward as far as FS 1385, aft as far as FS 1412, left as far as LBL 6 and right as far as RBL 50 (see Photo 3).

The fire burned miscellaneous debris and partially consumed the insulation blankets on the forward and aft face of the FS 1395 floor beam and the insulation blanket lining the bottom of the pressurized hull. As well, the fire damaged the underside of the floor board between RBL 22 and RBL 44. It breached the cargo compartment liner at RBL 44 and progressed behind the right sloping sidewall to RBL 50. The undersides of the two baggage containers loaded directly above the fire were scorched and blackened with soot, but showed no signs of damage. There were no reported claims of damage for any of the associated luggage or cargo. Externally, the fuselage paint directly below the fire location was blistered.

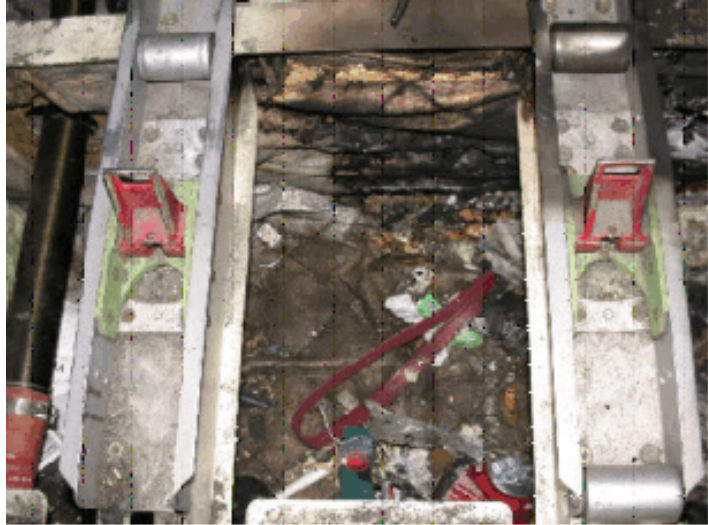
Contaminated thermal acoustic insulation blankets in the vicinity of the heater ribbon provided fuel for the fire. The contamination consisted of soiled insulation blankets and of flammable debris in the form of paper, candy wrappers, Styrofoam packing peanuts, small polyethylene beads, and rubber powder from a PDU (see Photo 4). Samples of the burnt PET-covered insulation blankets were analyzed for the presence of fire accelerants. An isoparaffin solvent was detected. These types of solvents are often clear

Photo 4. Contaminated insulation blankets and debris

combustible liquids that readily form flammable mixtures; they are used for parts cleaning and degreasing applications and as solvents in inks, paints, and agrochemical formulations such as pesticides. They may have originated from sources such as aircraft cargo, luggage, recent repair or maintenance activities, or from pesticide products. The occurrence aircraft had been operated in South America and may have been exposed to pesticides in association with operations in a tropical environment. The isoparaffin contaminant would, if retained, create a significant heat release once ignited. The relatively high-temperature, localized fire damage observed on the floor beam web of the occurrence aircraft is consistent with a post-fire effect from the isoparaffin solvent alone or in combination with combustible debris.

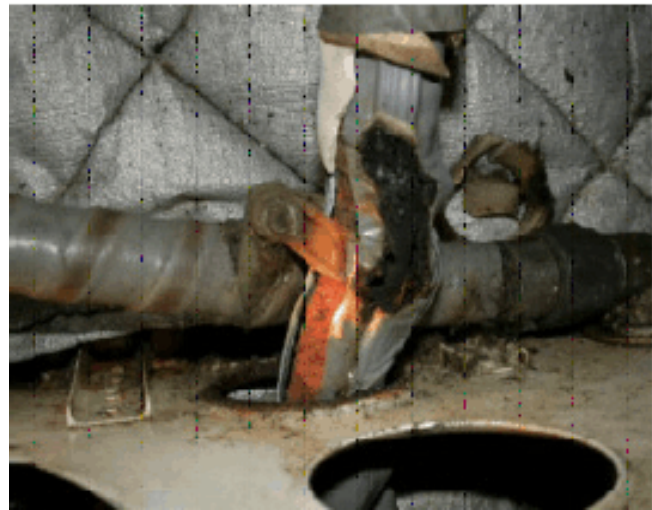
In addition to the fire damage associated with the occurrence flight, TSB investigators found a burned Cox & Company heater ribbon, protective tape, and Rubatex foam insulation behind the aft wall of the aft cargo area on the occurrence aircraft (see Photo 5). Although a self-propagating fire had not occurred, the area had become hot enough to burn through the Rubatex foam insulation and a nearby plastic clamp.

Photo 5. Burned heater ribbon behind aft wall

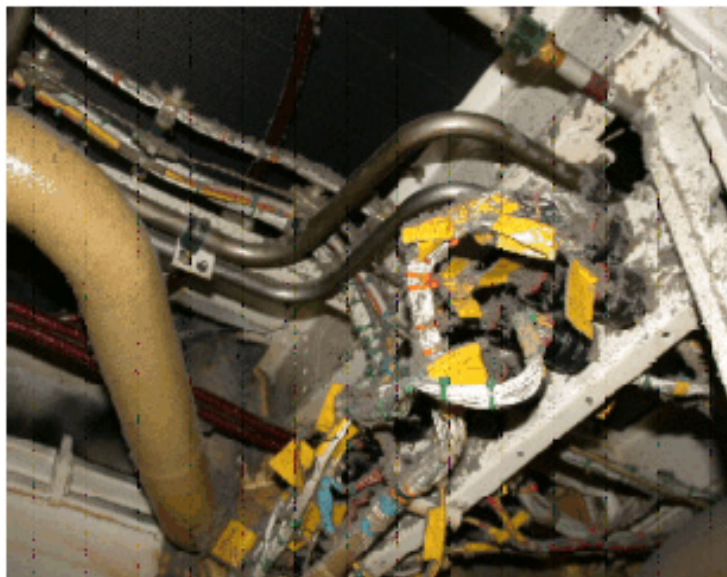
Photo 6. Dust and lint accumulation on wiring bundles behind wall panel

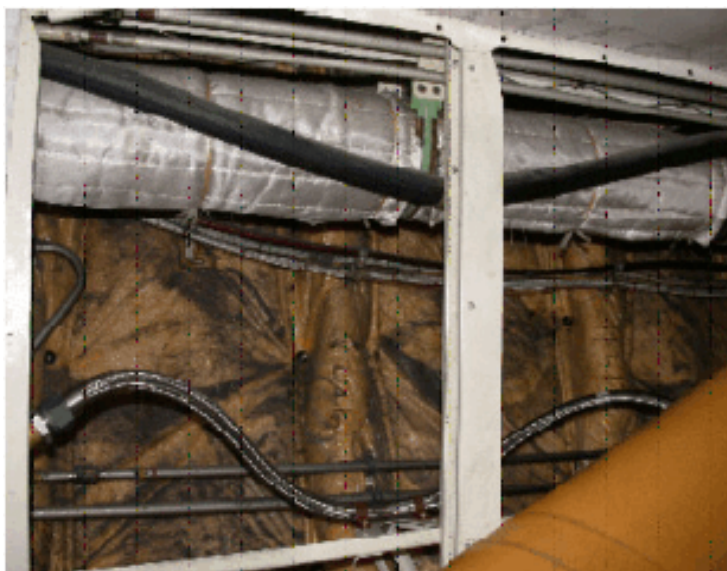
Photo 7. Dust and lint accumulation on thermal acoustic insulation behind wall panel
