AVIATION INVESTIGATION REPORT

A02Q0098

IN-FLIGHT SEPARATION OF RIGHT WING

GILLES LÉGER SUPER CHIPMUNK C-GLSC

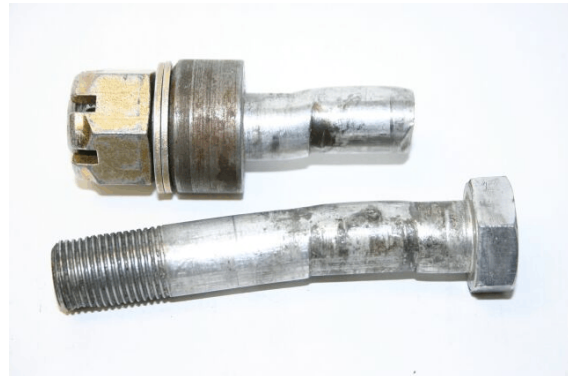
The builder-pilot could not find any original attachment bolts (original reference 06256 then 05179), which were specifically made by de Havilland. These bolts had a diameter of 0.731 inch and were tempered to 150 ksi.<sup>2</sup> The bolts used by the builder (AN10-23) were 0.625 inch in diameter. The hardness standard for these bolts is established at 125 ksi, and the bolts from the accident aircraft were measured at 26 to 28 on the Rockwell scale, which corresponds to 123 ksi to 129 ksi. Therefore, the bolts were in compliance with the AN standard. However, an O-shaped mark on the bolt head indicates a strength of 145 ksi to 165 ksi, according to the National Aircraft Parts catalogue. It was determined that, using bolts tempered to 125 ksi, the strength of the fitting was reduced to 61 per cent of the original strength; using bolts tempered to 150 ksi reduced it to 72 per cent. Bushings were machined to adapt the size of the holes to the bolts. Photo 1 shows the failed bolt from the right main spar. The lower bolt is from the left spar. Its deformation indicates that it was about to fail.

All the structural elements related to the wing attachments were thoroughly examined at the TSB Engineering Laboratory. The report found that the lower bolt from the right main spar failed first. The initial upward movement of the wing tore the front attachment fitting, and the wing then folded aft, tearing the root of the upper fitting of the main spar from the wing.

Observations made about the bolt indicate that it failed under combined shearing and tension caused by stretching when it was deformed.

1. The aircraft was subjected to stresses exceeding its structural envelope, and the bolt securing the right lower spar failed in overload.

2. The four bolts securing the main spars to the fuselage had been replaced with bolts of lesser diameter and strength. The strength of the replacement bolts was approximately 61 per cent to 72 per cent of that of the original bolts.

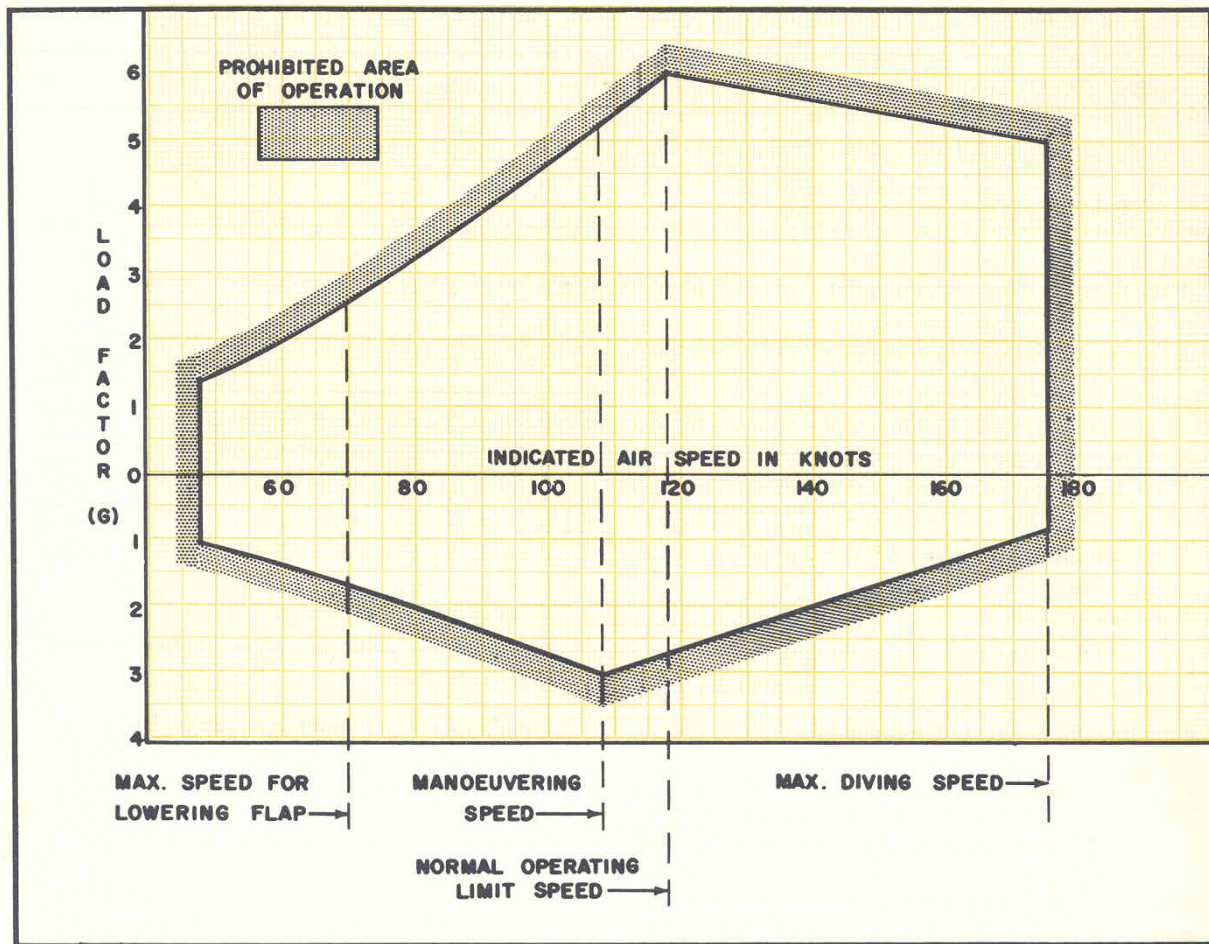
Appendix A - Load Table: Chipmunk

The builder had an excerpt from the Chipmunk manual indicating that, at a maximum weight of 1930 pounds and an indicated airspeed of 136 mph, the DHC-1B could withstand a load factor of 9 g. The document also indicated that, at 230 mph, the maximum load factor was reduced to 6.75 g. However, the document was accompanied by a graph indicating that the highest load factor could be reached at 136 mph (120 knots) and that it was limited to 6 g. According to the graph, the load factor decreases to 4.9 g at the maximum indicated airspeed of 202 mph (175 knots). It was not possible to determine from which manual precisely the excerpt was taken (see Appendix A).

Pursuant to Section 523.303 of the regulations, except where otherwise indicated, a safety factor of 1.5 must be applied to maximum loading. The resulting value is referred to as ultimate load.<sup>3</sup> Theoretically, based on the graph at Appendix A, the unmodified wings of the original Chipmunk mounted on the Super Chipmunk could have withstood an ultimate load of 7.2 g before breaking or being permanently deformed. The ultimate load would be calculated as follows: 1930 pounds x 6 g x 1.5/2400 pounds. However, the relationship between the increase in the maximum allowable weight and the load factor is not necessarily linear, and testing it normally required to confirm the strength factor. Since the aircraft was not intended to be certificated for unlimited aerobatics, no strength tests or calculations were required by the regulations. Therefore, the builder was not required to provide a new flight parameter graph. The Super Chipmunk documentation describing the aircraft characteristics indicates that the aircraft will withstand a positive load factor of 9 g and a negative load factor of 6 g.
