AVIATION INVESTIGATION REPORT

A02W0064

COLLISION WITH TERRAIN

ROBINSON R22 BETA HELICOPTER C-FVBG

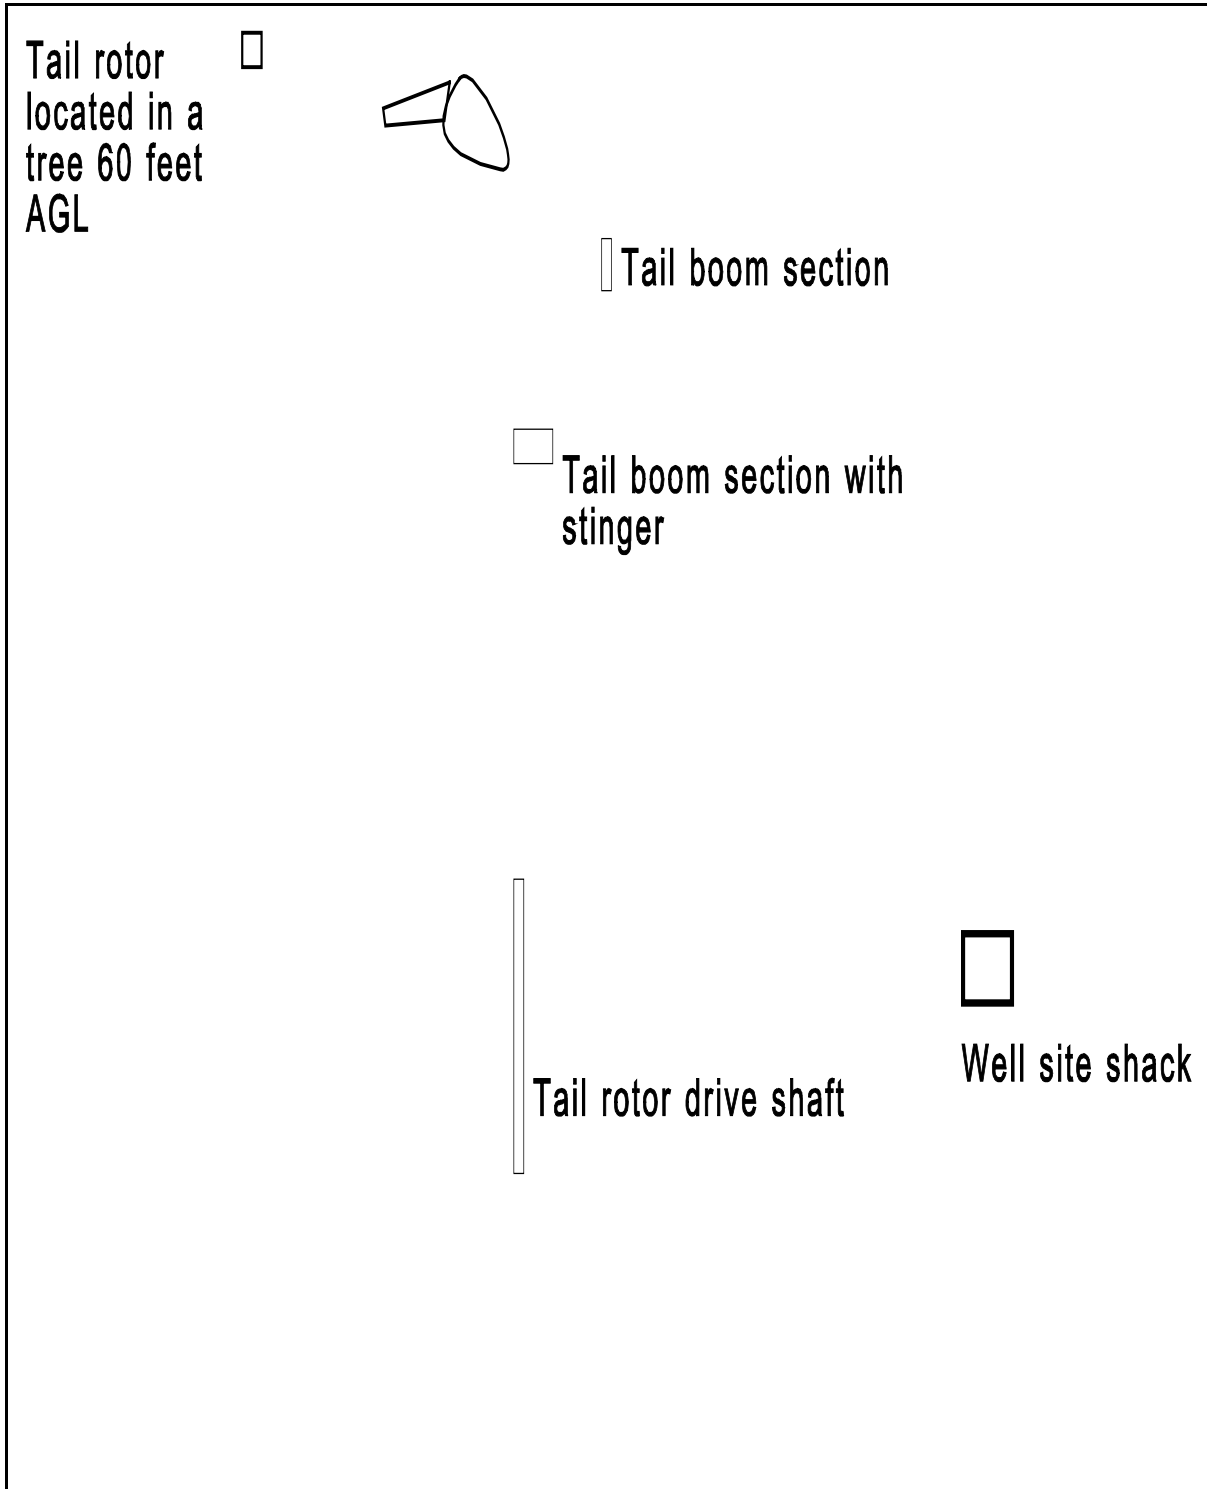
Appendix A - Diagram of the Accident Site

The helicopter had crashed in the northwest corner of a well site. Several tree tops were observed to have been struck and broken. A tree, approximately 60 feet tall and 35 feet behind the wreckage, held a nearly intact tail rotor and tail cone section about 2 feet long. The remainder of the hull was forward of this on the edge of the site, in an upright position, with the engine section deeper in the ground than the cabin. The bottom portion of the tail rotor warning stinger was found approximately 40 feet forward and to the right (about 45°) of the main wreckage. The forward portion of the tail boom had two main rotor strike indications. Each M/R blade also had a bent leading edge and paint residue from the tail boom. Most of the windscreen/canopy was shattered into various pieces and spread forward of the main cabin. A section of tail boom that held the rotating beacon had been hit with a main rotor blade and was approximately 50 feet in front of the cabin. The tail rotor drive shaft was to the right of the wreckage approximately 150 feet. (See Appendix A).
