AVIATION INVESTIGATION REPORT

A02W0115

LOSS OF SEPARATION

EDMONTON AREA CONTROL CENTRE

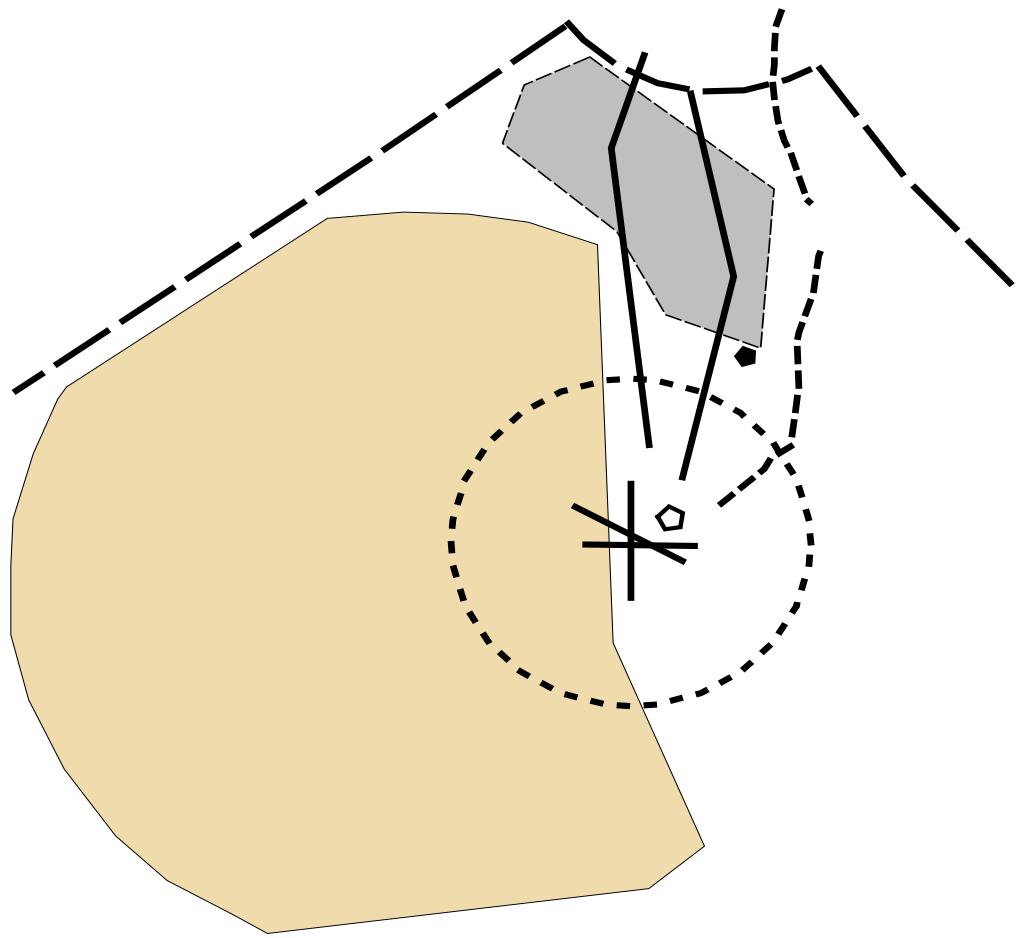
Appendix A - Occurrence Diagram

For the three-day duration of the G-8 Conference at Kananaskis, Class F restricted airspace (CYR255) was established to prevent unauthorized aircraft from entering the area. CYR255 was an irregularly shaped area with an approximate 80 nautical mile radius around the conference site. (See Appendix A - Occurrence Diagram). Aircraft travelling west from Calgary had to be routed around the northeast corner of CYR255 in the Red Deer en route sector before proceeding west. Civilian flights were only to be allowed into the restricted area in emergency situations, and unauthorized aircraft penetrating the restricted area were at risk of being intercepted by military fighters.
