AVIATION INVESTIGATION REPORT

A03O0135

LOSS OF CONTROL ON WATER

DE HAVILLAND DHC-6-300 (AMPHIBIOUS) C-GOGC

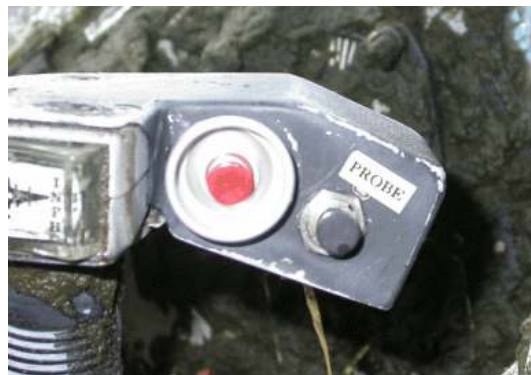
There is a probe control switch toggle switch located on the centre panel. At the request of flight crews, a push button probe switch was added to the control yoke. Once the modification was complete, the probes were controlled by the push button switch installed adjacent to the bomb door push button switch on the yoke (Figure 1). The pilots could now operate the doors and probes by moving the thumb between the two switches, while maintaining both hands on the yoke. The bomb door push button switch and probe switch are similar in size and type.

Figure 1 - Bomb door and probe switches on aircraft yoke

C-GOGC was not equipped with a hinged cover plate over the bomb door switch. It was reported that the original switch became unserviceable and was replaced, but the hinged cover plate was not reinstalled. During the investigation, a second MNR Twin Otter was flown to Hornepayne, and it was observed to have a hinged cover plate covering the bomb door switch.

During the approach, the Vital Action checklist was not completed as per the SOPs, and the bomb door armed switch was left in the On position. After completing the scooping operation, the pilot intended to retract the probes by pressing the probe switch but inadvertently pressed the adjacent bomb door switch. Since this system remained armed from the previous bombing run, the doors extended into the water. The drag from the doors and the water rushing into the floats through the door openings resulted in the aircraft nosing over. The proximity of the probe and bomb door push button switches and the missing cover plate on the bomb door switch increased the likelihood of selecting the bomb door switch instead of the probe switch.

The MNR has verified that every Twin Otter aircraft in their fleet is equipped with the cover plate over the bomb door push button switch. The MNR will ensure that any future modifications to aircraft will be standardized to decrease the potential for inadvertent operation of systems.

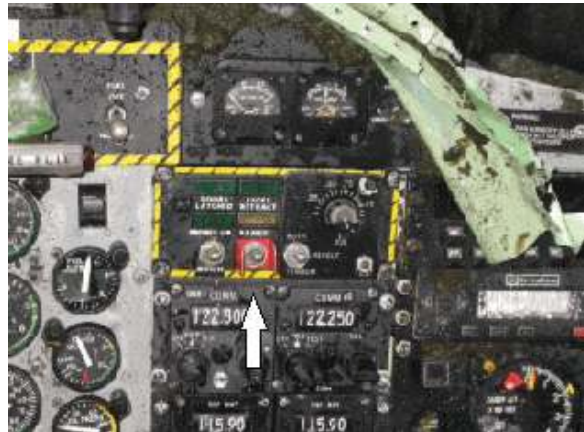
Prior to scooping, the bomb door armed switch on the centre panel must be selected Off to prevent the inadvertent activation of the bomb door open operation if the bomb door push button switch is pressed. The armed switch should be On only after the scooping operation is complete and the floats have cleared the water surface. After the occurrence, when the position of the centre panel switches were examined, the door armed switch was found in the On position.

Figure 2 - System indicating lights and door armed switch (indicated by white arrow) in the On position

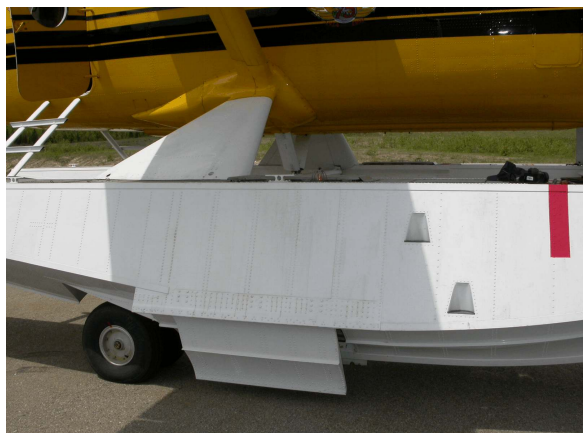
On initial examination of the aircraft, the right bomb doors were found in the extended position. The left bomb doors were closed, but there were indications of damage where the trailing edge of the doors and the float interface. When the aircraft was raised to an upright position, both sets of left bomb doors free fell to the extended position. The probes were fully extended.

Figure 3 - Left bomb door open

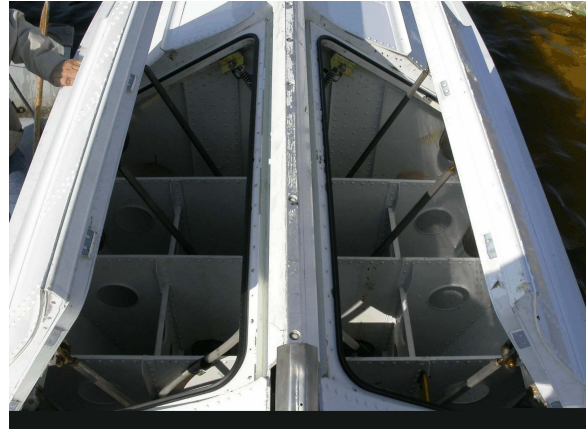
Figure 4 - Bomb doors open (float upside down)
