AVIATION INVESTIGATION REPORT

A03O0341

LOSS OF CONTROL AFTER TAKE-OFF

DE HAVILLAND DHC-3 (OTTER), C-GOFF

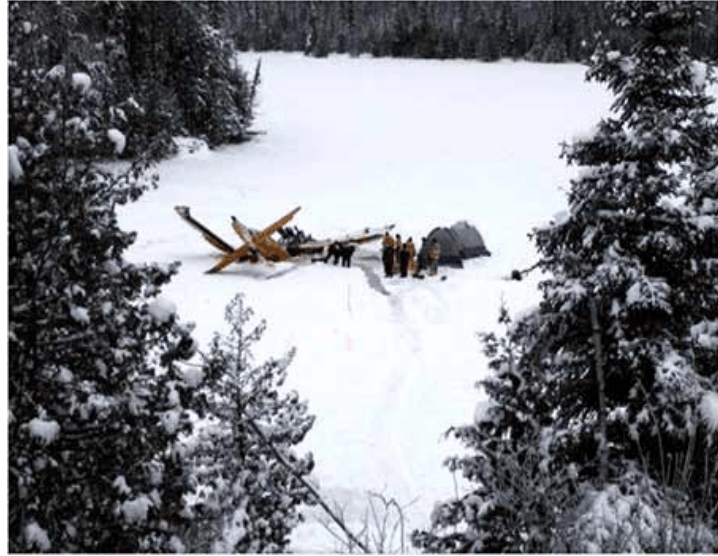
Photo 1. View looking downward from the end of the airstrip.

The airfield is located on private property, and the east/west airstrip is approximately 3400 feet long. Winter maintenance is limited to plowing a vehicle road that provides access to a maintenance hangar. Trees line the west and south sides of the airstrip, and at the east end of the runway there is a drop-off of approximately seventy feet to a lake. A metal tower, equipped with an anemometer, a windsock, and temperature and humidity transmitters is located at the midpoint of the airstrip on the north side.

Examination of the tracks showed that the main landing gear skis and the tail wheel had maintained contact with the snow throughout the take-off roll and had lifted off at the same moment, just prior to the departure end of the airstrip. The distance between lift-off and the end of the airstrip where the aircraft's wing contacted the brush was approximately 370 feet, and the impact with the tree was a short distance beyond that. Information obtained from the airstrip owner, the surviving passenger and a local air operator, who also operated a turbine-equipped Otter, indicated that this type of aircraft would normally be airborne by the mid-point of the airstrip, approximately abeam the metal tower.

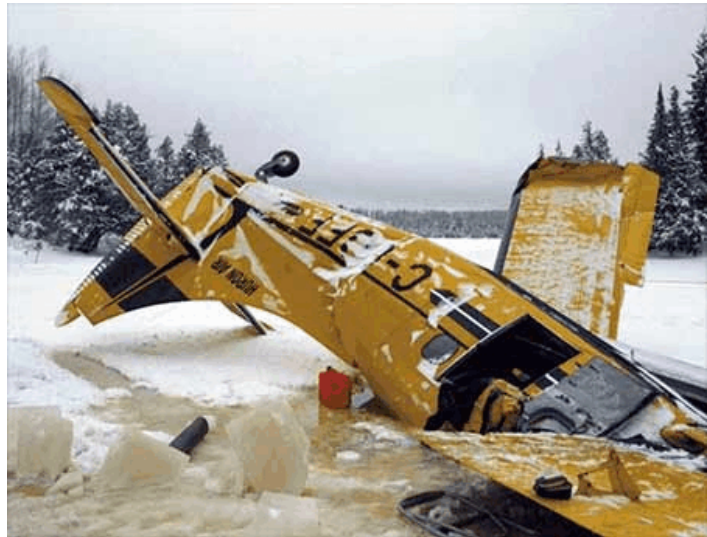
The aircraft wreckage was removed from the lake and examined. The cockpit compartment and most of the fuselage aft of the cockpit was substantially damaged. Both wings had separated from the fuselage at the wing-to-fuselage attachment points. The right wing had substantially more damage than the left as a result of absorbing the initial impact forces with the frozen surface. From the mid-point of the fuselage to the tail section the damage was minor. The propeller separated from the engine and a section of the gearbox remained attached. The extensive curling and torsional twisting of the propeller blades indicated that the engine was producing substantial power at impact. A flight control examination revealed no anomalies. The main landing gear was equipped with wheel/skis. The wreckage examination determined the two skis were down during the take-off. The track markings in the snow at the airstrip also indicated the skis were in the down position. Examination of the wheel/skis revealed no sign of contamination on the base of the skis.

Photo 2. Aircraft came to rest on the frozen lake surface.

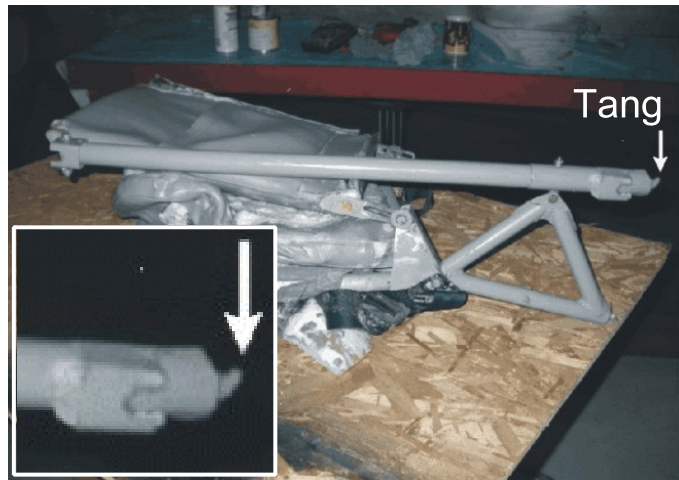
It was determined that the folding, cabin utility seat, occupied by the survivor, failed in overload. Further examination revealed that the tangs (Photo 3) at the bottom of the seat legs, which are inserted into the floor pick-up plate for seat security, were facing rearward. A de Havilland Alert Service Bulletin (A3/49 dated 19 July 1991) called for an inspection of the tangs to verify they are facing forward. In this occurrence the impact was of sufficient force that the seat would have failed even if the tangs had been installed correctly.

Photo 3. Survivor's seat — arrow points to the tang in the reversed position.

1. The validity of the aircraft's certificate of airworthiness was affected while it flew more flights than allowed by the ferry permit issued by Transport Canada.
2. The rear passenger seat was found to be installed incorrectly, contrary to de Havilland Alert Service Bulletin A3/49, dated 19 July 1991.
