AVIATION INVESTIGATION REPORT

A03W0148

LOSS OF POWER – MECHANICAL MALFUNCTION

BELL 204B C-GTNP

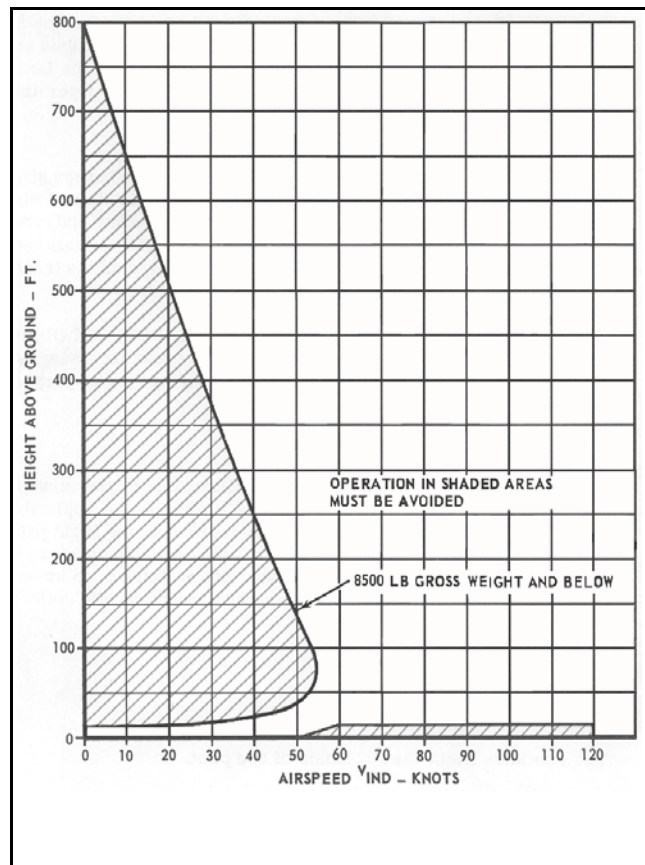
Section 1 of the approved flight manual for the Bell 204B (BH204) contains a height-velocity (H-V) chart, which has a shaded area that was originally a flight limitation “. . . critical in the event of an engine failure during take-off, landing or other operation near the surface” (see Figure 1). Operation in this critical area reduces the possibility of a successful autorotative landing in the event of an engine failure. This H-V chart has been appended as an operating limitation for Canadian-operated helicopters conducting external load operations, as an addendum (BHT-204-FM-CAN-O) to the flight manual. However, the information is relevant for all low-level operations.

The helicopter was being operated at a weight exceeding the maximum out-of-ground-effect hover weight, but within the increased gross weight limit with an external load at the time of the accident. The increased weight would have required a significant amount of collective pitch for all phases of flight, especially at lower speeds or in a hover. When the engine failed, the undriven main rotor blades generated a considerable amount of drag, resulting in the rapid decay of the main rotor speed. This loss of rotor speed reduced the rotor system kinetic energy available to the pilot for control of the helicopter’s descent, and, combined with the low altitude, the attached load and airspeed delineated within the critical area of the H-V chart, thereby increasing the severity of the impact and injuries.

1. The helicopter was being operated at a weight that exceeded the maximum out-of-ground-effect hover weight, and within the speed and height parameters that the aircraft flight manual H-V diagram states should be avoided.

- stressing the importance of understanding and applying aircraft performance charts, specifically, hover in and out-of-ground-effect charts and the H-V charts;
- including more detailed questions regarding performance charts on the written aircraft type examinations; and
- establishing an in-house pilot decision making course, using in-house examples for review.
