AVIATION INVESTIGATION REPORT

A04C0174

LANDING GEAR COLLAPSE – RUNWAY EXCURSION

FAIRCHILD SA-227-AC METRO III C-FIPW

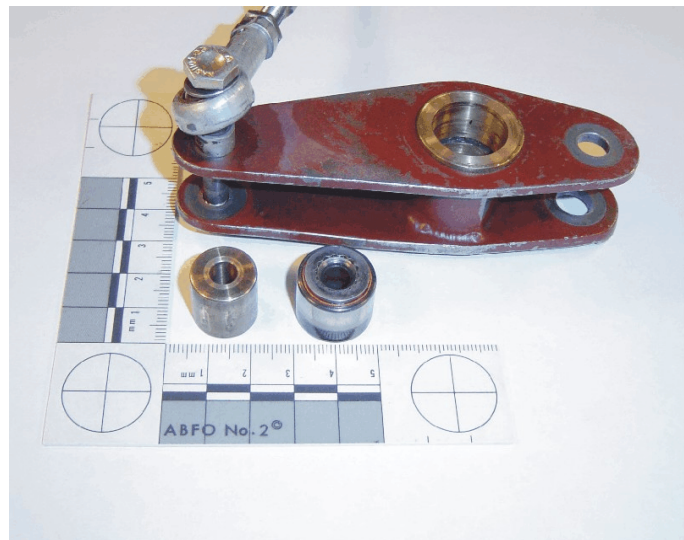
The outboard bellcrank roller could not be measured because the roller was found to be undersized (0.625-inch diameter instead of the designed 0.750-inch diameter). The smaller diameter roller reduced the required rigging allowances for the bellcrank-to-cam assembly in the down-and-locked position. Marks or gouges were found on the roller where the lip of the positioning cam had been making contact.

A review of the aircraft technical records showed that the left gear outboard bellcrank roller had been replaced with a part number 5453032-1 roller on 09 August 2004, approximately 209 flight hours prior to the accident. The manufacturer's parts manual shows part number 5453032-1 to be that of a landing gear uplock roller for this type of aircraft's vice bellcrank roller; it is made of a solid bushing material (see Figure 1). The proper bellcrank roller is listed as a part number YCRS-12 bearing, comprised of an outer race running around rollers over an inner race. The YCRS-12 bearing roller is larger in diameter than the one installed.

Photo 1. Bellcrank assembly with a part number 5453032-1 roller on the left and a YCRS-12 bearing on the right

The roller installed on the outboard landing gear bellcrank was of a smaller diameter than the required part and was designed to be used as an uplock roller vice bellcrank roller. The smaller diameter of the roller reduced the required clearance in relation to the roller's location on the heel of the positioning cam. Repetitive landing loads transmitted through the drag brace were initially absorbed by the roller hitting the lip of the cam, until the lip of the cam was worn away. The wear eventually allowed the roller to move beyond the cam cutout position. Consequently, the drag brace was primarily held in the down-and-locked position by the inboard bellcrank roller and the positioning cam, both of which were out of adjustment and held in position by spring tension only.

All maintenance staff of the AMO responsible for Northern Dene Airways Ltd.'s aircraft met to review the company's maintenance procedures outlined in its *Maintenance Policy Manual*. The following policy was reinforced: "No one is to install any parts on any aircraft without first referring to the appropriate parts and service manuals to ensure correct part number and also that the integrity of the affected aircraft system is still in place."
