AVIATION INVESTIGATION REPORT

A04O0237

FLIGHT CONTROL DIFFICULTIES

DE HAVILLAND DHC-8-102 C-FGRP

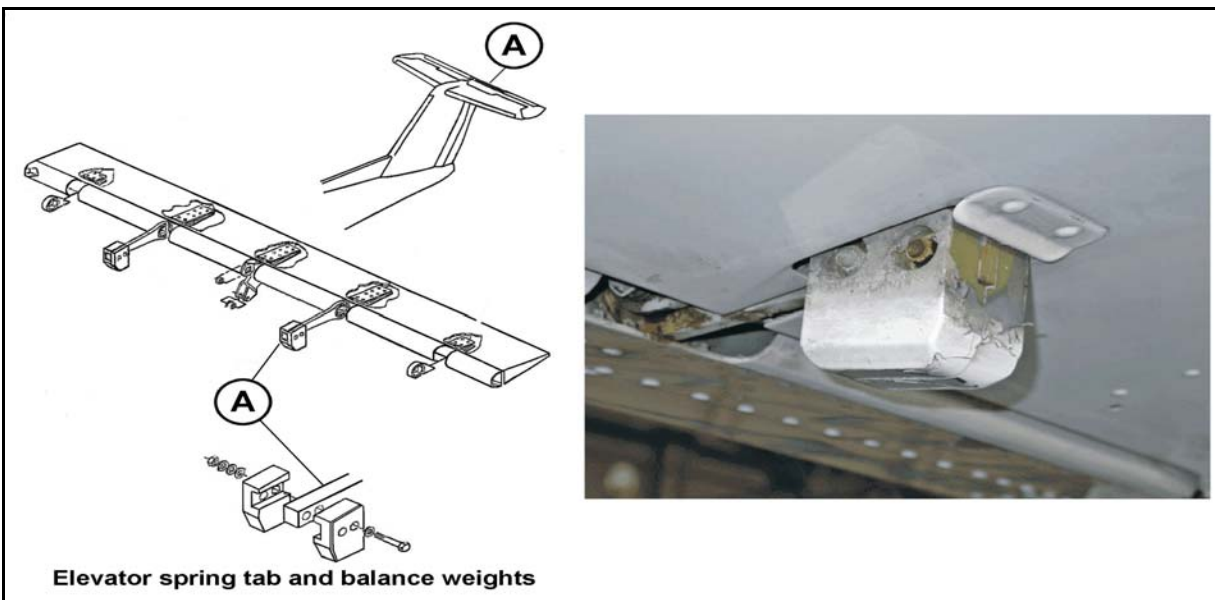
Figure 1. Elevator spring tab and balance weights

When the aircraft was inspected after landing, half of one of the balance weights from the right-side elevator spring tab, and the two nuts that secure it were missing. The two bolts had migrated out of the remaining half weight and jammed on the top surface of the elevator, holding the elevator spring tab in the trailing-edge-down position.

Elevator Spring Tab Operation

Although it is possible that the nuts and washers were not reinstalled for the balance check, it is more likely that they were installed but left loose intentionally to facilitate re-removal of the weights should additional grinding be required. In any event, the final step of tightening them was overlooked. Without the nuts installed, the bolts migrated out of the weights, and when the outboard weight fell off, the bolts jammed on the top surface of the elevator.

1. The nuts securing the counter balance weight to the weight arm were not tightened. They fell off, which in turn allowed the bolts to migrate out of the weights. When the outboard weight fell off, the bolts jammed on the top surface of the elevator.
2. The independent inspection was not adequate, in that it did not reveal that the securing nuts were not tight.

- The inspection form "Preparation for Aircraft Paint Visit" was amended to record additional information that will indicate if it was necessary to adjust the balance weights when the control surfaces and tabs were checked for balance.
- A communication was transmitted to all maintenance personnel to restate the requirements and expectations of an independent inspection.
- Procedures are being drafted to monitor, approve, and limit extended amounts of overtime.
- Flight crew training syllabuses are being modified to include information and procedures for "soft" jam situations.

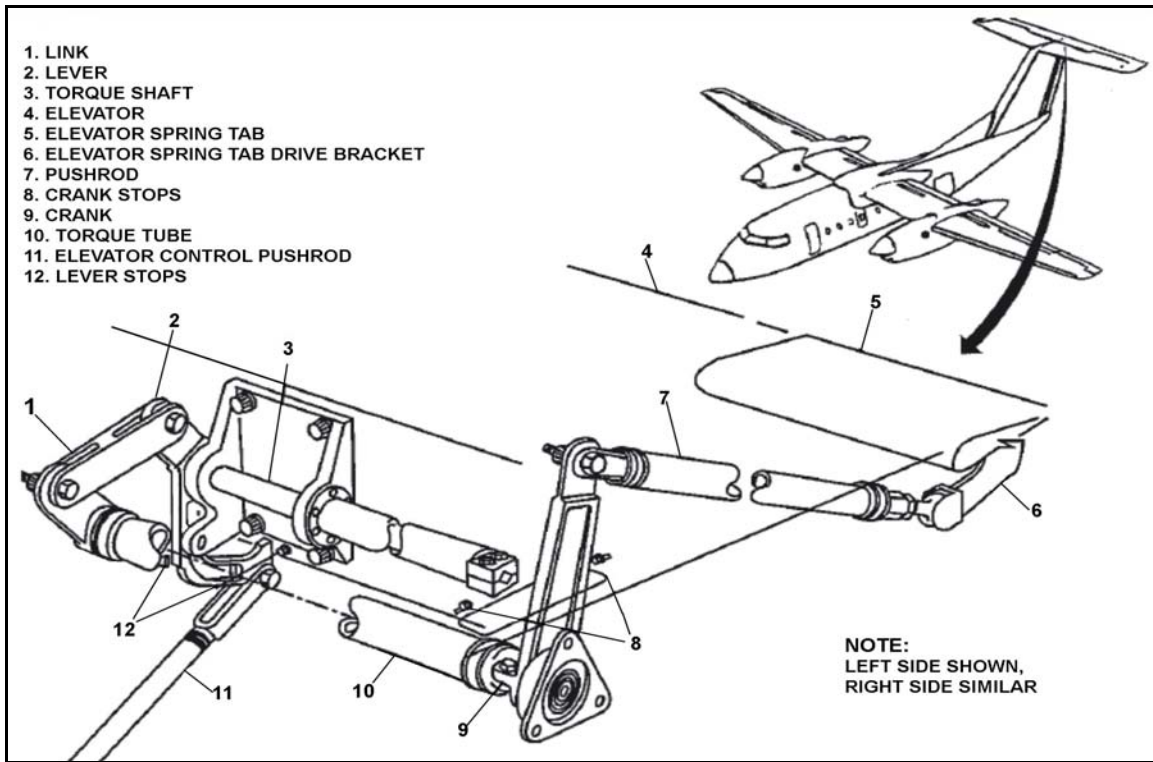
Figure 2. Elevator control

When the elevators are actuated, the control column movements go directly to the spring tab and then to the elevator through the torque shaft (see Figure 2, item 3). With the airplane on the ground and no aerodynamic load, the stiffness of the torque shaft overcomes the weight of the elevator, causing it to move with the control column. The geometry of the actuating hardware causes the elevator to move in the opposite direction to the spring tab. Maximum spring tab deflection is limited by the crank stops (Figure 2, item 8), after which the elevators are moved directly by the control column. Maximum elevator deflection is limited by the lever stops (Figure 2, item 12).

The flight data recorder showed that the two elevators were moving approximately in sync with each other until the aircraft was accelerating on the take-off run. The maximum differential in elevator deflection was reached when the airspeed was at approximately 120 KIAS; the right elevator was approximately 12° trailing edge up and the left elevator was approximately 8° trailing edge down. According to calculations completed after the occurrence, at 185 KIAS, the stress on the tail was close to its structural limit, and a specific, one-time maintenance inspection was designed to look for additional damage.

When the right elevator spring tab was checked, it was nose heavy and required rebalancing. This work was not noted on the check sheets. Checking the balance of the elevator spring tab is accomplished by disconnecting the tab drive bracket (Figure 2, item 6) from the pushrod (Figure 2, item 7) and attaching a specific weight to the trailing edge of the tab. The rebalancing was accomplished by removing the steel balance weights and grinding some material from the
