AVIATION INVESTIGATION REPORT

A04P0033

IN-FLIGHT BREAKUP

BEAR CREEK CONTRACTING LTD.
ROBINSON R22 (HELICOPTER) C-FILW
KUMEALON INLET, BRITISH COLUMBIA
20 FEBRUARY 2004

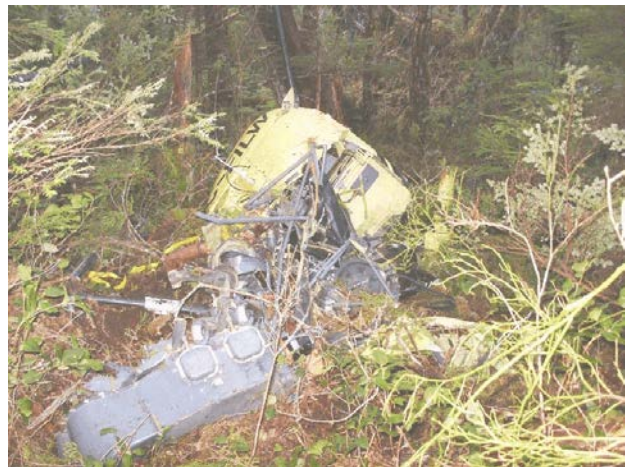
The detached main-rotor blade was found three days after the accident approximately 150 metres from the main wreckage site. It was bent more than 90 degrees down at approximately 78 cm from the blade root. The pitch horn was bent and the pitch change rod was broken. Examination of the wreckage

indicated that the blade attachment bolt had broken at the coning hinge, so an extensive search of the area was carried out. Part of the subject bolt was found a week later. It was examined with optical enhancement and determined to have broken/sheared from overload. The other blade attachment bolt was examined and found to demonstrate signatures of an impending shear. Both bolts were tested for hardness and dimension; they met design specifications.
