**AVIATION INVESTIGATION REPORT**  
**A05C0222**

**RUNWAY EXCURSION**

**AIR CANADA**  
**AIRBUS A319-112 C-GJTC**  
**WINNIPEG INTERNATIONAL AIRPORT, MANITOBA**  
**26 DECEMBER 2005**

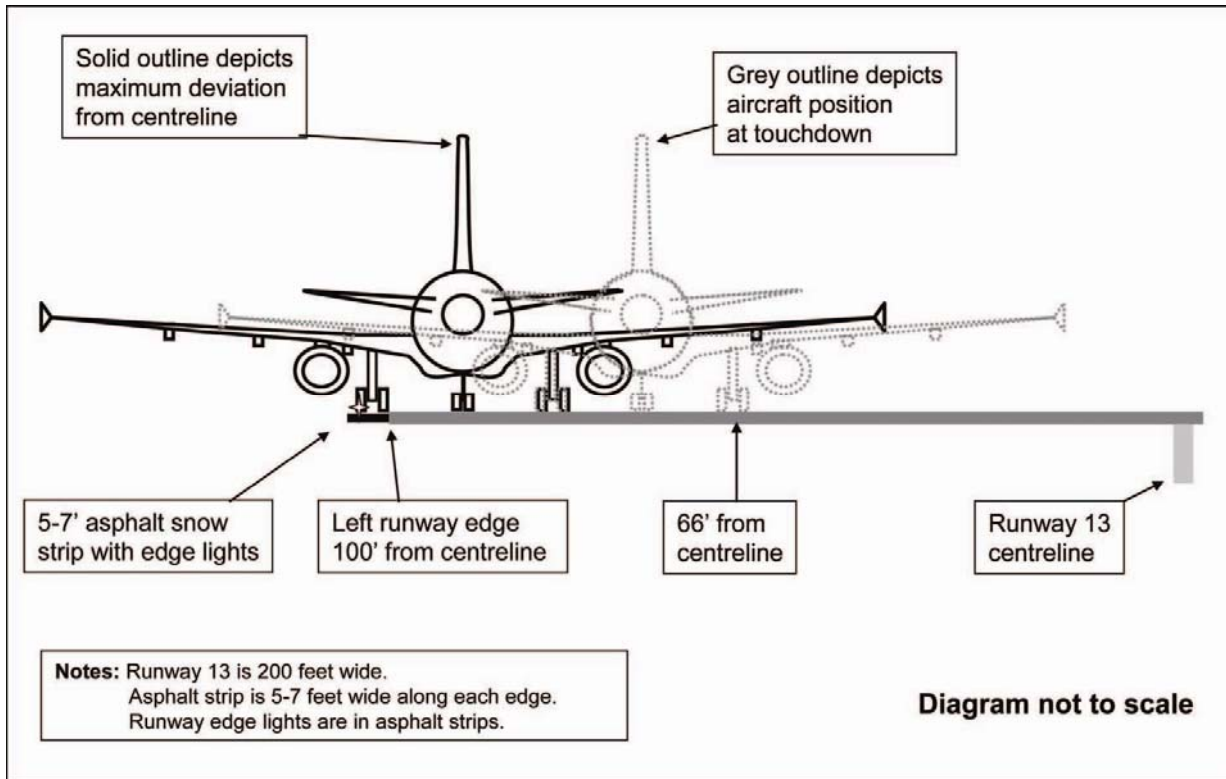
**Figure 1.** View in direction of landing

are spaced at 200-foot intervals for the full length of the runway and were set at full intensity, level 5, at the time of the incident. The edge lights are light weight and frangible. The lights are positioned about five feet outside of the runway edge, in asphalt strips. The asphalt strips, which extend seven feet on each side of the runway and along its entire length, facilitate snow clearing around the edge lights (Figure 1).

A runway inspection was conducted by airport staff immediately after the occurrence. Skid marks from the aircraft's right main gear tires were found on the runway. Two broken runway edge lights were found in the path of the aircraft's left landing gear (see Figure 1).

The skid marks of the right main gear tires continued towards the left edge of the runway for about 350 feet and then tracked back towards the centreline for another 350 feet. The furthest point of the right main gear tires skid mark from the centreline was approximately 83 feet. The left main gear of the aircraft struck two runway edge lights. Approximately 350 feet from the touchdown point, the left main gear was about 108 feet from the centreline, 8 feet outside the runway, on the left asphalt snow strip (see figures 1 and 2).

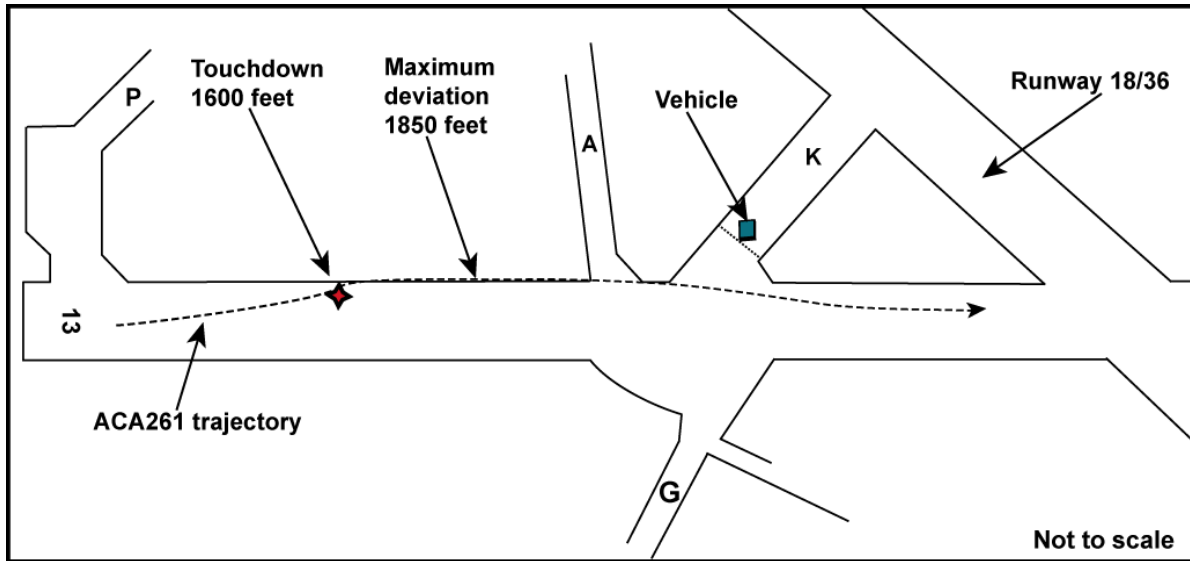
Figure 2. Overhead view of Runway 13 and ACA261 trajectory

The radar tape showed the aircraft crossing the runway threshold near the runway centreline. The aircraft then drifted left of the centreline, with the radar track corresponding to the wheel skid marks found on the runway. The ASDE also revealed that, as ACA261 was landing, a vehicle was holding on Taxiway Kilo, at the hold line for Runway 13 (see Figure 2).
