AVIATION INVESTIGATION REPORT

A05O0258

LOSS OF CONTROL – COLLISION WITH TERRAIN

RYAN AERONAUTICAL NAVION B C-FTRM

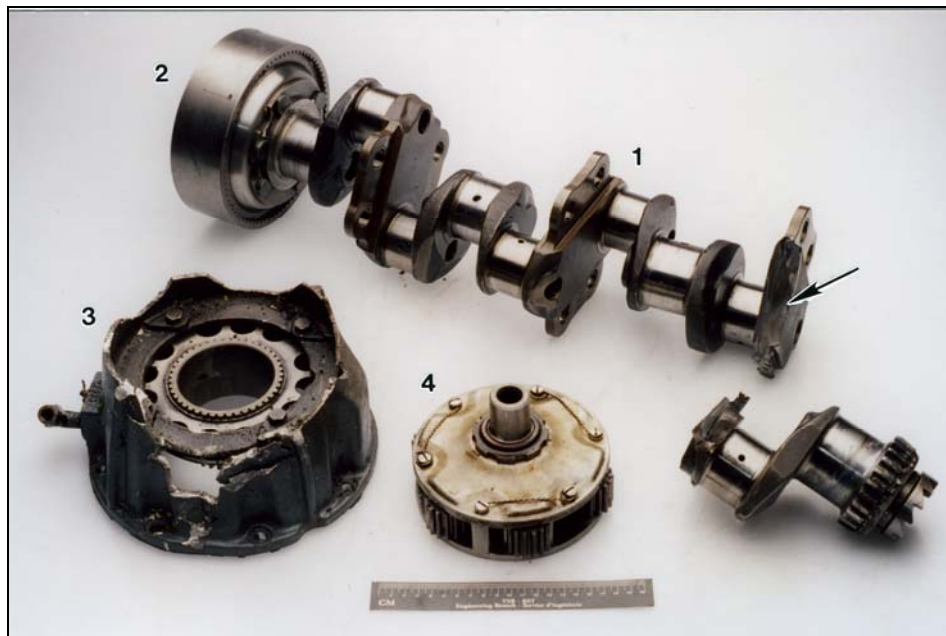
The fractured crankshaft and parts of the engine-to-propeller reduction gearbox assembly are shown in Photo 1. The location of the failure, as shown in Photo 1 by the small arrow, was at the forward fillet radius of the number six connecting rod journal (see Photo 2 – Close-up of fractured crankshaft).

Photo 1. Fractured crankshaft (1) and reduction gearbox assembly (2, 3, and 4)

A crack on the crankshaft initiated on the surface of the forward fillet radius to the number six connecting rod journal. Examination of the crankshaft revealed crack progression markings that confirmed the fracture as a progressive fatigue failure. The fatigue crack progressed across 95 per cent of the cross section of the crankshaft, before its fracture. The final fracture occurred as the weakened shaft was unable to sustain the applied loads. The transition from the fatigue crack to the fracture appeared continuous, indicating that the failure occurred while the engine was being run under normal operations.

The material of the crankshaft was a low alloy steel containing manganese, chromium and nickel alloying additions. The general structure of the crankshaft showed hardness consistent with the required quenched and tempered heat treatment process, performed during the manufacture of the crankshaft. However, the forward fillet radius to the number six connecting rod journal and the journal surface showed an absence of case hardening at the origin of the fatigue crack. The equivalent location on the aft fillet radius and the forward radius 180° from the fatigue crack origin showed acceptable case-hardened layers. The number five connecting rod journal also showed the presence of normal case-hardened surface layers. There is no indication in the engine logbooks of any reworking of the crankshaft. It is possible that the absence of the case hardening at the fatigue crack origin dates from the time of manufacture and installation in the engine. This may have contributed to a faster crack growth rate than would normally be the case for a properly manufactured crankshaft.

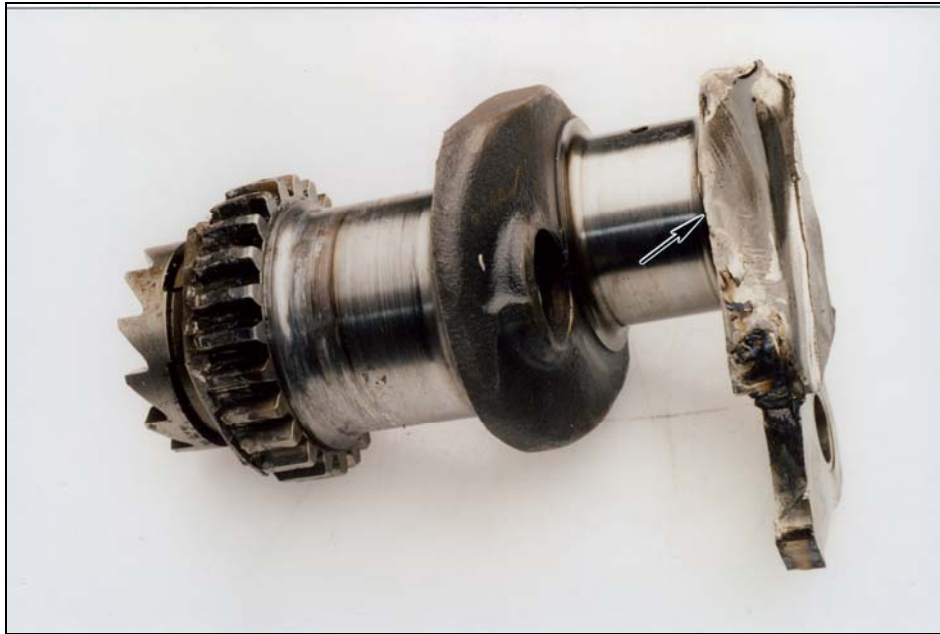
Photo 2. Close-up of fractured crankshaft

A section of the fracture surface, including the crack origin area and a portion of the fillet radius, was removed for scanning electron microscope (SEM) examination. This examination did not reveal any overload, such as a propeller strike, before or after the initiation of the fatigue crack. Close inspection of the origin area with the SEM showed regions of corrosion pitting, which may have been where the fatigue crack originated.

The crankshaft failed as a result of a fatigue crack that developed on the forward fillet radius of the number six connecting rod journal. The crack most likely originated in an area where there was corrosion pitting. The fatigue crack developed at an undetermined time during the lifecycle of the engine and was not discovered on any of the three overhauls that were recorded in the aircraft logbooks. The crack appeared to have spread under normal operating conditions until the crankshaft could not support the required operating loads. The absence of a case-hardened layer on the fillet radius in the region of the fatigue crack initiation also contributed to the failure. The deficiency in the material heat treatment condition is believed to have been the result of a manufacturing error. Fatigue failure of the engine crankshaft resulted in a complete loss of power.

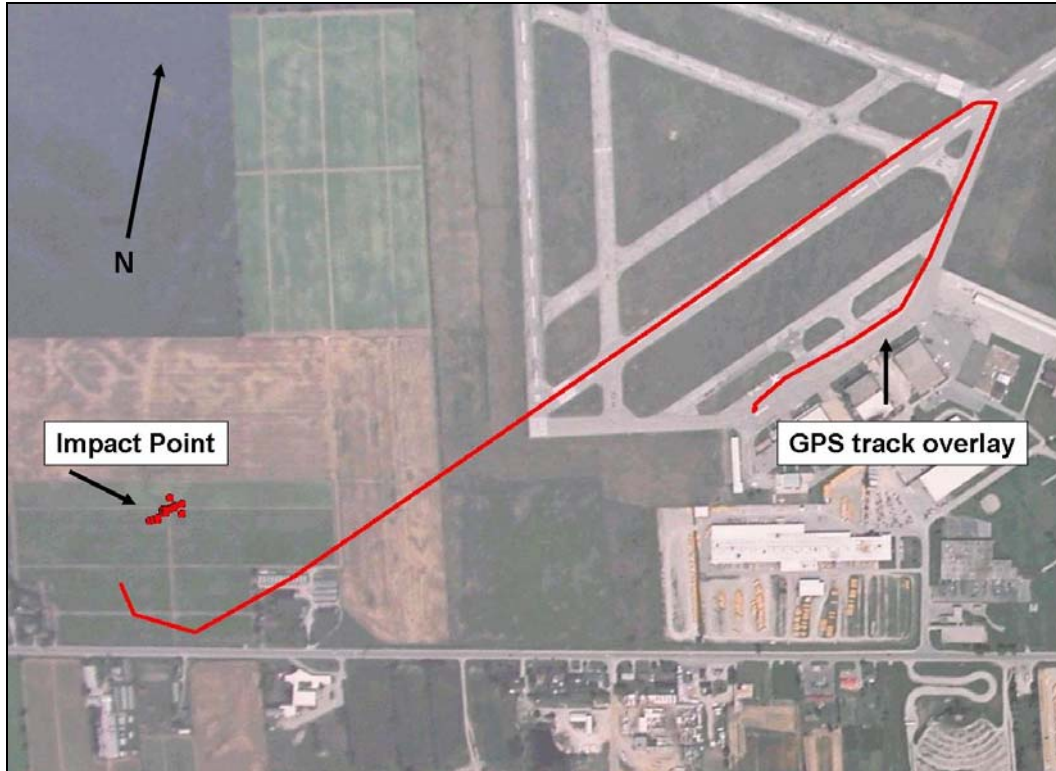
The aircraft was equipped with a Garmin 295 global positioning system (GPS). Although extensively damaged during the accident, the GPS memory was successfully downloaded at the TSB Engineering Laboratory. Information regarding the occurrence take-off was retrieved from the GPS (see Appendix B – GPS Overlay of Brantford Airport). The data indicated that the aircraft climbed at a rate of 850 feet per minute (fpm) until reaching an altitude of 450 feet above ground level (agl). The groundspeed decreased from 72 mph to 48 mph and the track of the aircraft increased from 222° T to 273° T before any loss of altitude. The rate of descent was initially 1300 fpm and increased to 3000 fpm before impact.

Photo 3. Overhead view of airport and crash site with GPS track

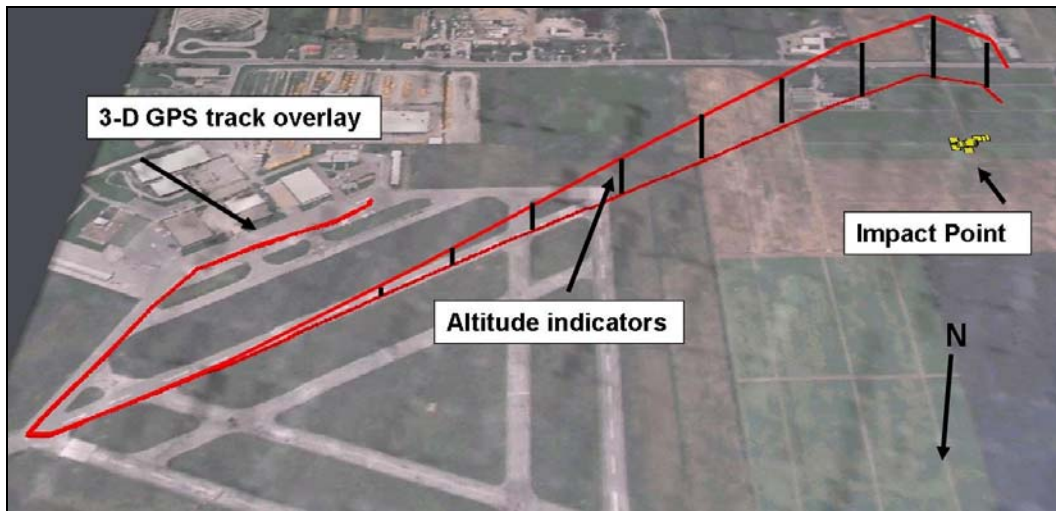
Photo 4. Overhead view of airport and crash site with 3-D GPS track overlay
