## AVIATION INVESTIGATION REPORT

A05W0205

**POWER LOSS - MECHANICAL MALFUNCTION**

**BELL 205A1 N205HQ**

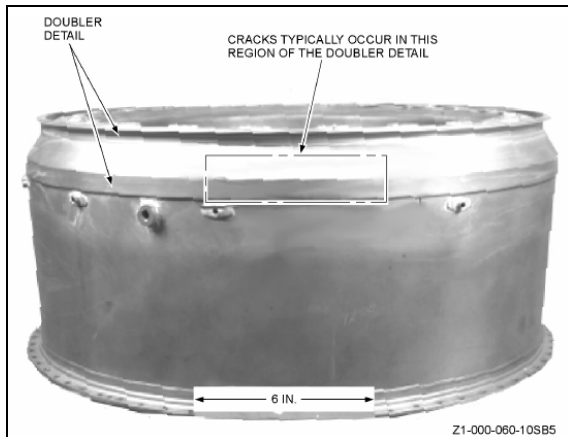
Examination of the engine revealed a large circumferential crack in the combustion chamber housing (CCH). The crack allowed high-pressure air from the engine compressor section to escape, resulting in a loss of engine power. The crack was 46 inches long and encompassed about 210° of the circumference of the chamber. It was centred on the approximate 6 o’clock position. The crack had propagated from multiple fatigue cracks initiated by corrosion pits on the inside diameter surface of a doubler joining the two main sections of the CCH (see photos 1 and 2).

**Photo 1.** Rear outer flange doubler detail

Due to the manner of construction of the CCH, an internal circumferential gap exists where the two sections are joined by the doubler. The internal circumferential gap allows the accumulation of moisture and combustion products.

The internal circumferential gap that existed in the CCH where the two sections were joined by the doubler allowed the accumulation of moisture and combustion products, which initiated and accelerated the corrosion and pitting process. Elimination of this gap by welding or other means would have prevented the corrosion.

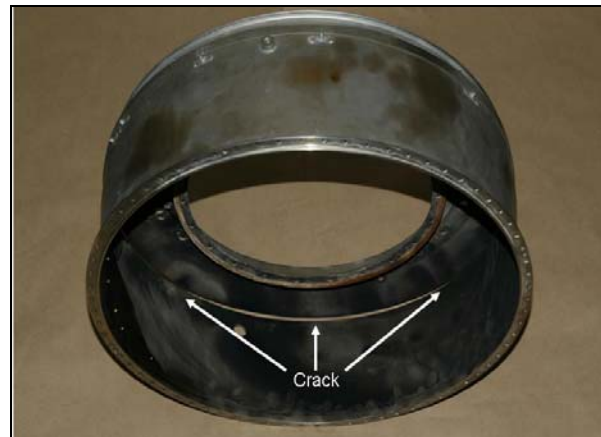
**Photo 2.** CCH crack detail (N205HQ)

On the CCH involved in this occurrence, there was a previous weld repair on the doubler, and the weld had been polished and refinished as to be almost undetectable. One end of the crack terminated at this weld. It was determined that the weld was not involved in the initiation of the crack; in fact, the weld had arrested the crack.

1. The engine failed when the combustion chamber housing (CCH) fractured and high-pressure combustion air was lost.
2. Internal corrosion pitting and cracking of the CCH was not detected by external inspection.
